## RCI & ESI Report – August 2023

Riparian Condition Improvement  
&  
Agricultural Practice Improvement

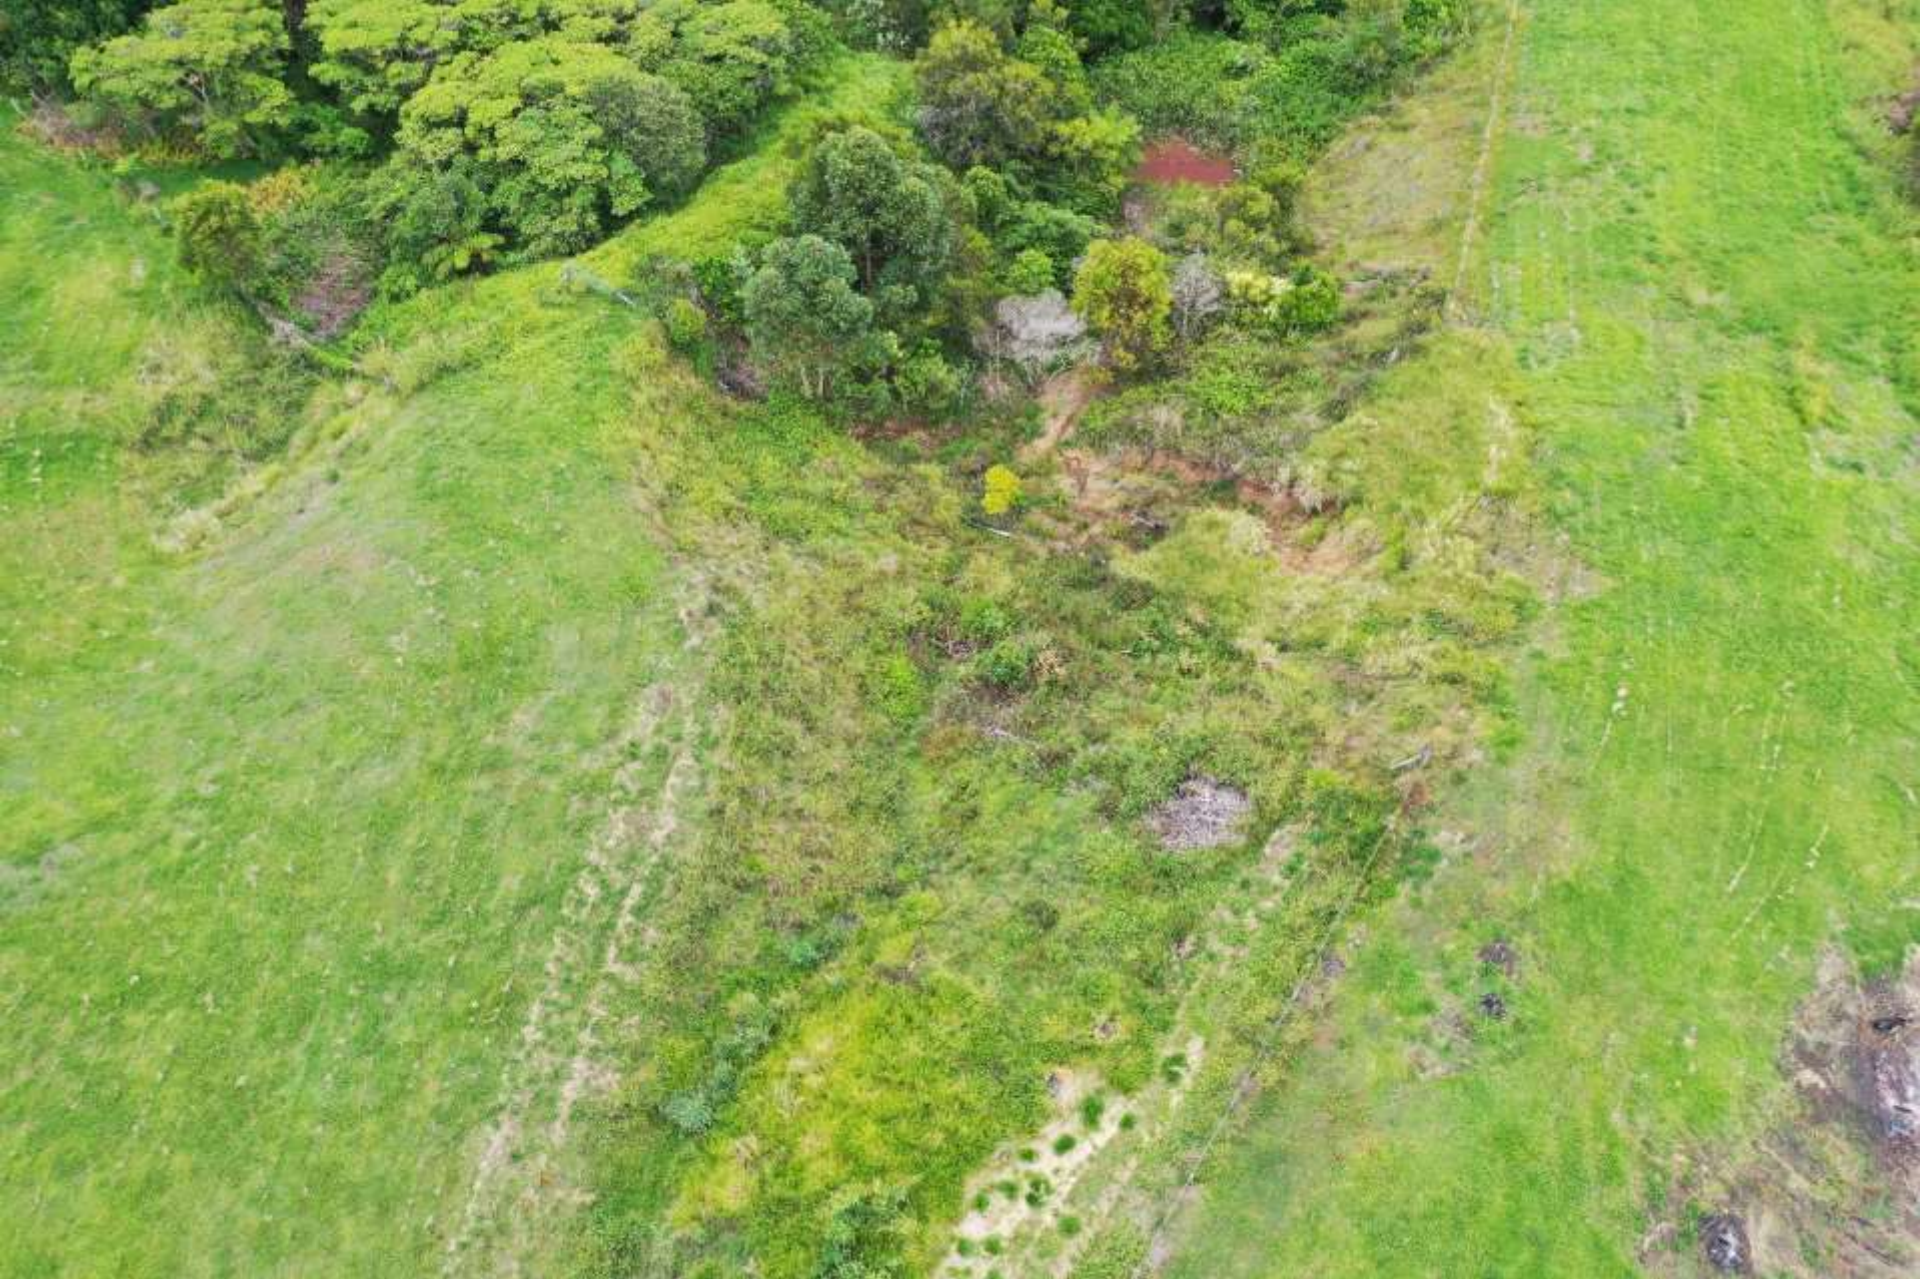
March 2023 – before project commencement

- Landslip and gully erosion causing sedimentation and turbidity in Obi Obi Creek.

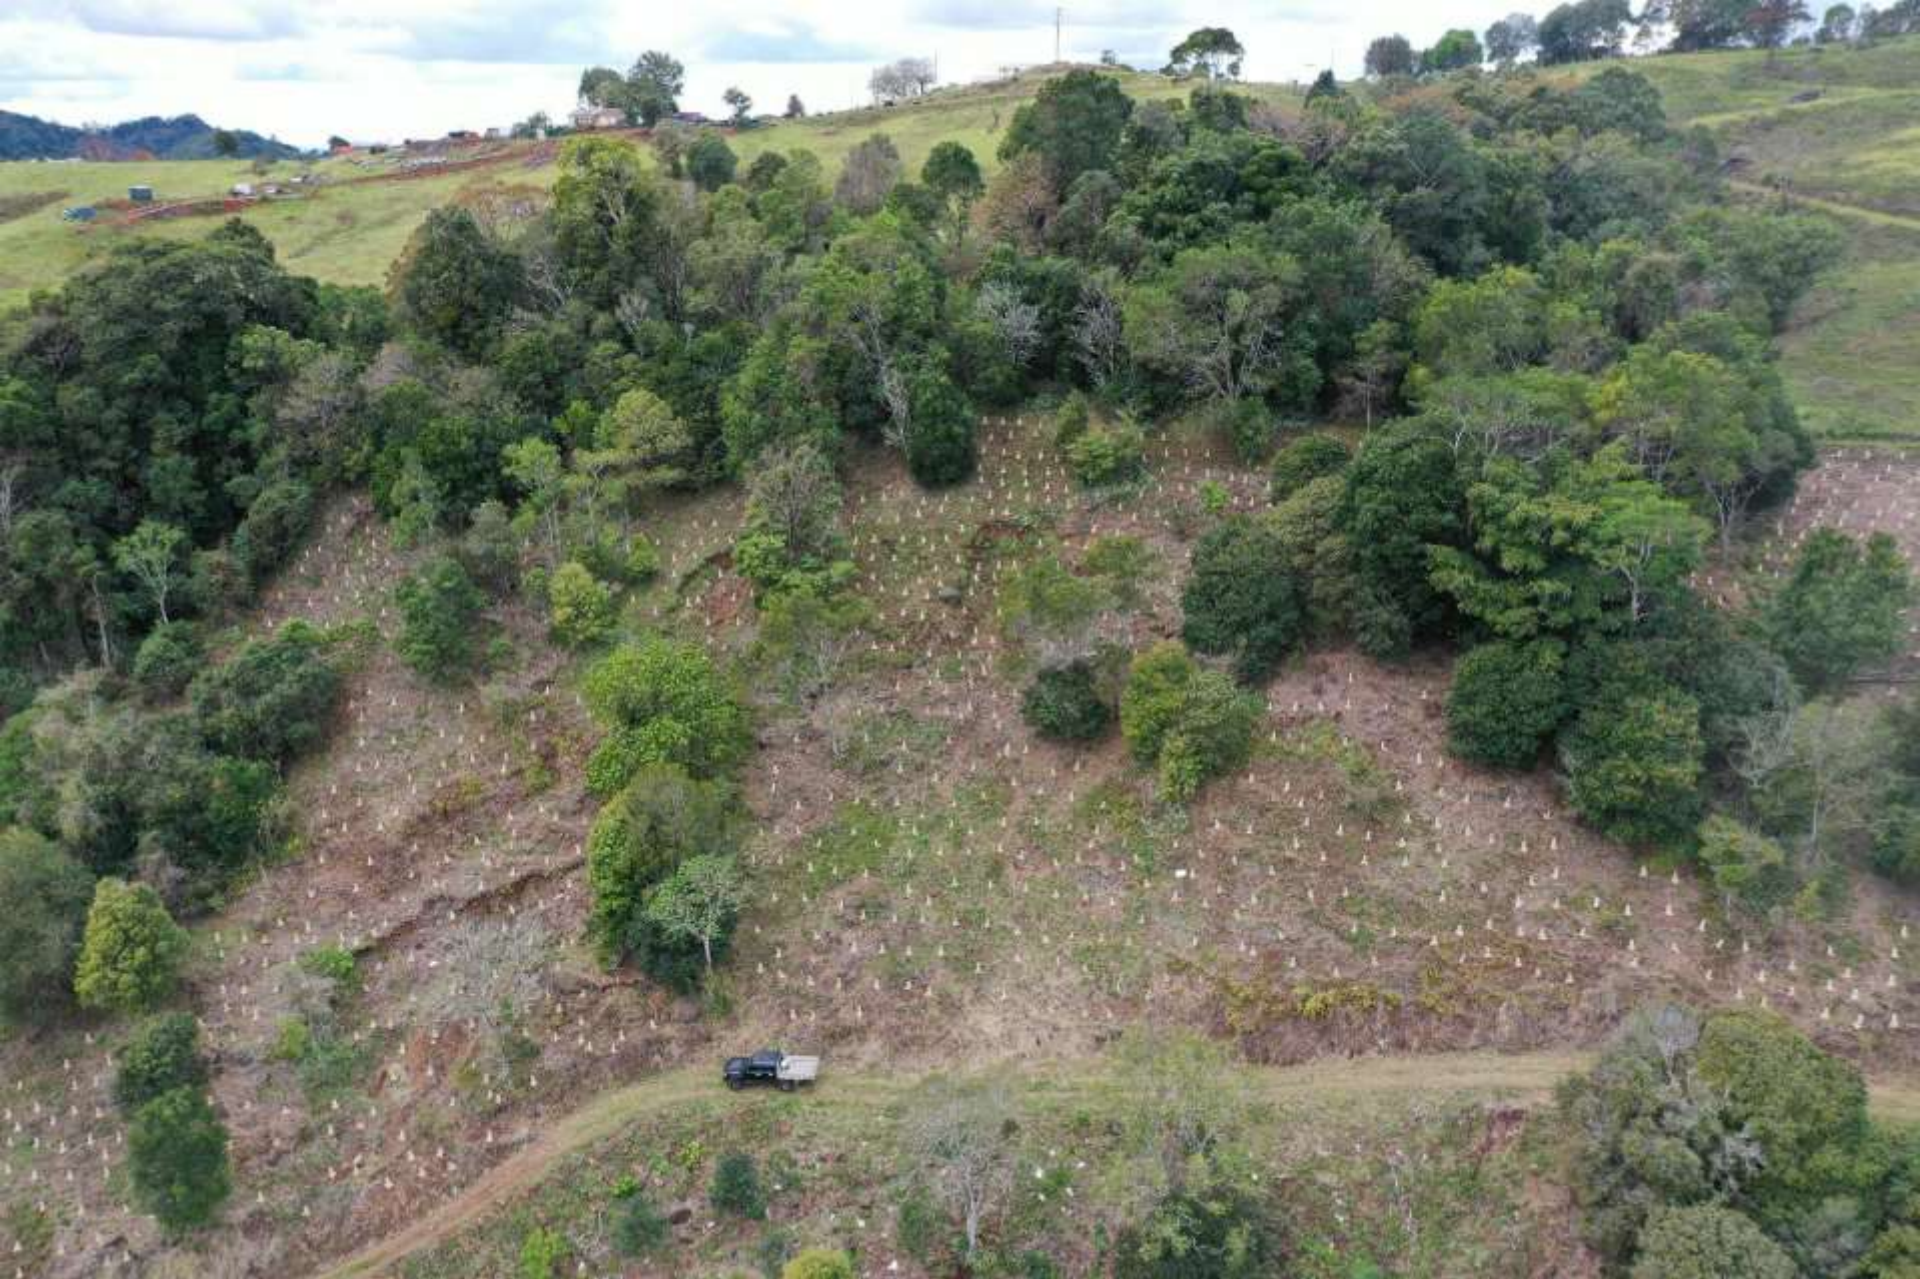
- Numerous areas of instability are present in the planting area
- 10% of the trees planted were Bunyas (250), to assist with the stabilisation over time

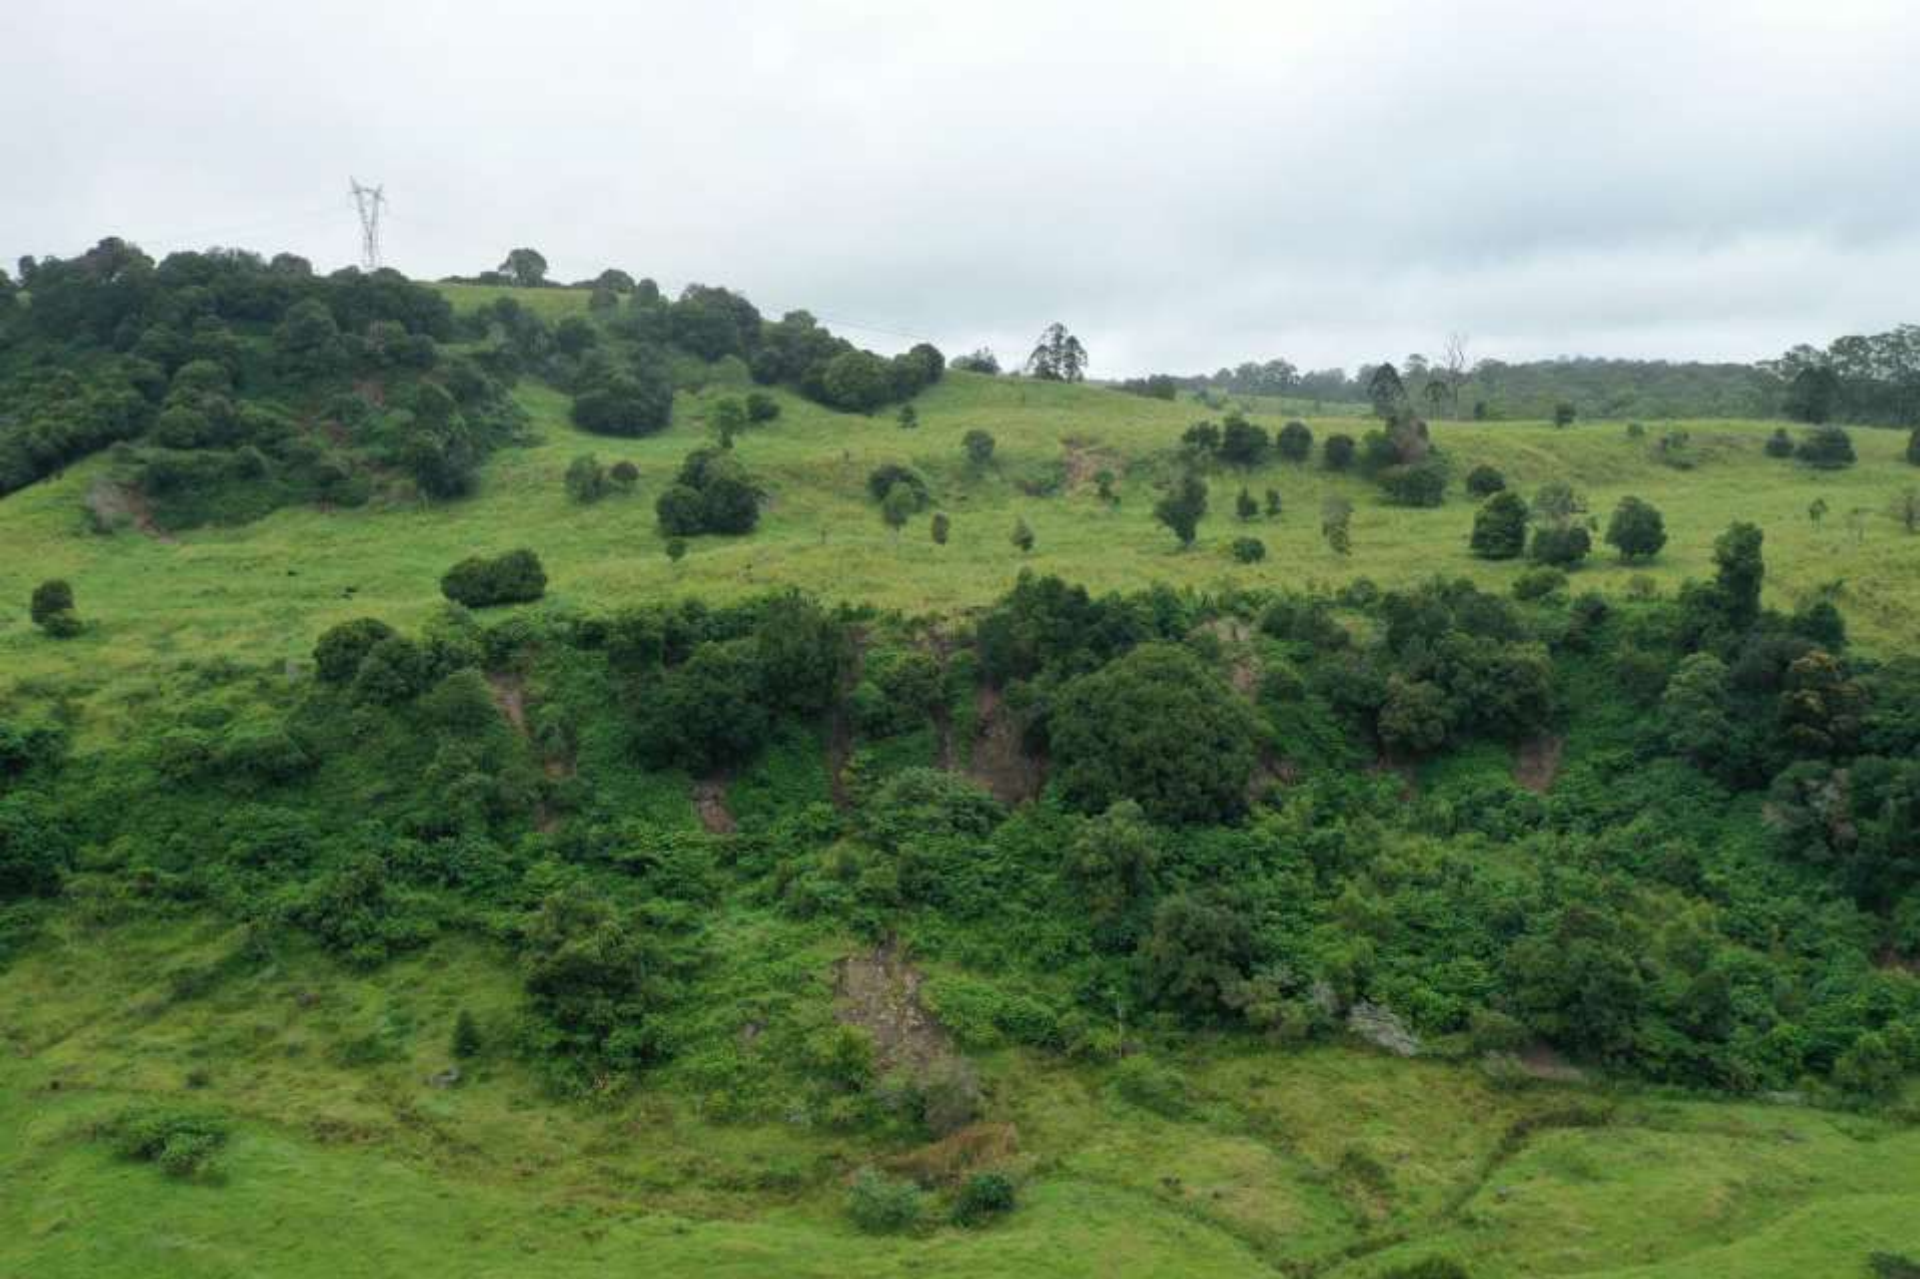
Feb 2022 damage – Leading into Bridge Creek

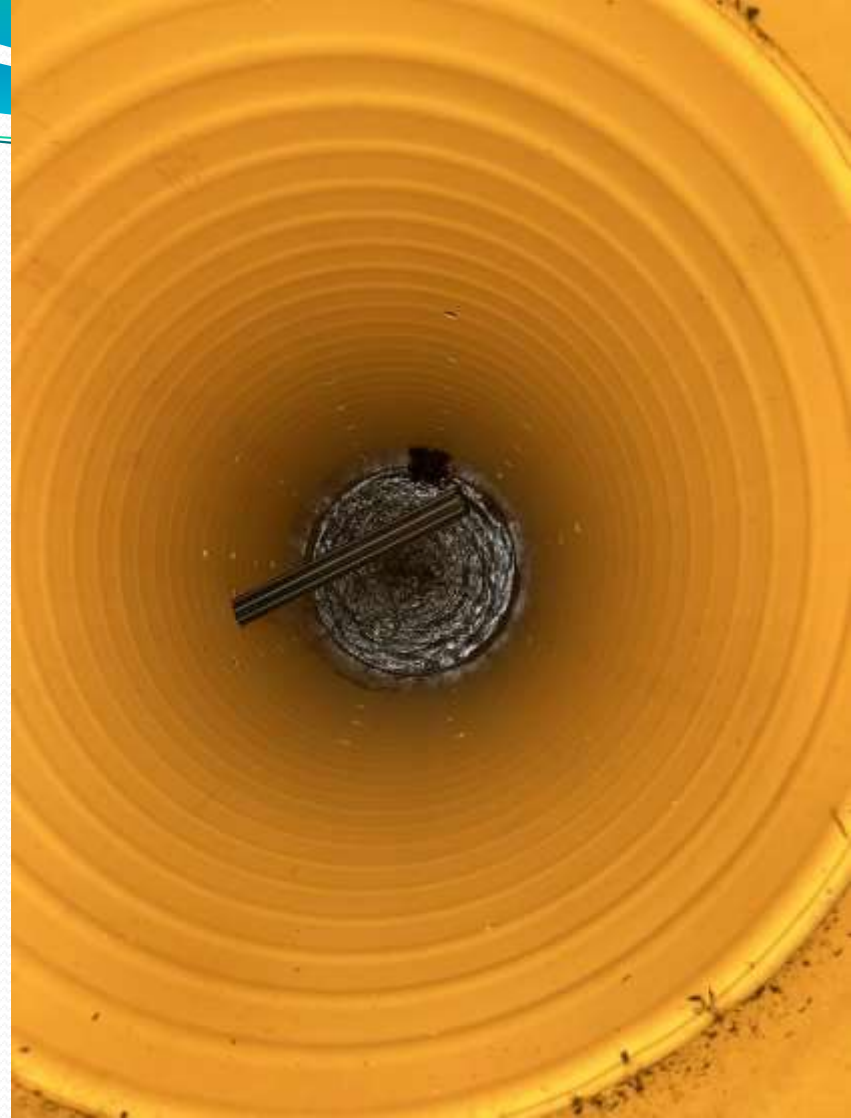
Water running in from the top well  
Site 1: 3,927 L/Day  
Site 2: 1,353 L/Day

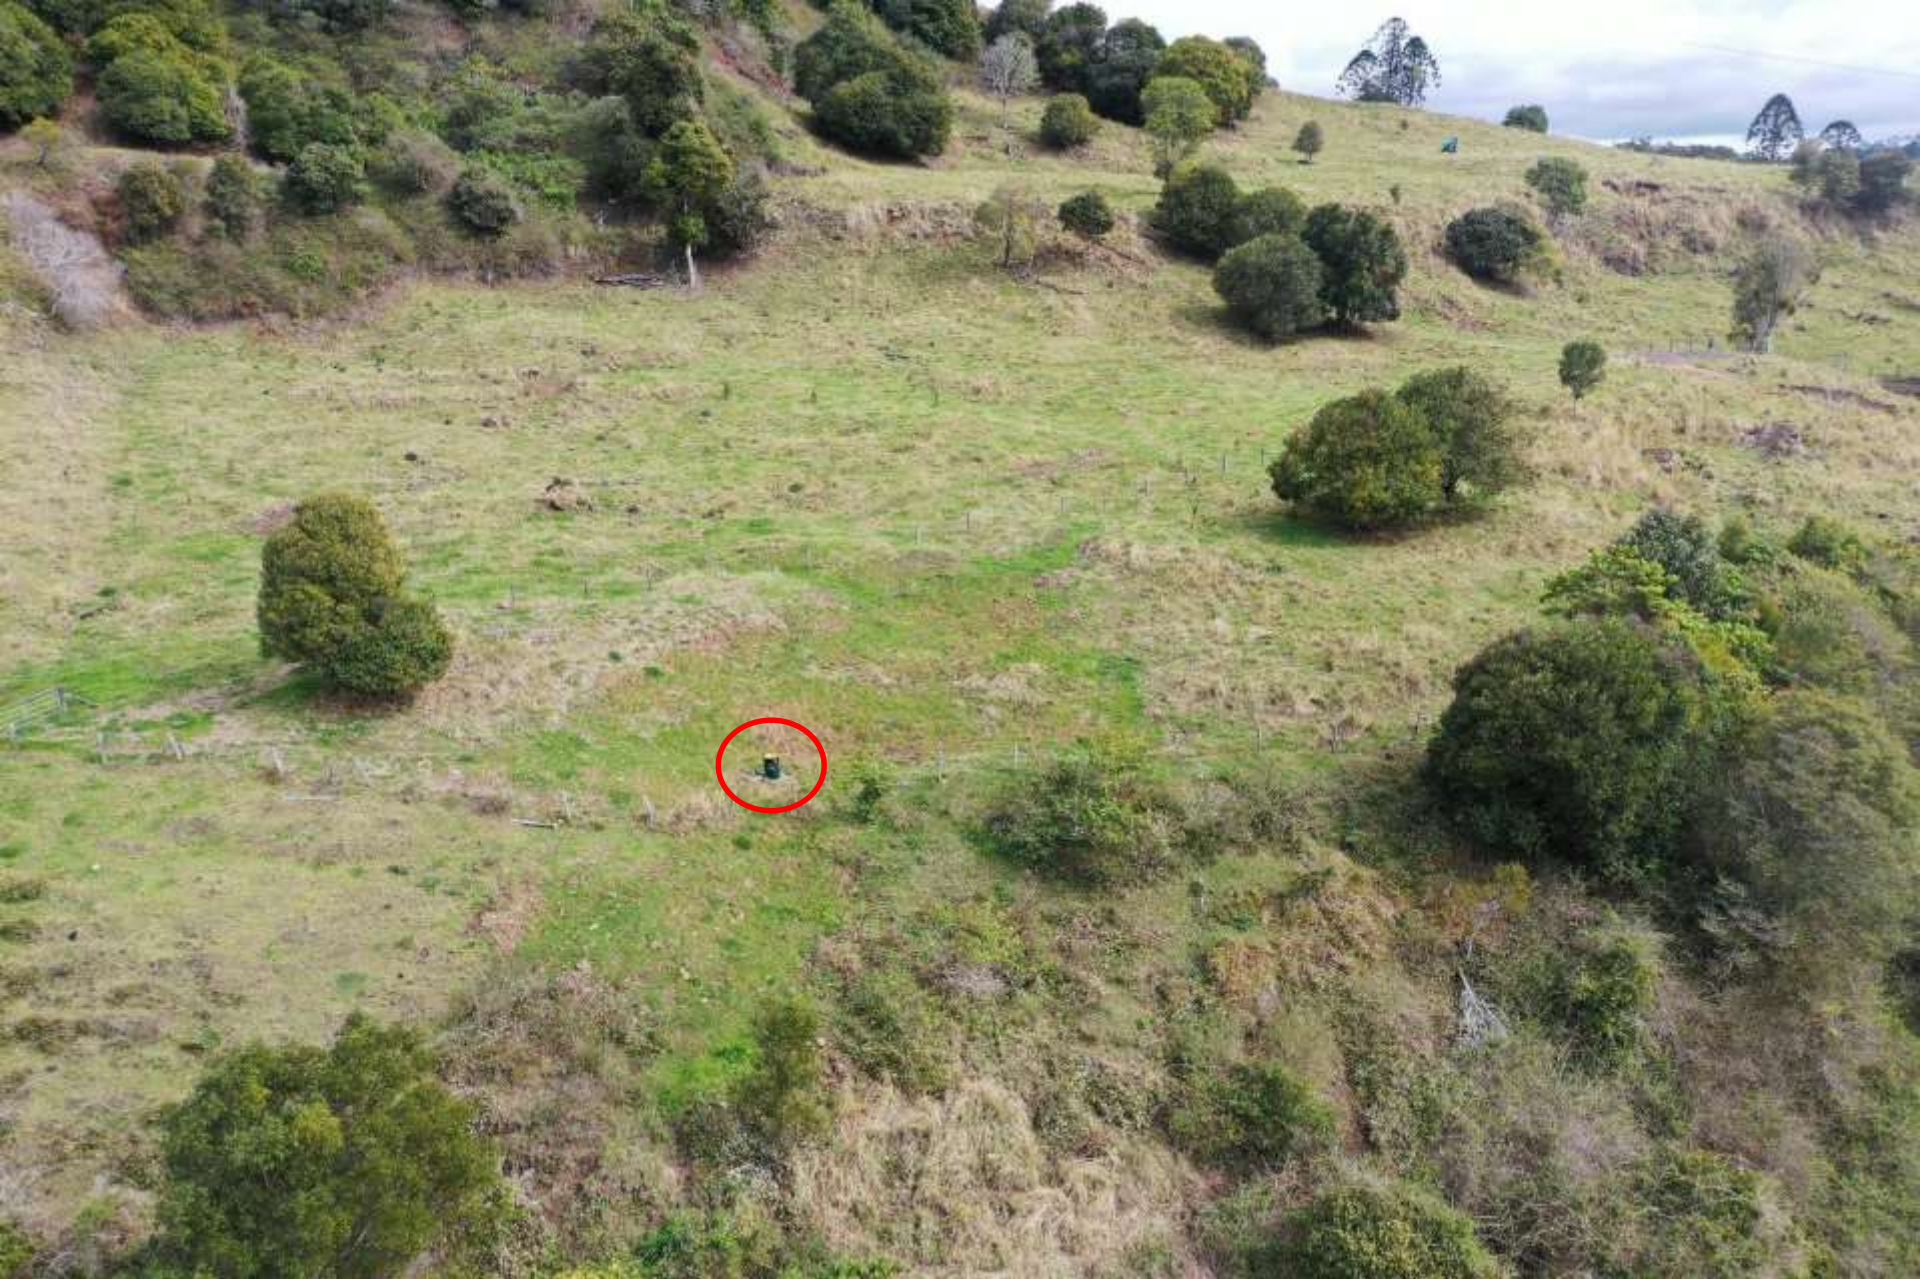
Site 1 - Completed

- 31-5-23 –  
5,760 L/Day

- 26/7/23 –  
3,927 L/Day

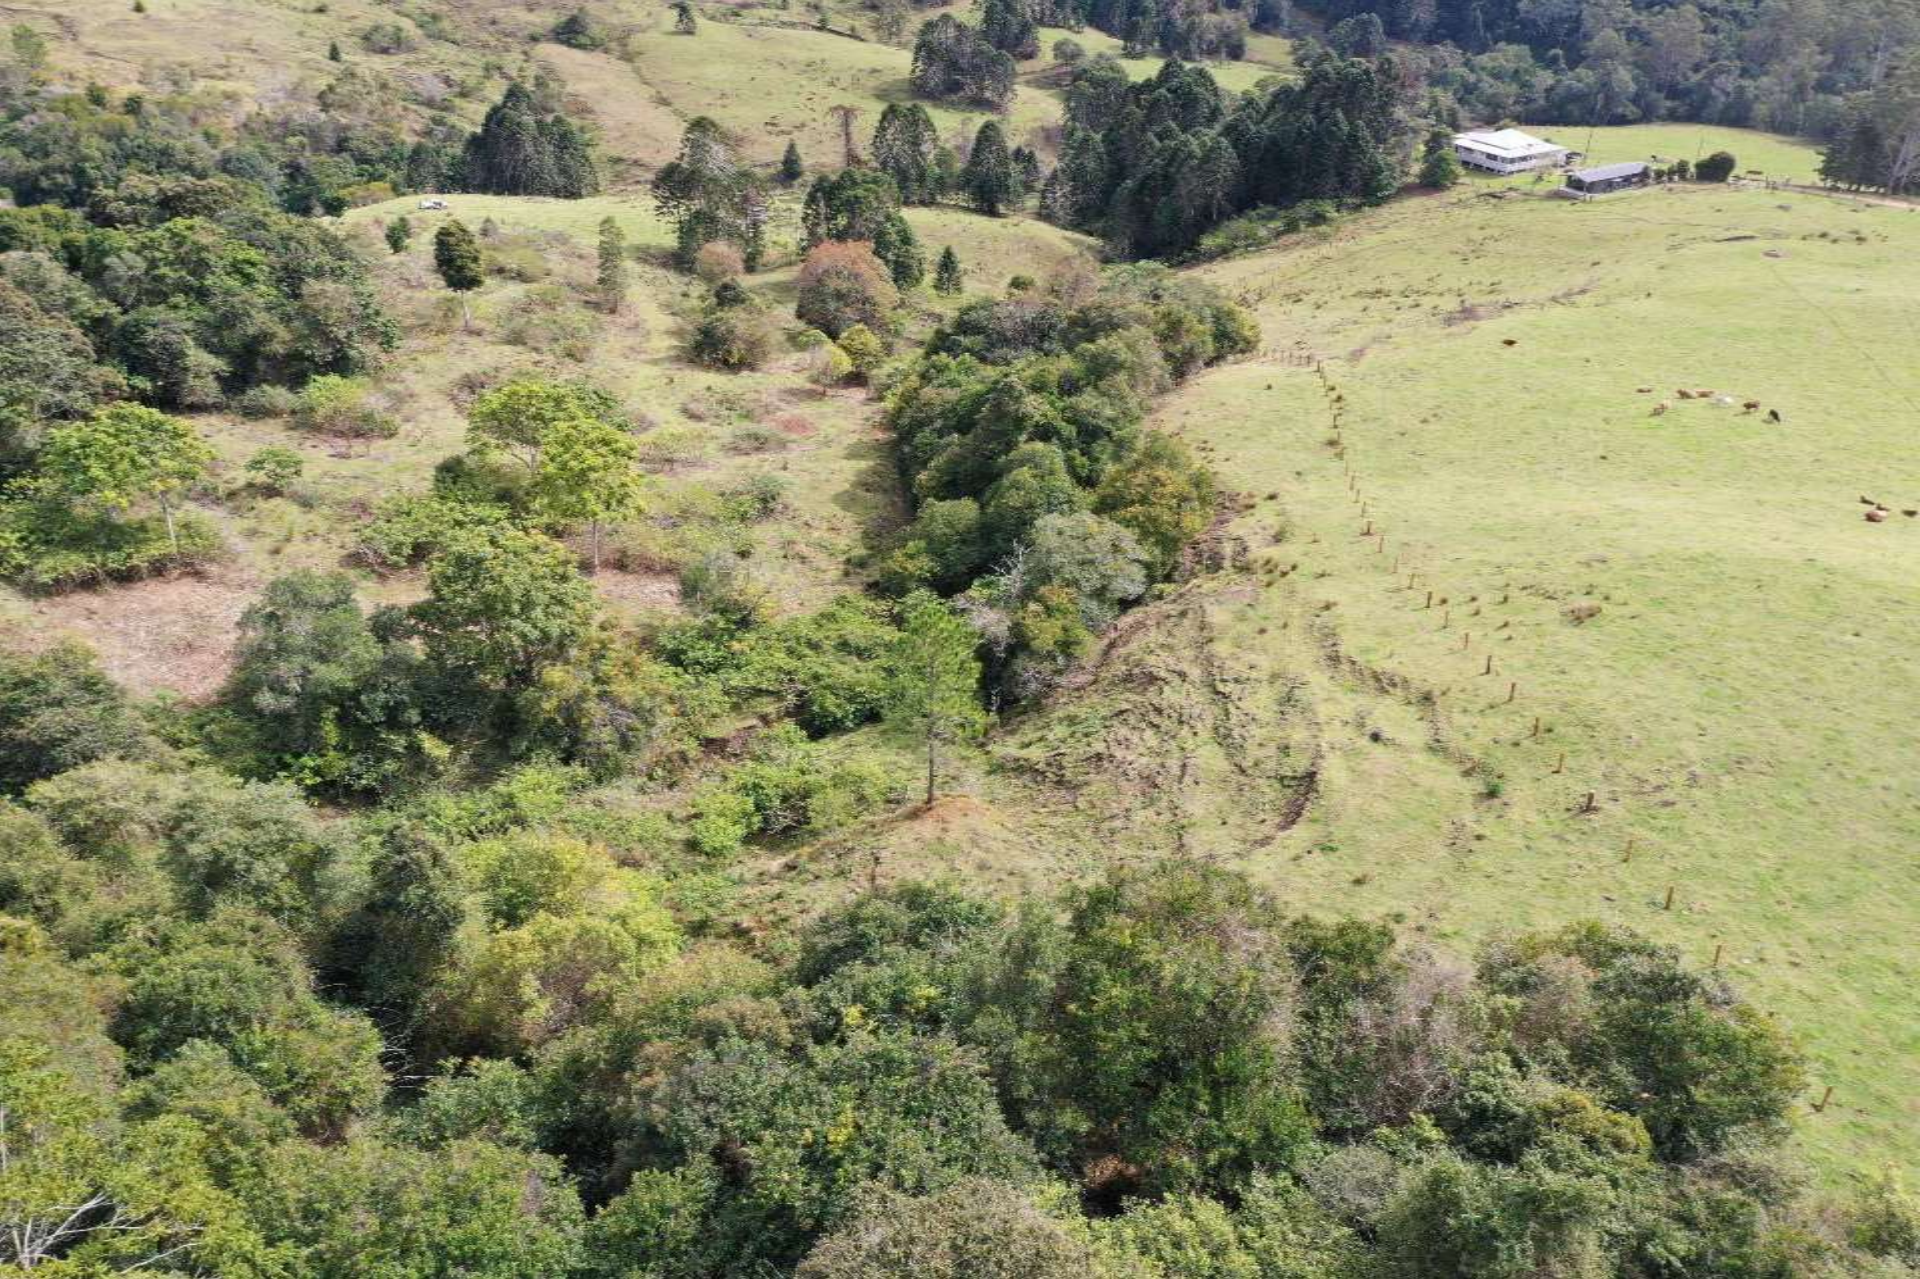
**Bridge Creek (fencing, weed control & revegetation)**

- Creek system with large areas of instability
