LAKE
BAROON
CATCHMENT
CARE
GROUP

Bridge Creek Rehabilitation (McLauchlan) Year 2

Project No. 1011-004

LAKE BAROON CATCHMENT CARE GROUP INC.**1. Project Details****PROJECT TITLE:** Bridge Creek Rehabilitation Project (McLauchlan)**PROJECT NUMBER:** 1011-004**DATE:** November 2010**PROJECT SUMMARY:**

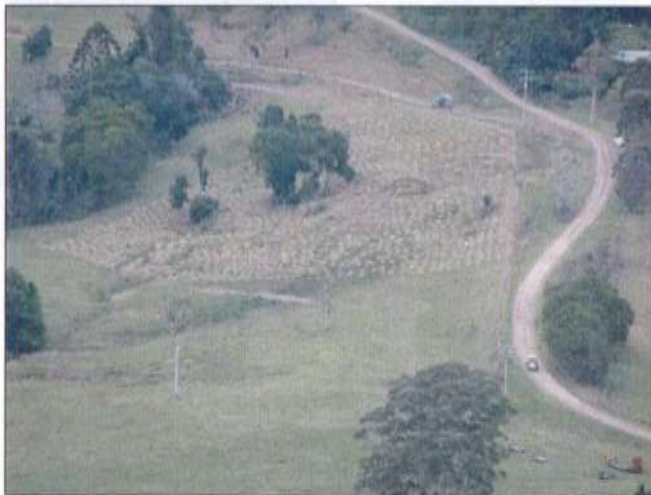
Figure 4: Revegetation of the site has been difficult due to large areas suffering from waterlogging. However through careful selection of species, results have been encouraging with less than 10% plant losses in the first 6 months.

Much of the area is subjected to water-logging and the species selection reflects this. Nevertheless the plantings are expected to perform well – particularly with the favourable conditions experienced during late winter and early Spring.

Predation by wallabies has affected plant growth, however guards have been installed to minimise damage.

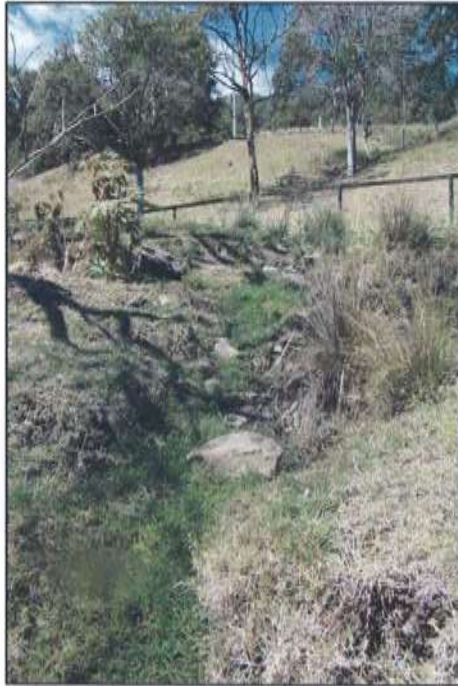
Figure 9: Site prior to rehabilitation.

The dam over-flow has had large woody debris placed in the gully which should improve stability and ensure the dam wall does not fail. Initially large (300mm) rock was suggested to be used however cost and availability was an issue.

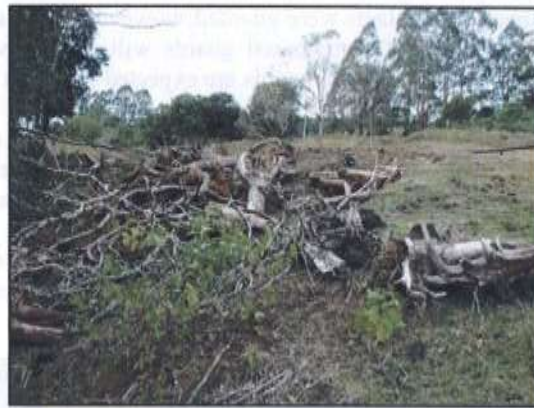
Figure 10: Large woody debris was placed in the eroding gully for stability.

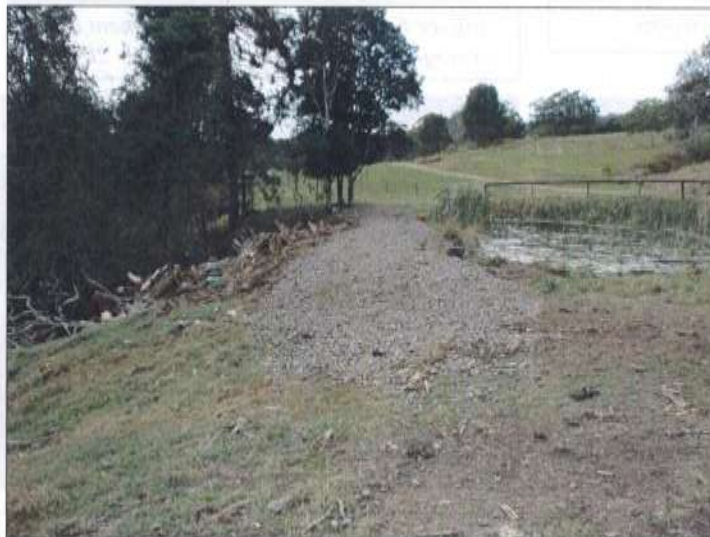
Figure 11: Road-base placed on dam bank.

Road-base was placed on the dam bank to further improve stability – the bank is used as an access point (crossing) for the western side of the waterway.

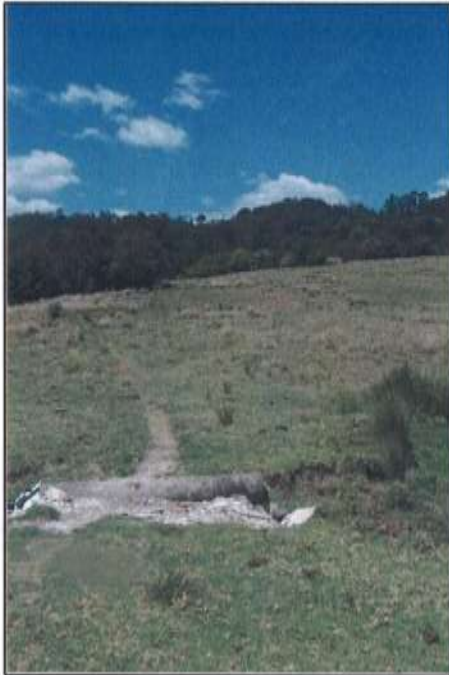
Figure 12: Crossing prior to rehabilitation.

Two existing crossings were rehabilitated with road-base to provide long-term stabilisation.

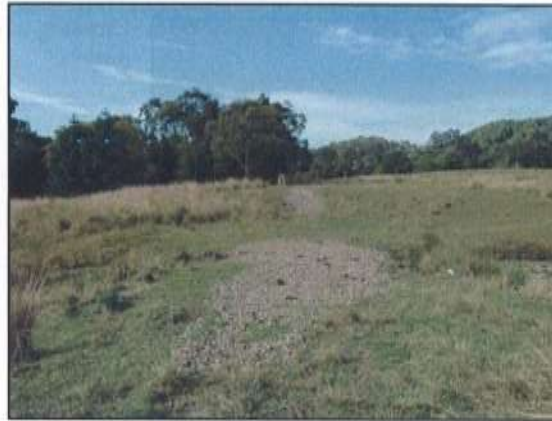
Figure 13: Road-base placed on the crossings provides a hardened surface for livestock to safely cross without placing the dam wall at risk of failure.

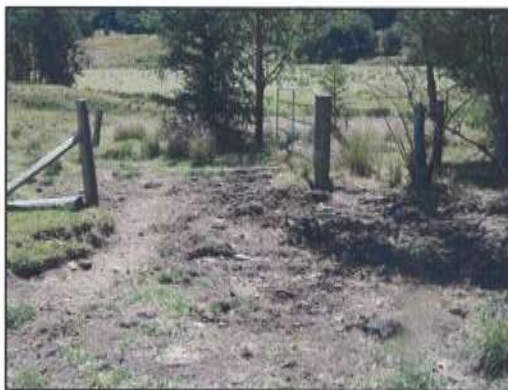
Figure 14: Gateway prior to rehabilitation.

Laneway and gateway has been rehabilitated with hardening with road-base to eliminate pugging and sediment run-off in high rainfall events.

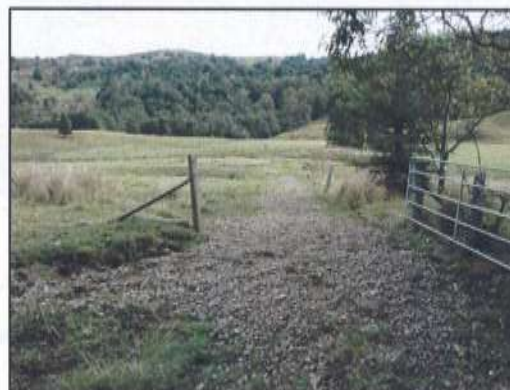
Figure 15: Hardening of gateway and laneway completed.

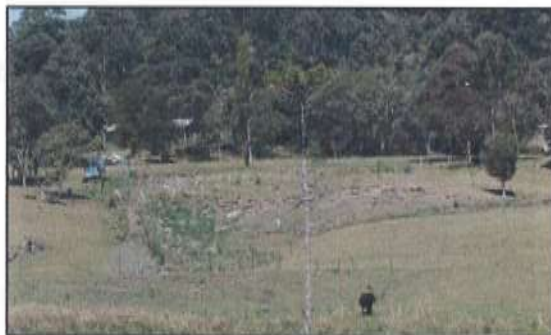
Figure 17: Land slip in September 2009. Temporary fencing and pasture seeding.

The land-slip on the McLauchlan (and Bull) property has been rehabilitated according to a geotechnical assessment by Paul Fraser of Civil Assurance.

This report recommended a three stage rehabilitation program:

1. Sub-surface drainage;
2. Surface profiling;
3. Revegetation.

'Wick' drains were installed consisting of coarse gravel wrapped in geo-fabric and placed in a herringbone pattern. The small dam at the head of the slip was filled with similar drainage gravel. The drain emerges at the dam downstream on David Bull's property.

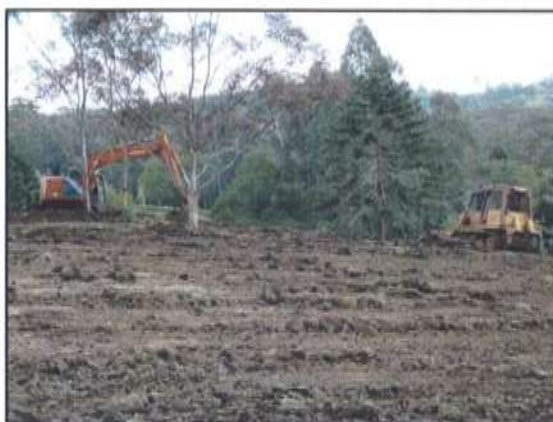
Figure 18: Site was profiled following drainage installation to ensure a free-draining surface.

The entire slip area was profiled to ensure a free-draining surface by Range Earthmoving, followed by a heavy covering of pasture grass seed.

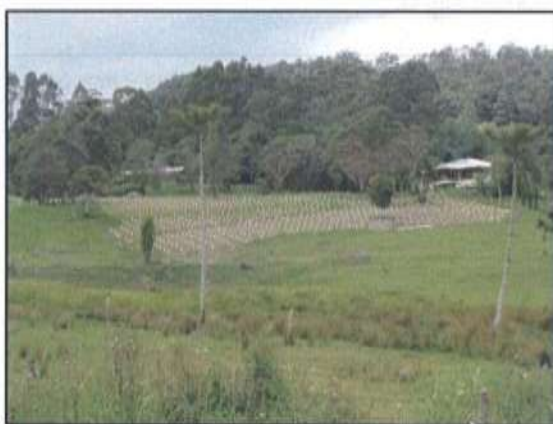
Figure 19: Site following revegetation.

Finally the slip area was permanently fenced and revegetated with species suited to land slip sites that were tolerant of widely varying soil moisture conditions; were fast growing and hardy.

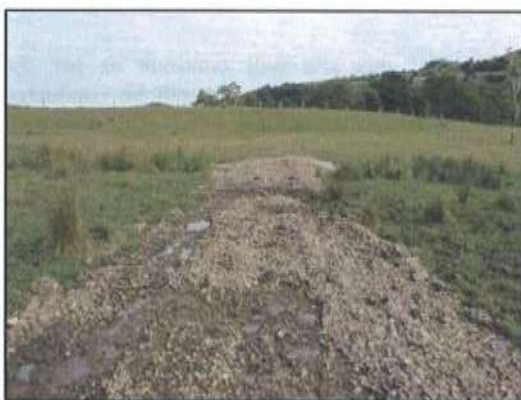
An additional waterway crossing was installed by the landholder immediately below Revegetation Site B. This was to improve access to the revegetation site and improve drainage.

Figure 20: The additional crossing.
