Restoring Bridge Creek – A Partnership of the Commonwealth, State and Community

PROJECT PLAN

Project No. 1213-003

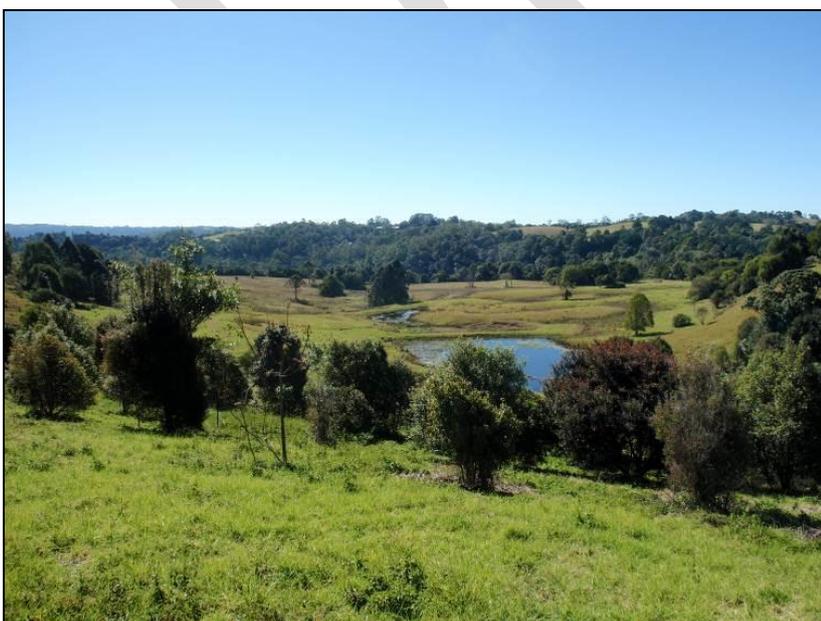
Left: The Lawley (Bridge) Creek tributary. The project is linking the remnant vegetation in the background of the photo with the wetlands and revegetation in the foreground – part of the Rangeviews Estate.

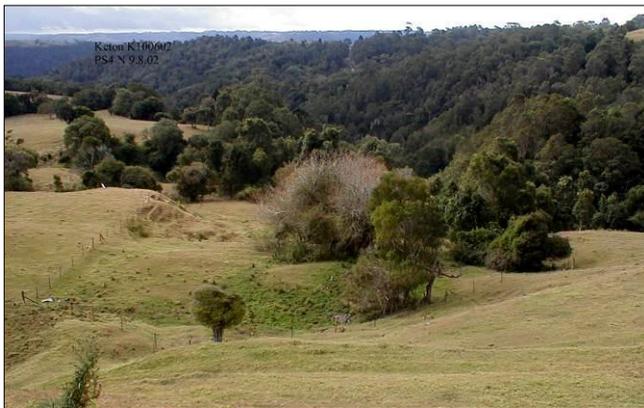
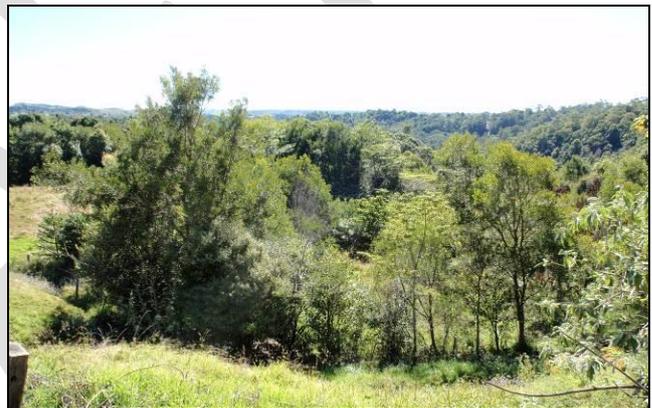
Keton Revegetation Project

Above: The Keton property fencing and revegetation project before (2002) and after (2012).

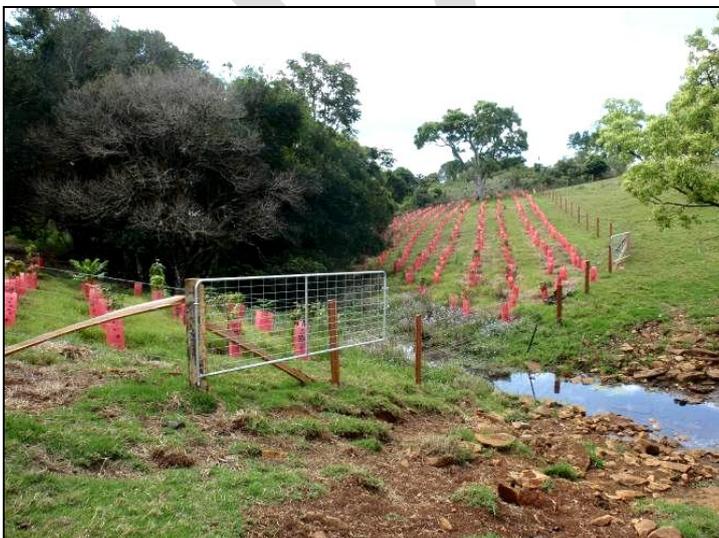
Left: Upper Lawley Creek Restoration has fenced and revegetated the upper reaches of Lawley creek.

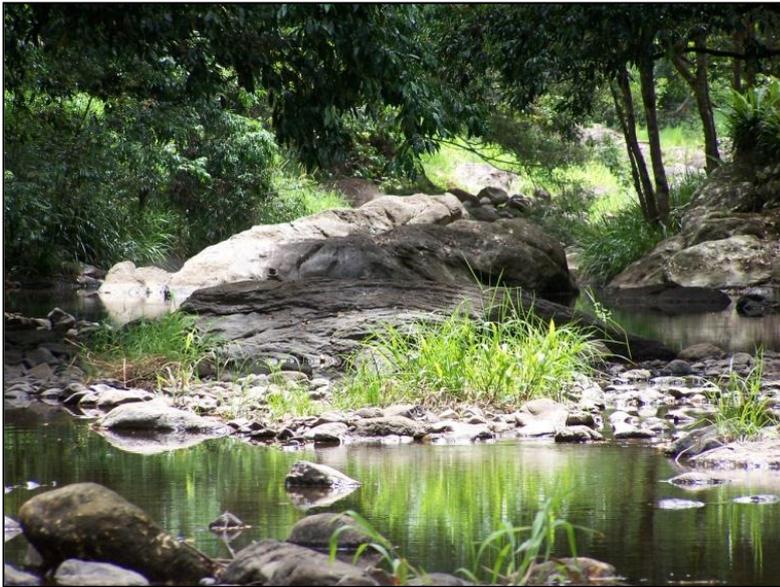
Left: Bridge Creek has good riparian vegetation and displays excellent bed diversity and bank stability. The creek however is threatened by excessive sediment loads entering the waterway through erosion in the catchment – particularly in the headwaters.

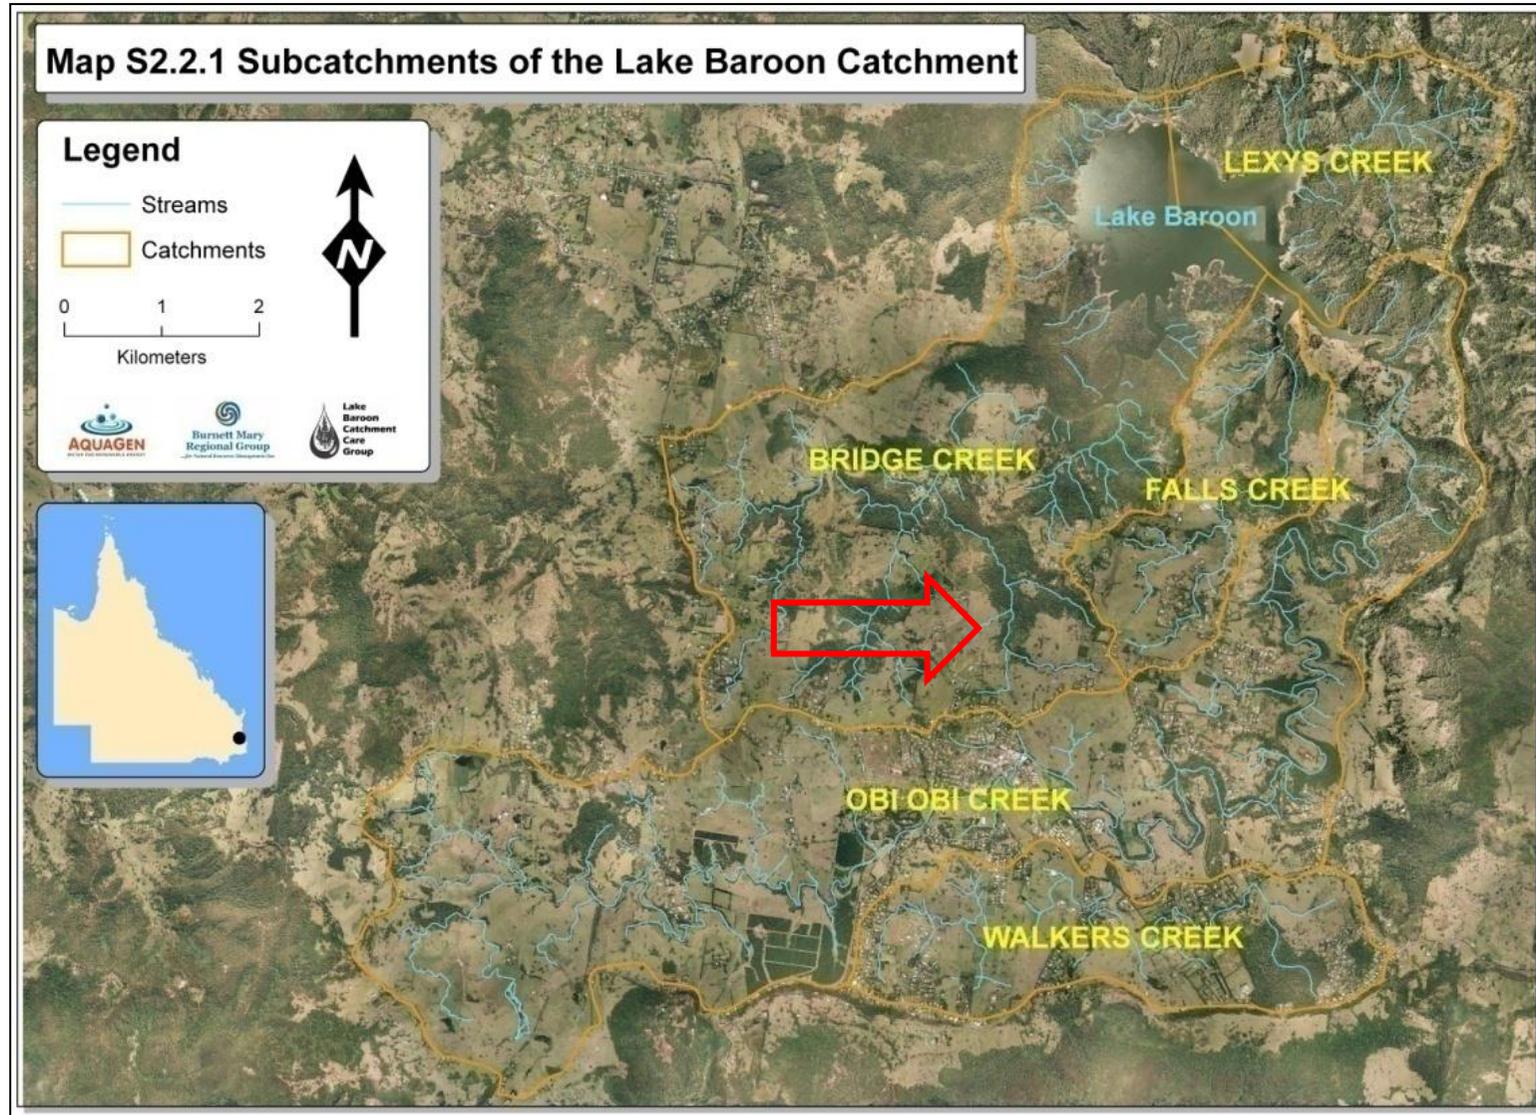
Figure 4: Lawley Creek is a tributary of the larger Bridge Creek catchment.

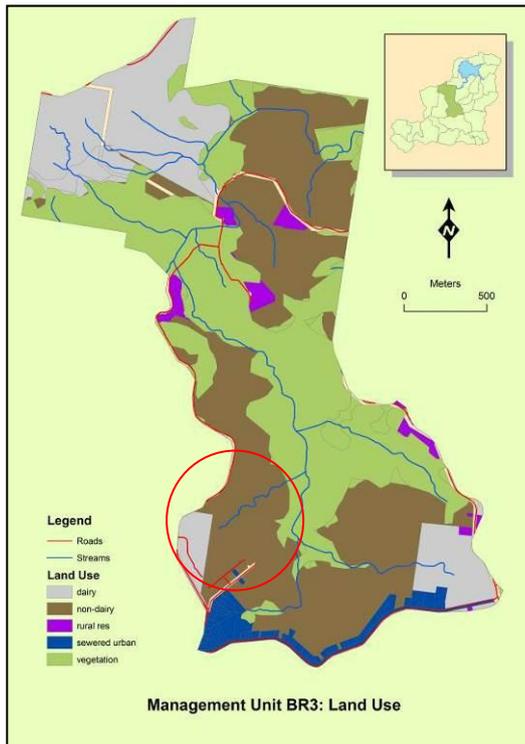
Left: The project will fence and revegetate a largely unprotected watercourse in the upper catchment of the MU.

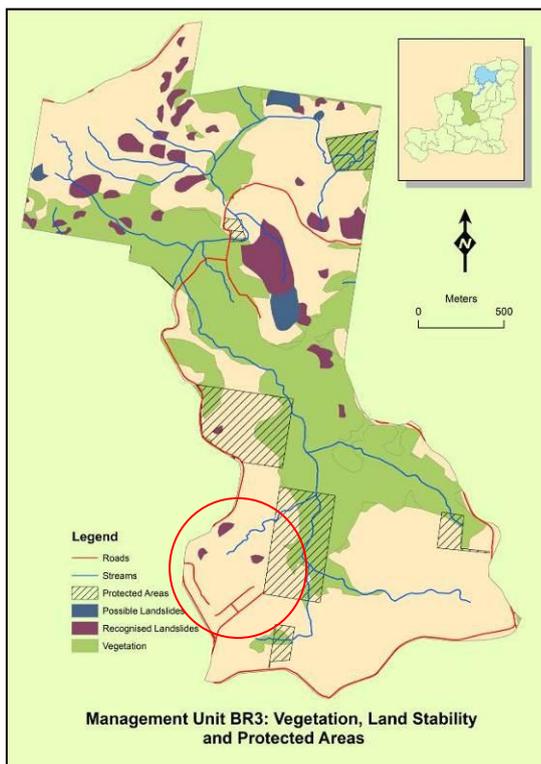
Left: The upper part of the MU is relatively stable – largely due to the presence of Red Ferrosol soils.

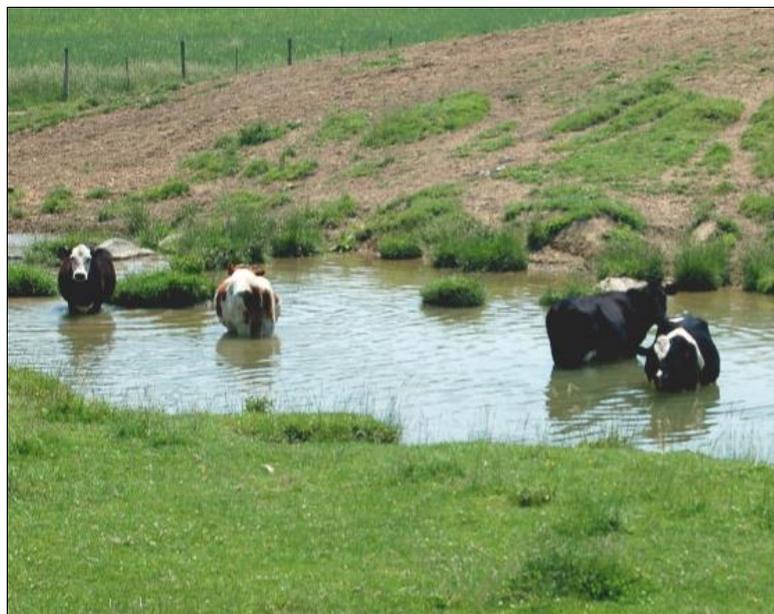
Left: Waterways provide essential access to water for livestock however unrestricted access is detrimental to water quality. Unmanaged access can cause erosion, destabilise banks, degrade the riparian buffer and deliver nutrients directly to the stream.

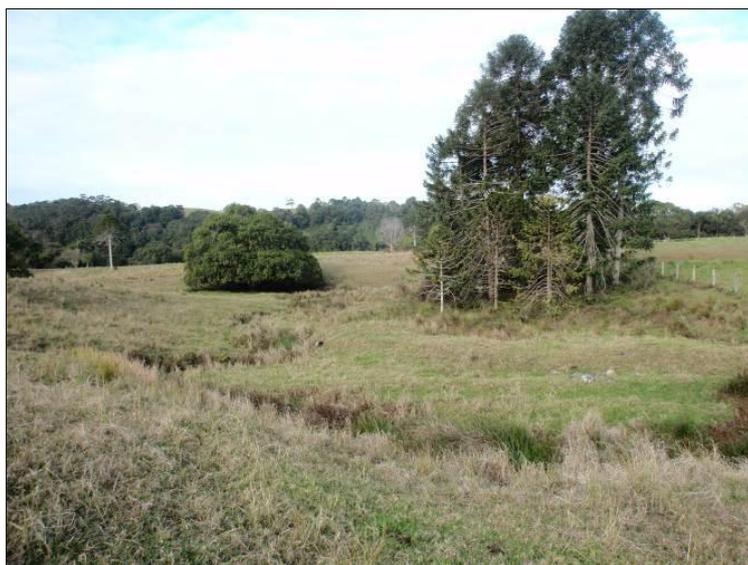
5.2.1 Reach 1 Smith

The Reaches' riparian vegetation has been simplified to a monoculture of pasture (various species) and some weeds – lantana, blackberry, camphor laurel, mist weed and other minor species. A stand of approximately 15 mature and juvenile Bunya Pine (*Araucaria bidwillii*) are the dominant remaining native vegetation with two mature *Waterhousia floribunda* and a single Small-leaf Fig (*Ficus sp.*). The waterway has permanent flow from a reliable spring further up the catchment. Two relatively large constructed wetlands are immediately upstream of the Smith boundary.

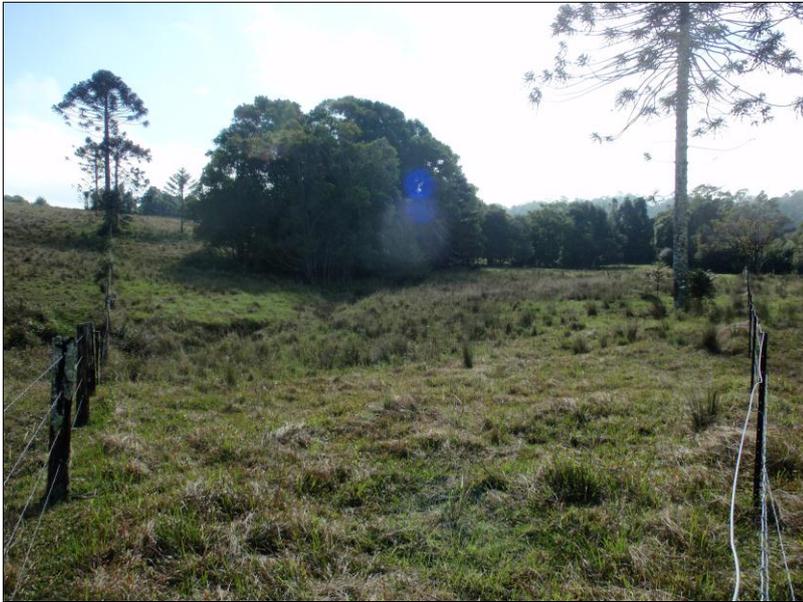
5.2.2 Reach 2 Keton

The Reach is similar to the upstream Reach 1.

This Reach retains significant remnant vegetation and is protected with a Voluntary Conservation Agreement (VCA). The vegetation is classified as RE 12.8.3. Importantly this remnant vegetation gives us a basis for the reinstatement of riparian vegetation, not only for this project but the larger upper catchment.

The vegetation has been subjected to unmanaged grazing for many years and consequently consists of primarily mature trees. Several Bunya Pine (with natural regeneration occurring) are present. It is expected that following the establishment of the revegetation and associated shading, natural regeneration will provide diversity to the planting.

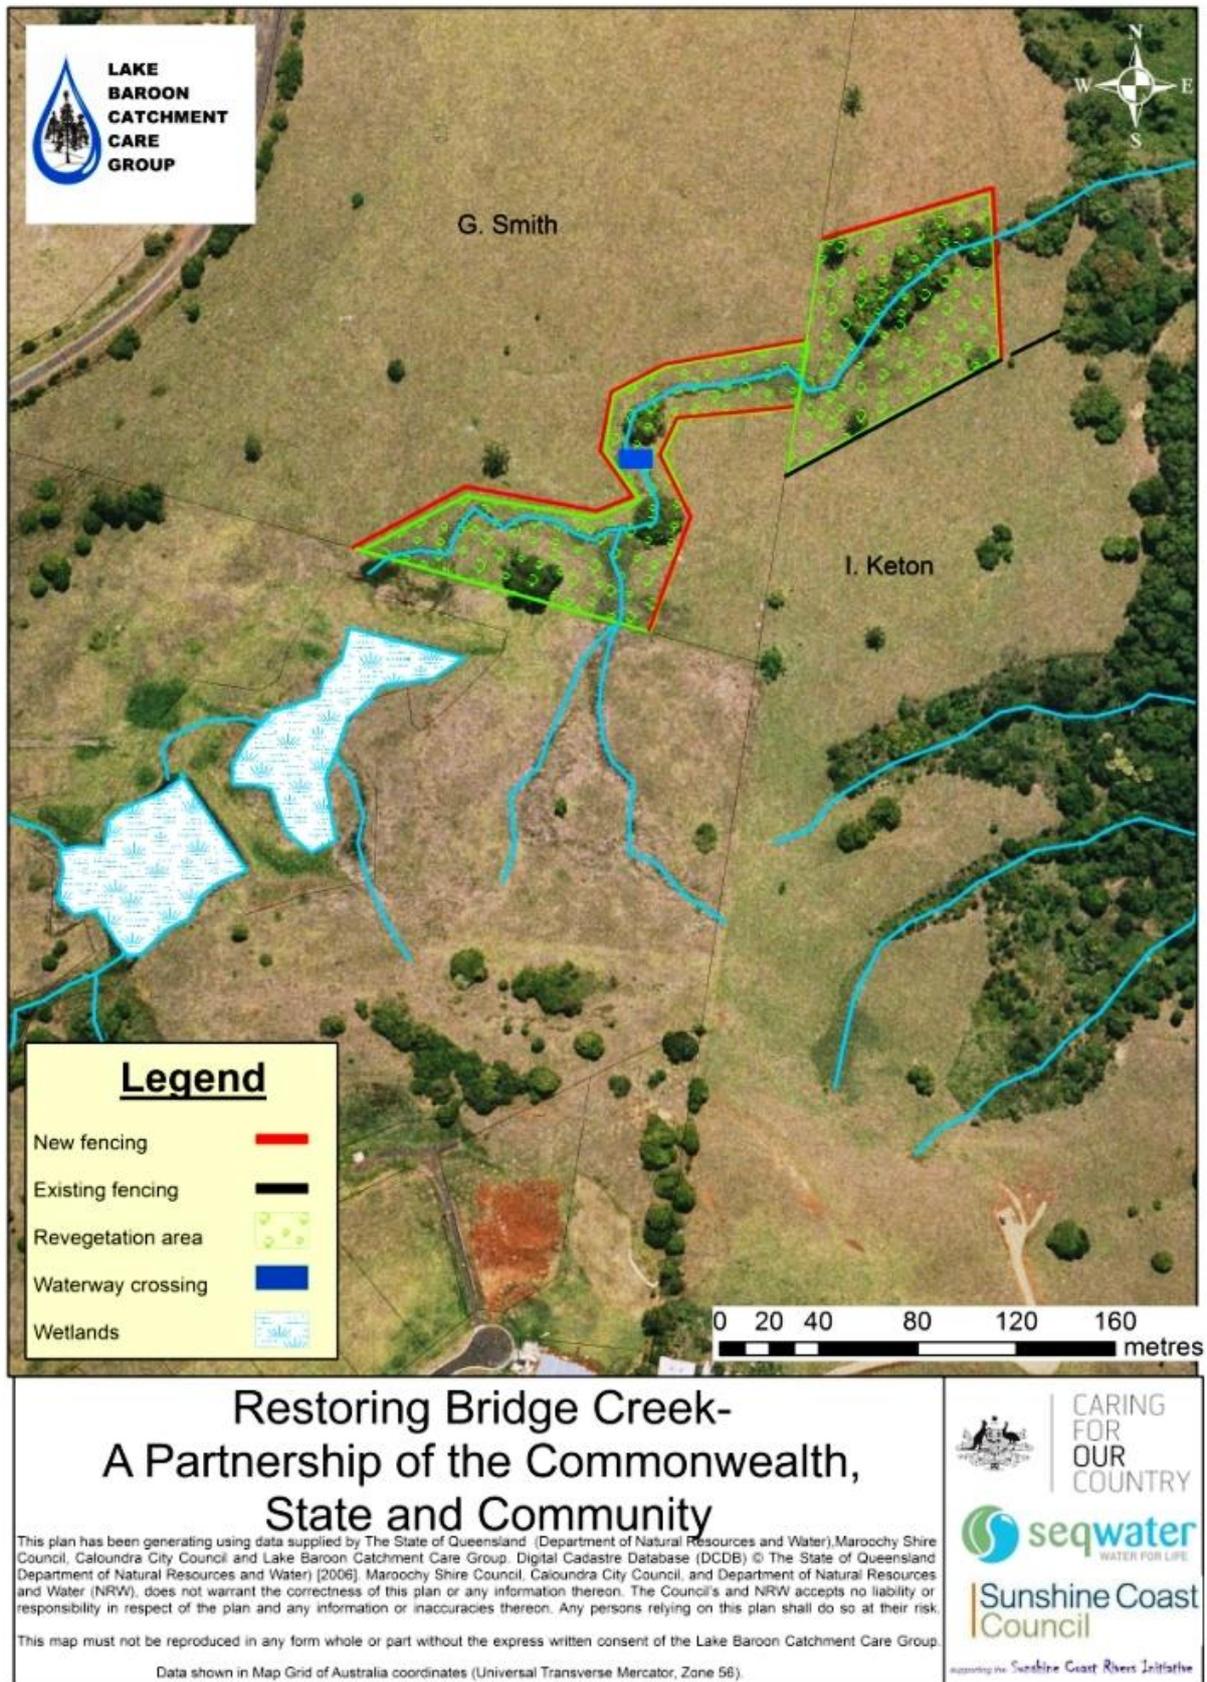
Above: Project Overview - proposed on-ground works.

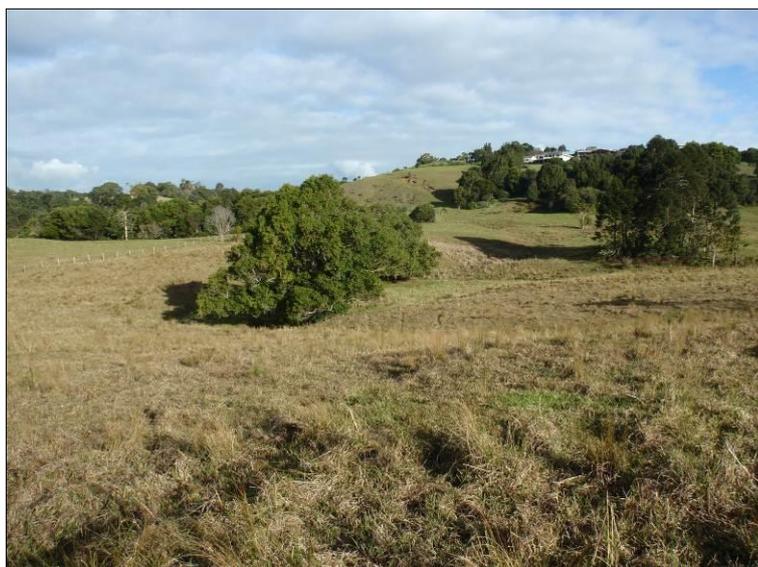
5.4.1.1 Reach 1 (Smith)

Standard cattle fencing will be erected on the Smith property in keeping with the rest of the property. This will consist of four strand barbed wire with timber split posts at approximately four metre spacings.

Approximately 469 metres of fencing will be required.

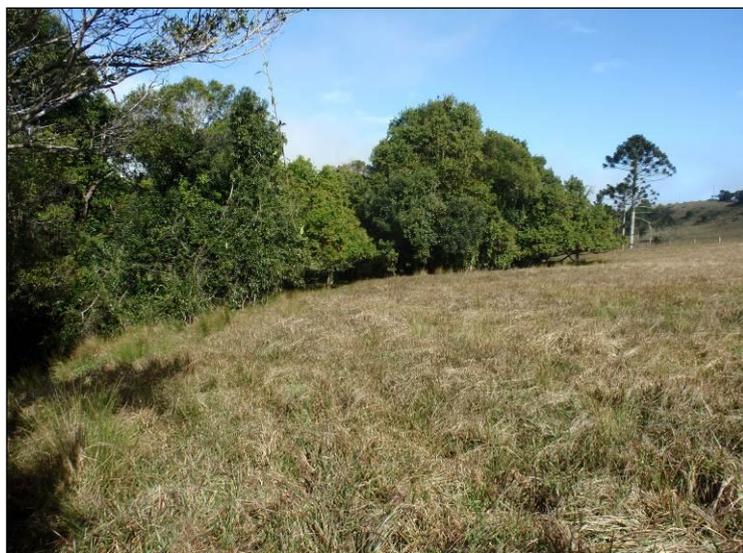
5.4.1.2 Reach 2 (Keton)

Fencing on the Keton property will be slightly different to the Smith fencing in that it will utilise plain top and bottom wires to minimise interference with native wildlife. With the site containing remnant vegetation and also the close proximity to the large area of remnant vegetation, wildlife – particularly bats and gliders is likely thus the need to minimise interference.

The site is already fenced on one side (requires minor restoration), therefore only approximately 142 metres of fencing is required.

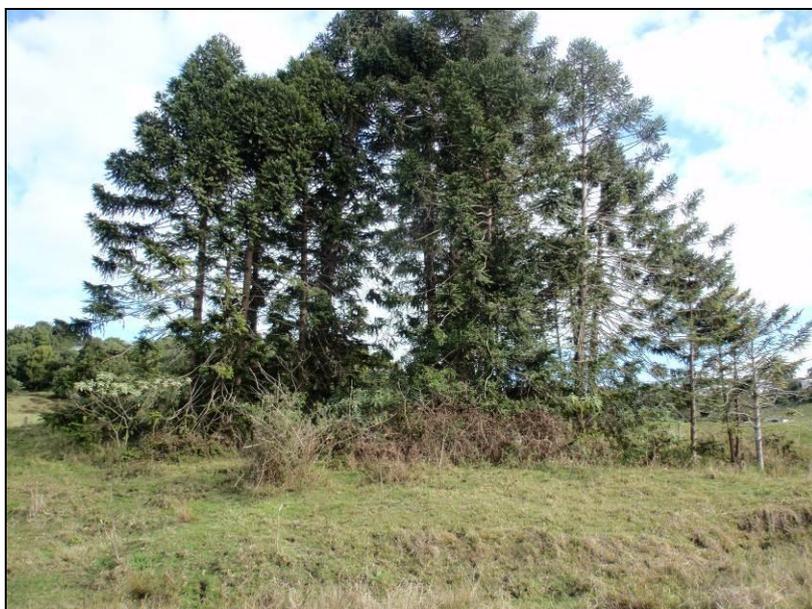
Stand of locally significant Bunya pine (Araucaria bidwillii) with lantana infestation.

Woody weed management will be implemented early in the implementation phase of the project with a maintenance program to ensure weeds do not re-establish. The majority of the weeds (excluding blackberry) occur under the canopy of the existing remnant vegetation/individual isolated native trees.

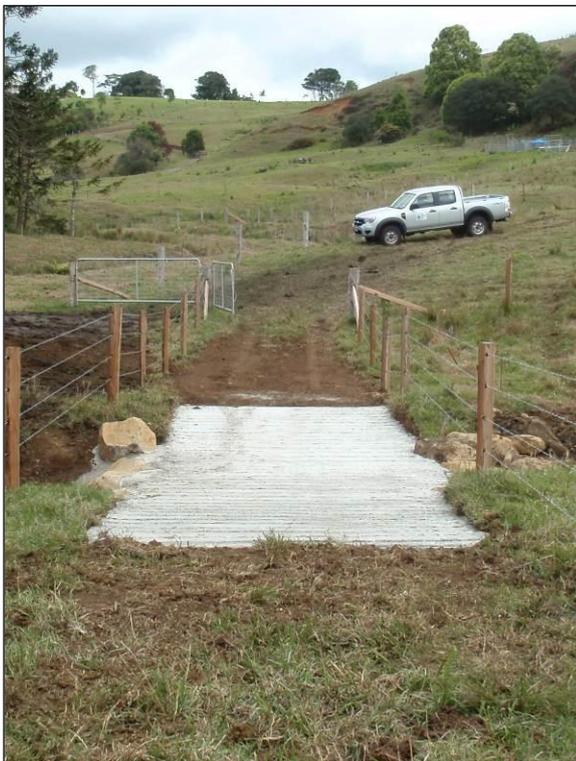
5.4.4 WATERWAY CROSSING

The watercourse on the Smith property bisects the property and a low level crossing is required for livestock and vehicular access to the small paddock in the south eastern corner.

Low level crossings are a simple design for relatively low flow waterways that are robust and result in minimal disturbance to the bed and banks of the waterway. Livestock access to the waterway is completely controlled eliminating pugging and associated erosion. In this case a small pool of water collects behind the crossing offering livestock access to water without stepping off the concrete.
