**LAKE
BAROON
CATCHMENT
CARE
GROUP**

Upper Alcorn Creek Riparian Fencing

PROJECT PLAN

Project No. 1213-009

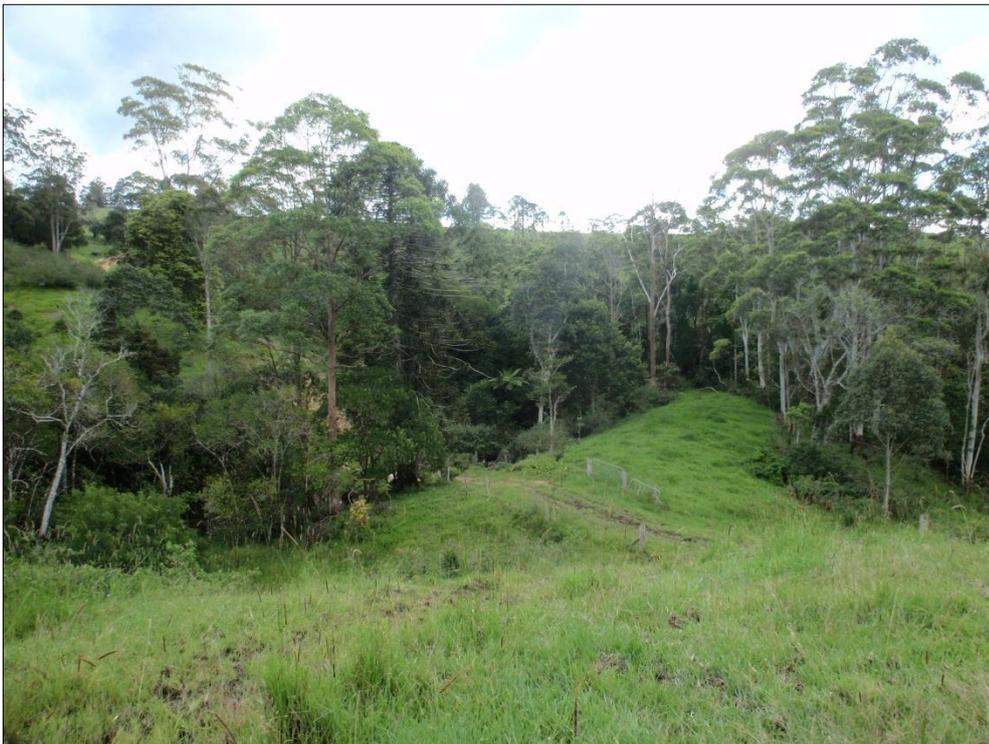
Left: Alcorn Creek on the Thorne/ Eastmure property. Note the remnant and regrowth riparian vegetation along the creek. To erect the fence on stable ground the fencing will include several large areas of open pasture which will require irregular grazing to manage weeds and maintain access.

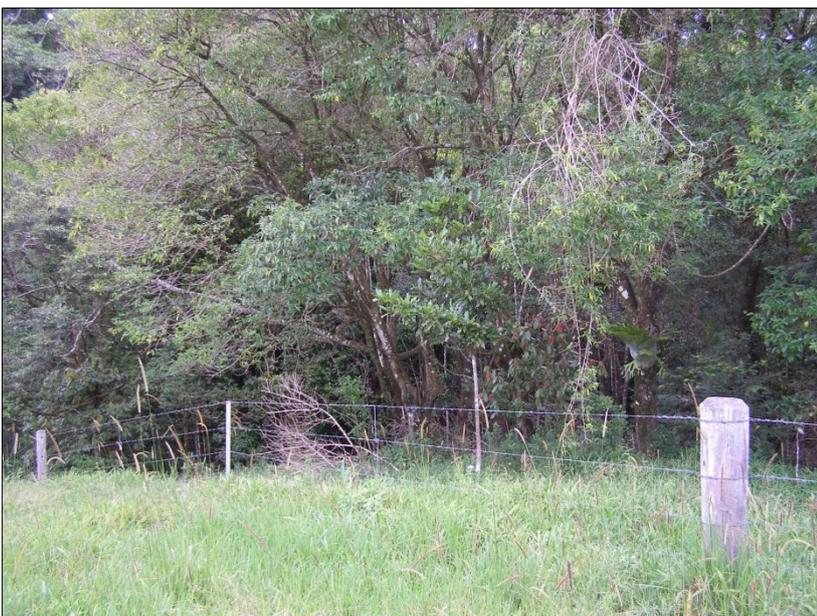
Left: Remnant vegetation previously fenced – although livestock can currently access the riparian zones of Alcorn Creek.

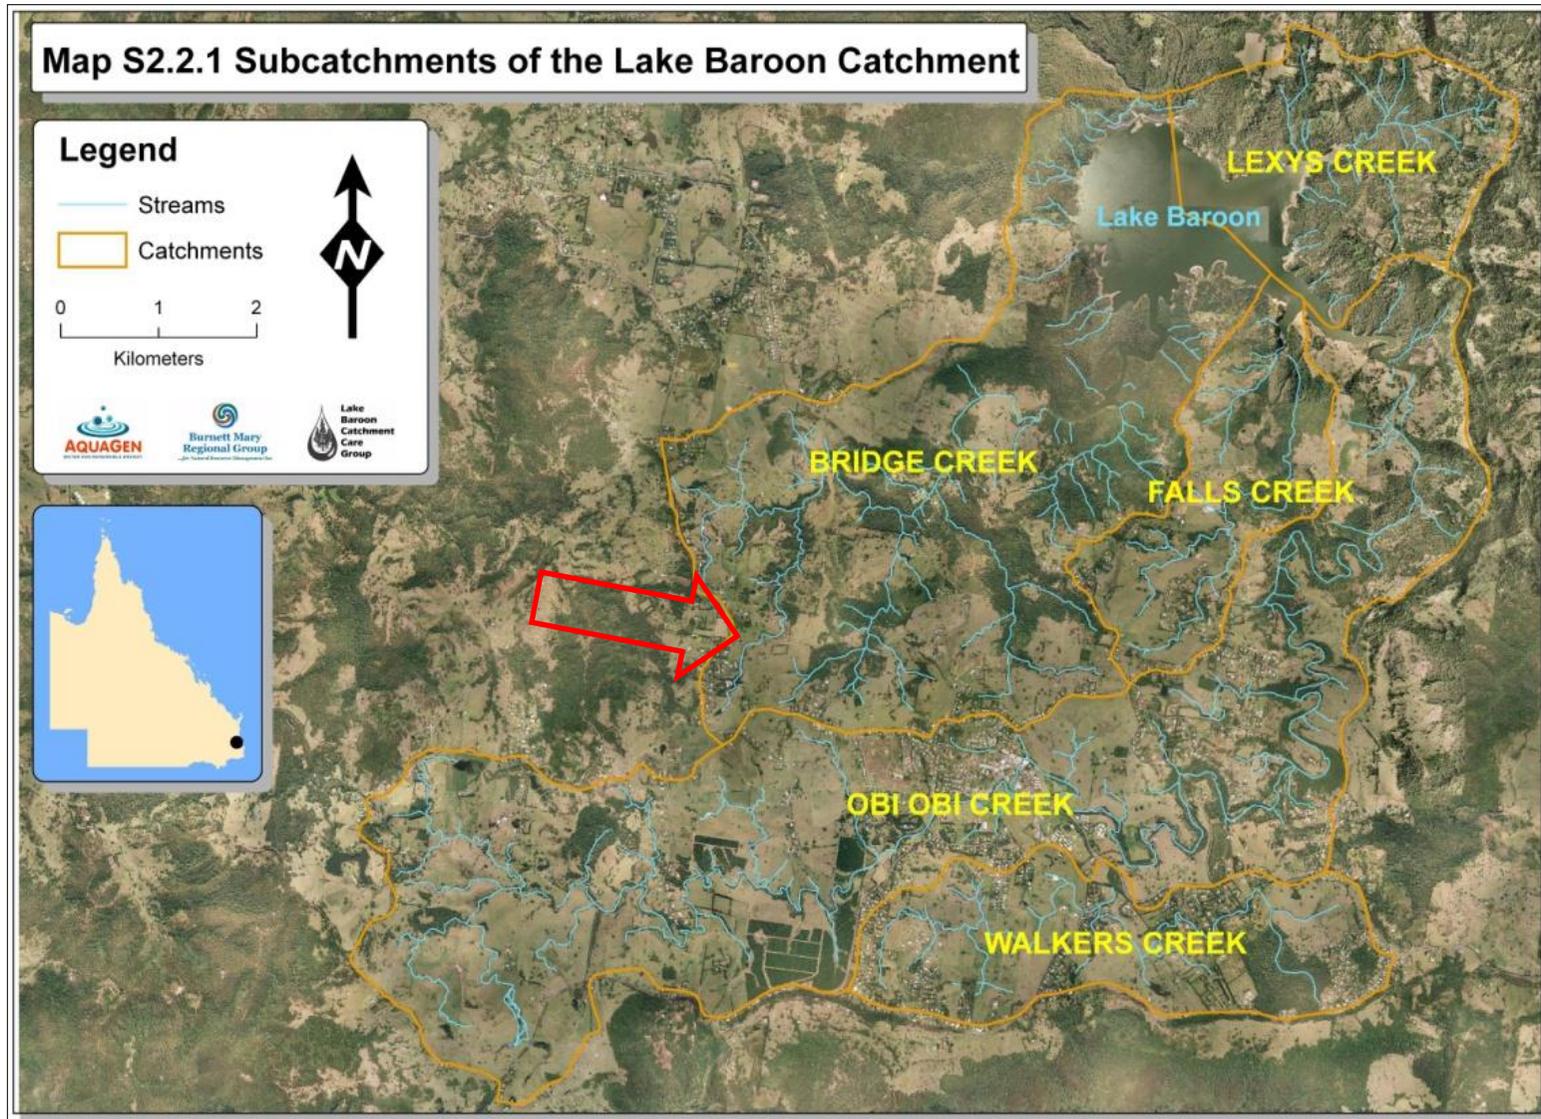
2.3 LOCATION MAP

Above: The Thorne/Eastmure property is located in Management Unit BR1 which encompasses virtually all of Alcorn Creek in its entirety. This MU is a significant contributor of excessive nutrients and sediments primarily due to the steep nature of the catchment.

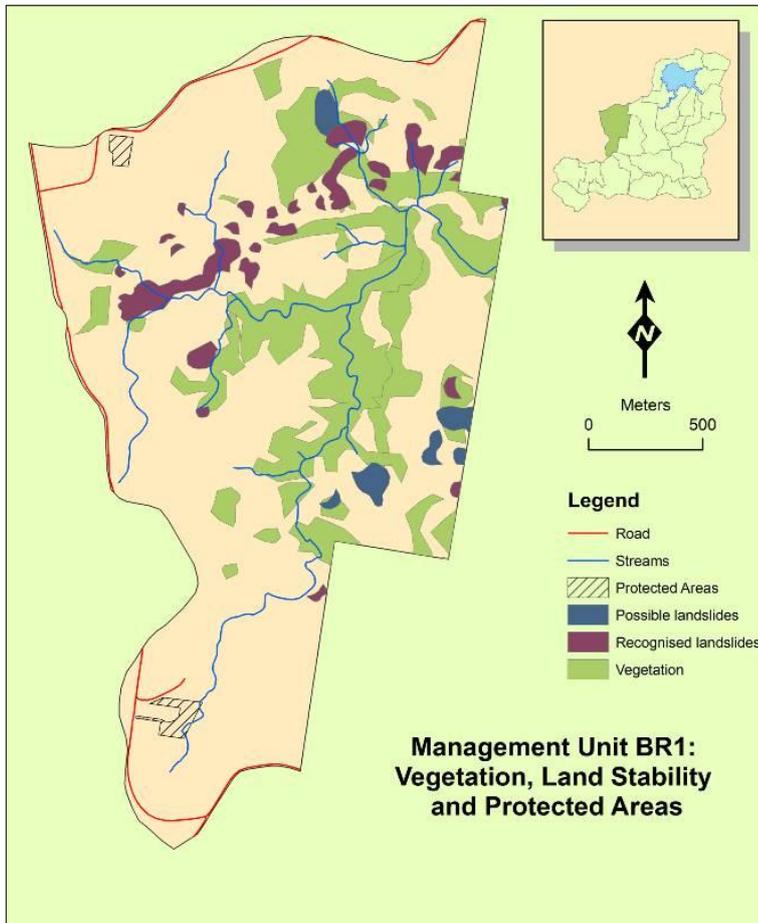
The project site, although displaying some of the attributes that contribute to mass movement is relatively stable. There is evidence of old slips and accumulation of colluvial material – most obvious by the unmistakable ‘hummocky’ appearance of the soil surface, surface cracking of dry soil and areas of waterlogging not directly associated with watercourses.

It is unlikely that the project activities will be affected by mass movement or land slips. The extensive vegetation along the watercourses provides excellent stability.

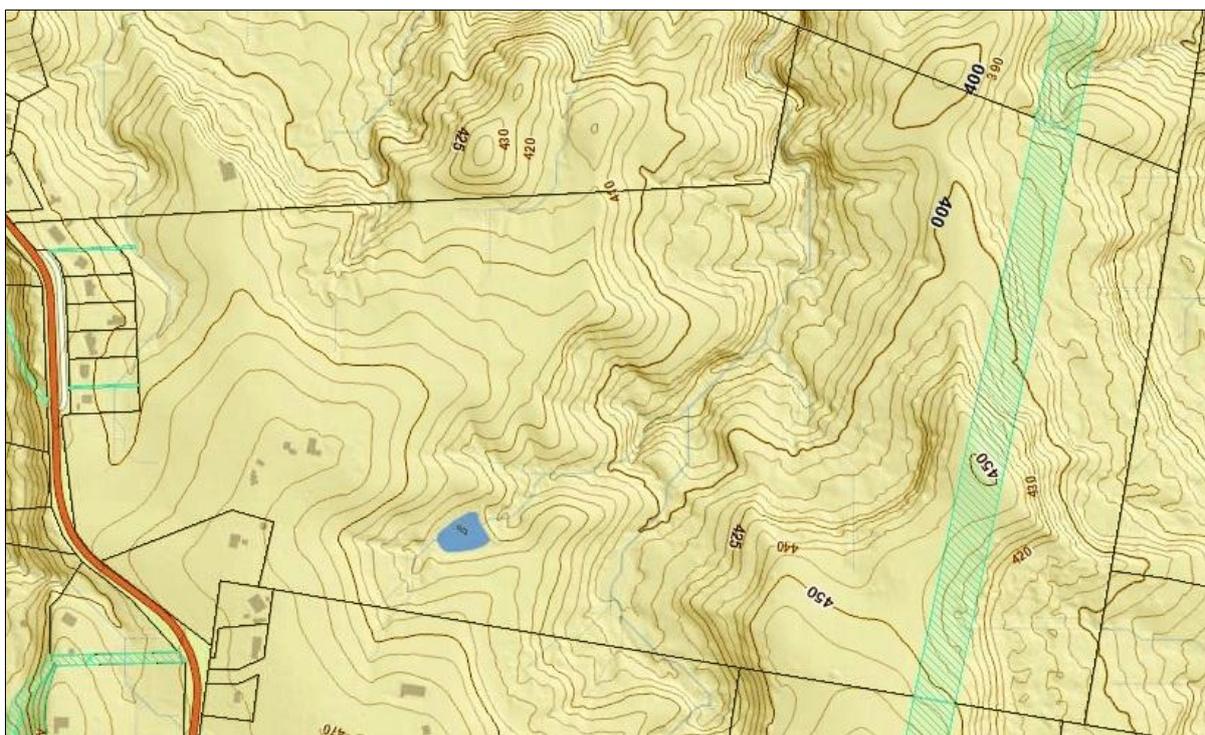
Below: The property is very steep towards the back or eastern side - particularly associated with Alcorn Creek which effectively splits the property in two.

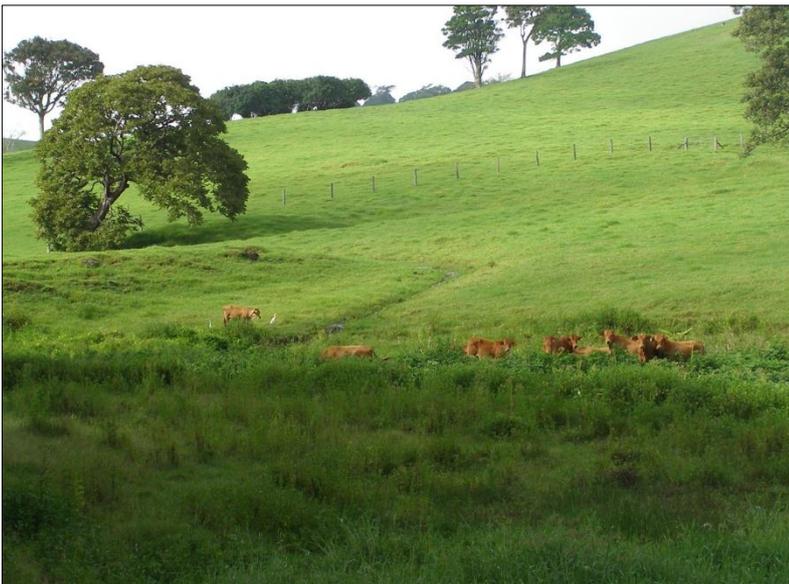
Left: Livestock in waterways are high risk to water quality.

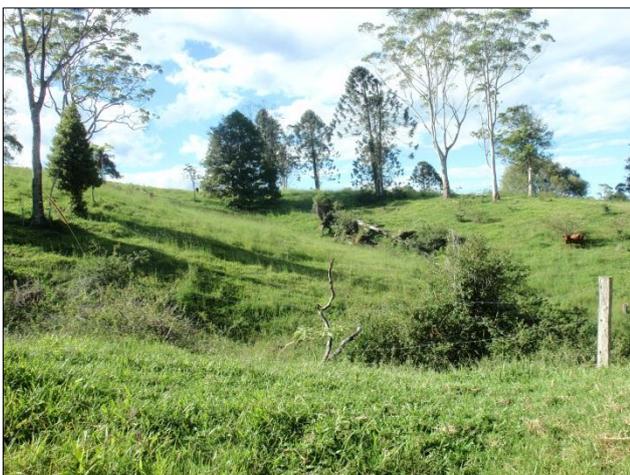
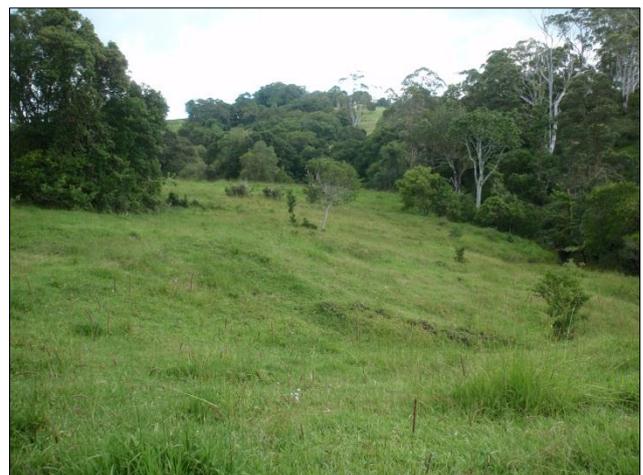
Above: Fencing will be erected well above the riparian zone on relatively flat areas.

Fencing will be erected according to existing vegetation and appropriate alignment. Fencing will consist of standard cattle fencing – timber split posts at 4-5 metre intervals with 4 strands of barb. Gates will be steel.

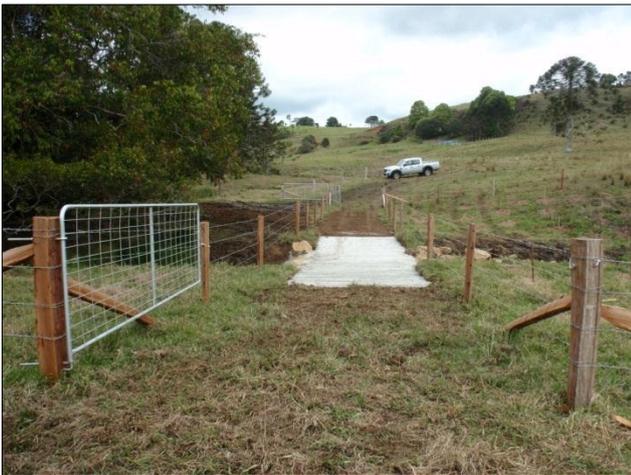
Above: Concrete low level crossing. This particular crossing has been raised to provide a watering point on the upstream side.

This crossing will consist of a low level concrete ford. The advantage of such a construction is that it effectively sits at bank and bed level and is unlikely to suffer from flood damage. Relatively cheap and simple to construct, a concrete crossing requires minimal disturbance to install and can, with minor design modification, create a simple stable watering point (although this will not be required here). The cost of the crossing takes into account the difficult access for concrete trucks and the approaches which will require hardening with road base.

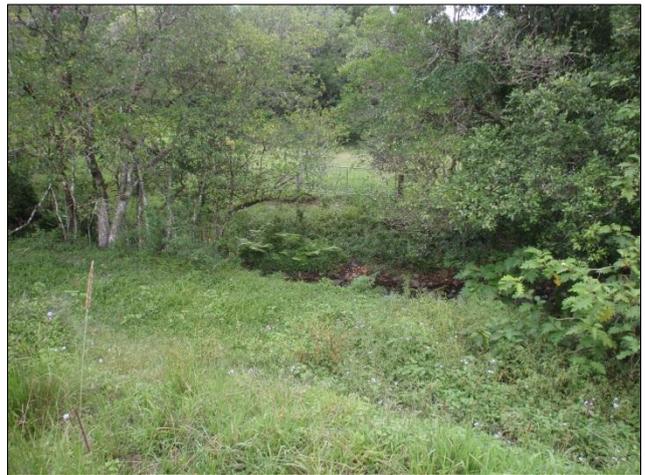
Above: Site for waterway crossing 1 (low level concrete ford).

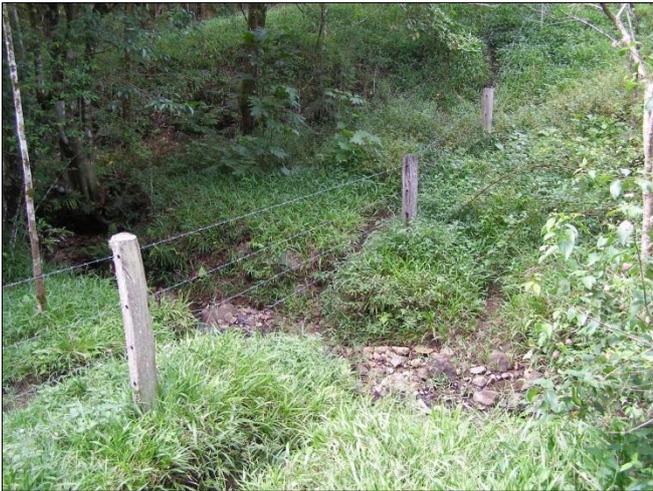
This crossing will be constructed over a tributary to Alcorn Creek to improve livestock mustering. The current crossing point is severely degraded by livestock and vehicles (and has deepened dramatically over the last few years). The crossing will utilise a 900 mm pipe and rock armouring.

Left: Site for waterway crossing 2 (pipe crossing).

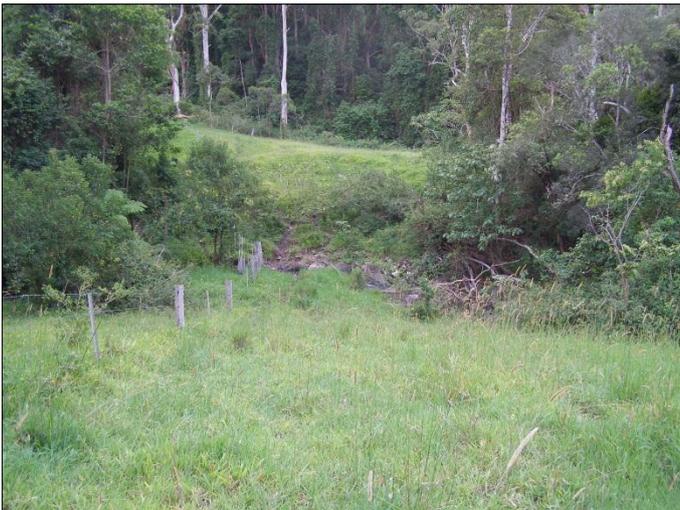
This crossing will be constructed at the downstream end of the property and due to the incised bed of Alcorn Creek will consist of two parallel poles with hard wood decking. This will provide a crossing that will sit above high flows and in the event of unanticipated flood events provide a low profile and be very unlikely to be washed away.

The span beams must be adequately anchored and will be placed on concrete footings. Getting concrete to the site is an issue and the cost includes the capacity to mix on site. Concrete aprons on either end of the bridge similarly will need to be mixed on site.

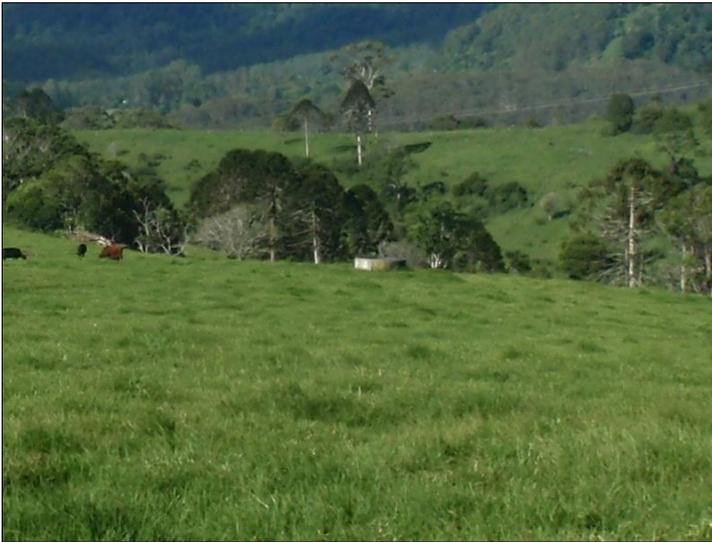
The properties western paddocks are currently serviced by an extensive off stream watering system. With the completion of the Alcorn Creek fencing, the properties eastern paddocks will require alternative water access.

The existing system will be extended to the eastern paddocks of the property. Approximately 1,000 metres of piping (50 mm diameter), holding tank of sufficient capacity for 100 livestock and series of troughs is required.

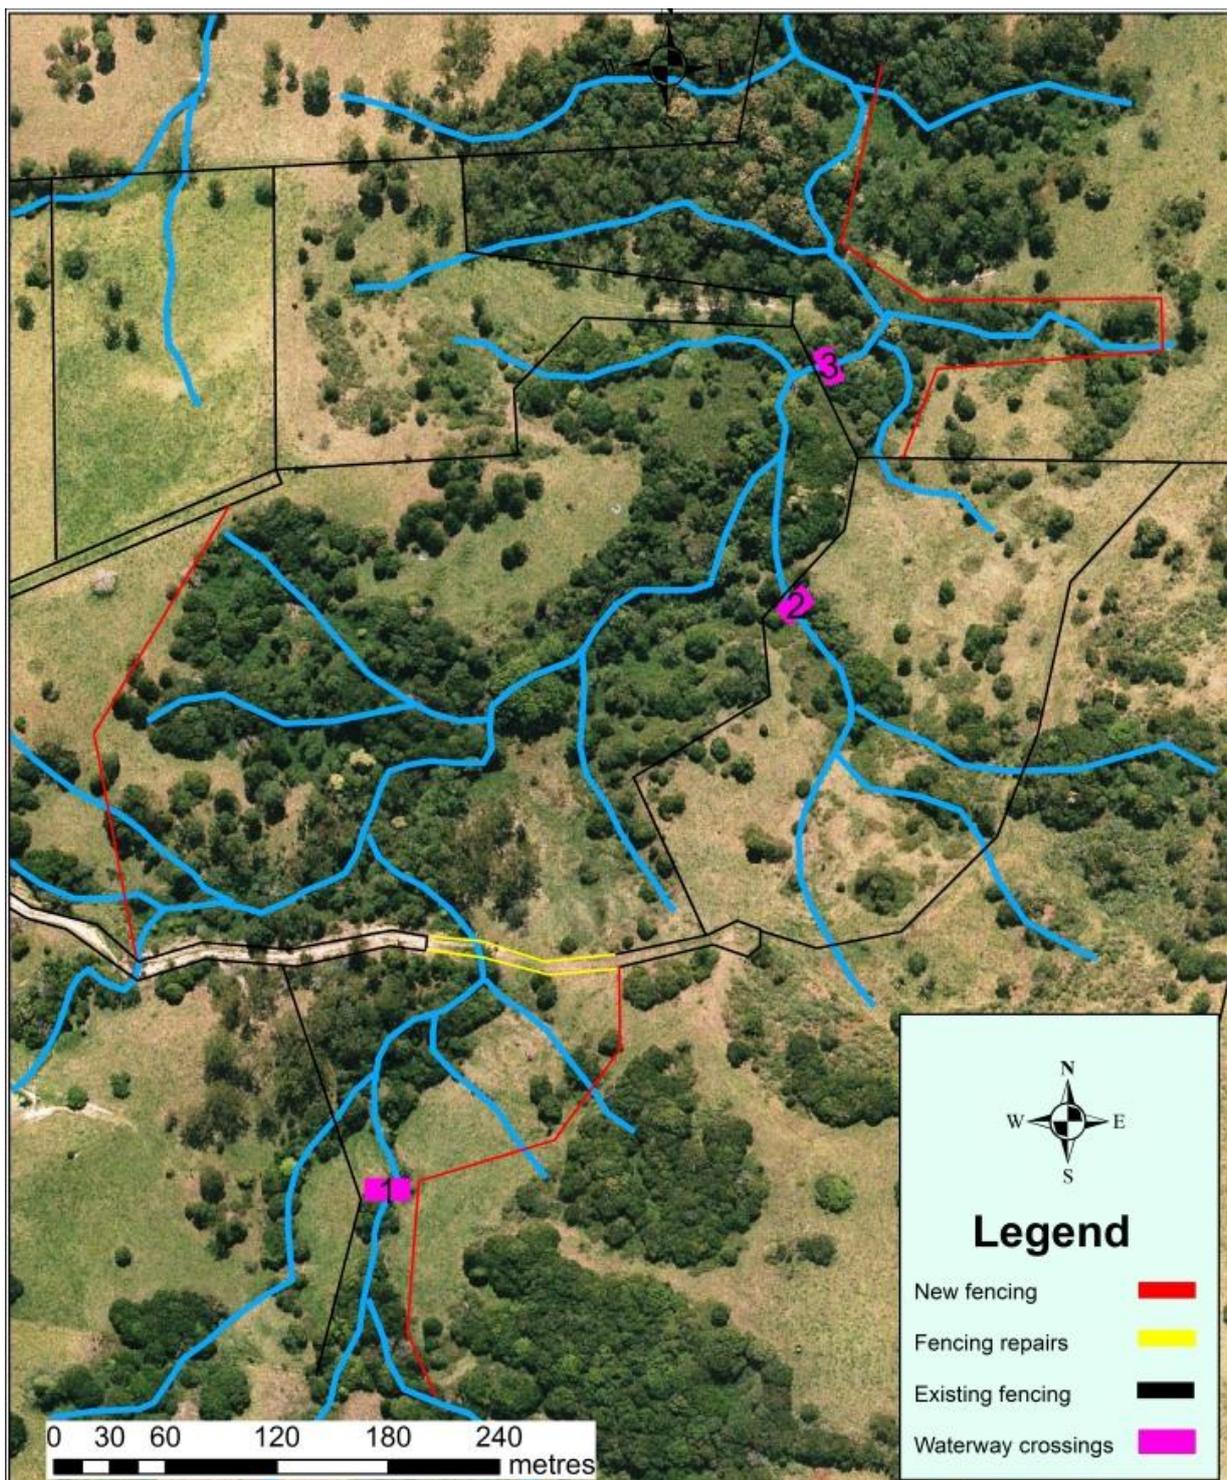
7.3 PROJECT MAP

Upper Alcorn Creek Riparian Fencing
