Lake
Baroon
Catchment
Care
Group

Alcorn Creek Recovery - Stage 1 (Walker)

PROJECT PLAN

Project No. 1516-014

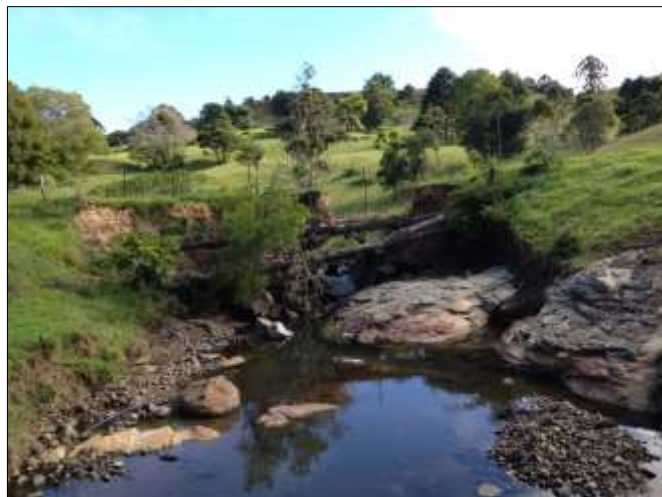
Failed pipe crossing. This is a remnant of the period when the property was grazed by the neighbouring dairy. The crossing is no longer required at this point and will be replaced by a low level crossing upstream that will permit access to the unstable slopes on the northern part of the property (Landslide Mitigation program)

A low level concrete crossing to replace a failed pipe crossing over the primary watercourse. The crossing site will be moved upstream 20 metres to avoid the need to two crossings.

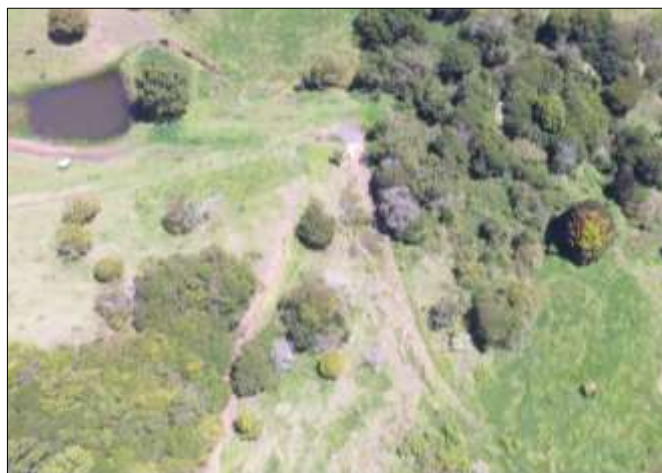
Laneway to be reconstructed in centre of figure

Old laneways constructed when the property was used for dairy grazing have fallen into disrepair and are eroding during high rainfall events. A short section (200 metres) requires reconstruction to minimise ongoing sediment loss and improve access for other components of the project, including the Landslide Mitigation Program.

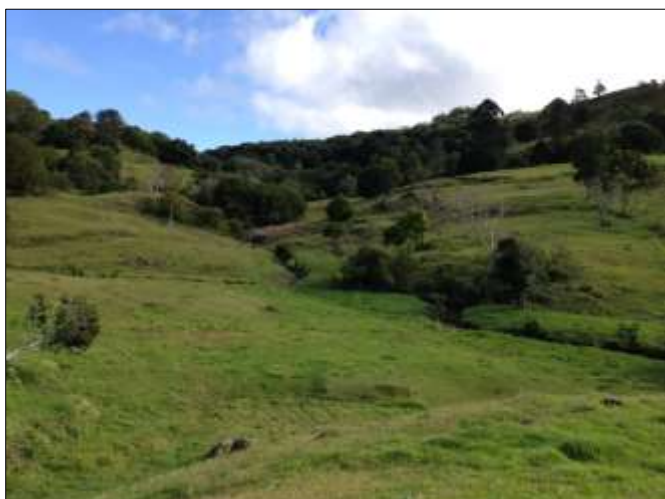
Alcorn Creek tributaries to be fenced

The majority of the numerous watercourses on the property are unfenced and grazed resulting in direct nutrient and pathogen inputs. Furthermore livestock damage the banks and bed of the streams.

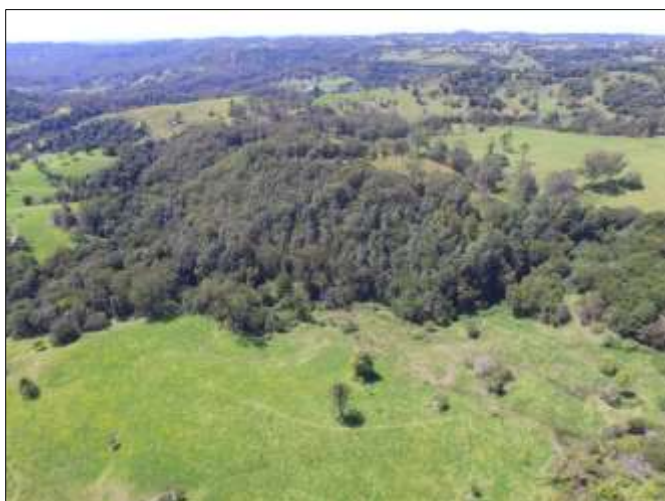
Remnant vegetation to be fenced

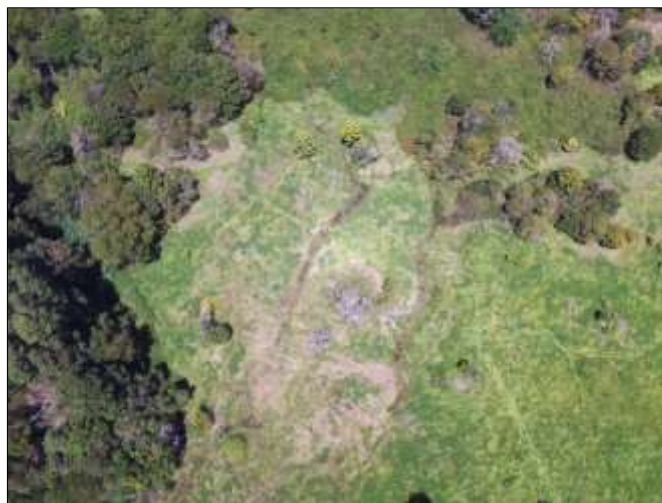
Erosion prone hillslopes require drainage to remove excess water. Pictured above is an area of poorly drained gentle slope that is retaining water as seasonal soaks

The key to stabilising landslips is the management of water. Landslip areas tend to trap and hold water, raising static pore water pressure which is exacerbated during high rainfall events, often beyond the ability of the soil to remain stable.

Careful construction of drains enables trapped water to escape.

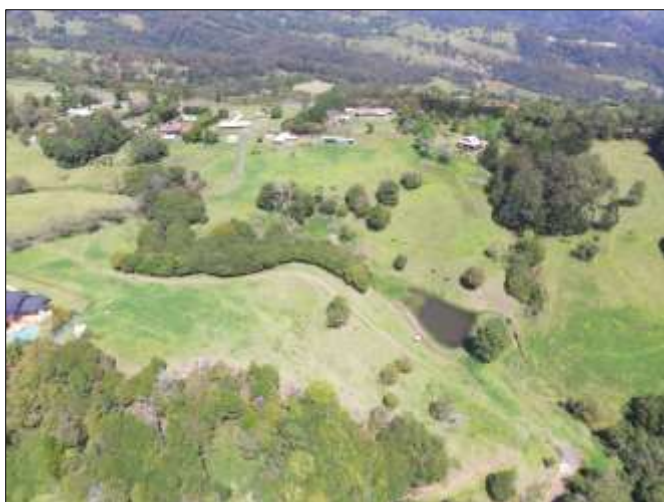
Laneway to be repaired can be seen mid figure

Hardened livestock laneways require regular maintenance to remain effective. The laneways were constructed when the property was utilised for dairy grazing, however they have fallen in to disrepair in the years between the cessation of dairying and the recent purchase by Matt Walker.

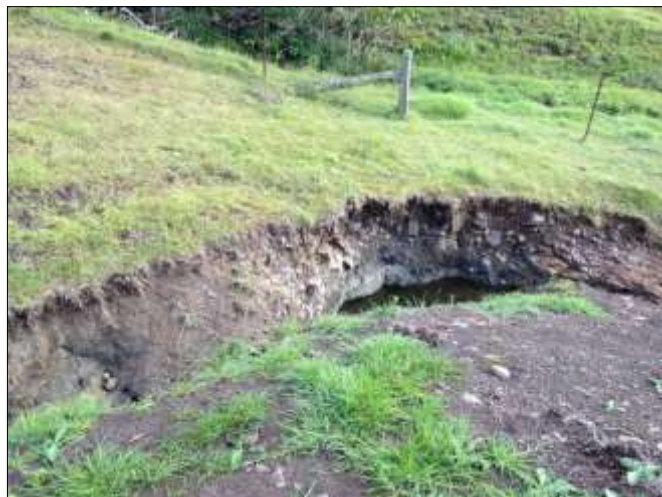
Head-ward erosion threatens the dam wall. The dam is critical for the off stream watering infrastructure. Dam wall failure can result in a significant delivery of sediment to catchment waterways

The dam is currently threatened by head-ward erosion and requires wall (bank) repair – including the addition of pipes.

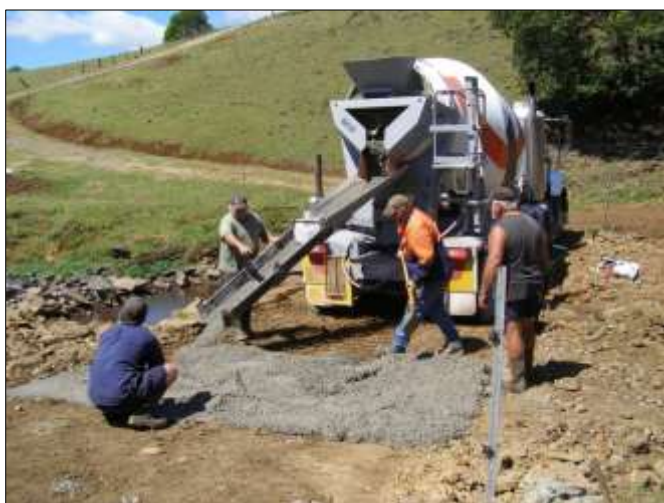
Low level concrete crossing construction

Low level crossings sit at bed level and therefore provide little to no obstruction to water flow and are therefore unlikely to be damaged by floods and/or debris. Furthermore they do not greatly obstruct aquatic passage – relative to natural obstructions commonly found throughout the catchment.

A good crossing is one that serves the purpose for a long time and requires minimal maintenance. The design must allow for a range of flow conditions and sustain as little damage as possible when flooding occurs. It is also essential to ensure that the crossing will have negligible environmental impacts.

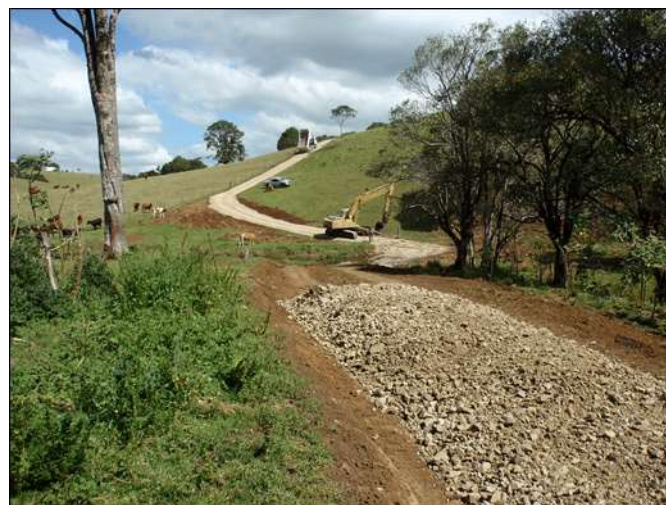
Laneway construction utilising locally sourced road base

Poorly designed or constructed laneways are prone to erosion. The farm environment is greatly improved by hardening laneways, not only because erosion is minimised but also cows tend to move faster between

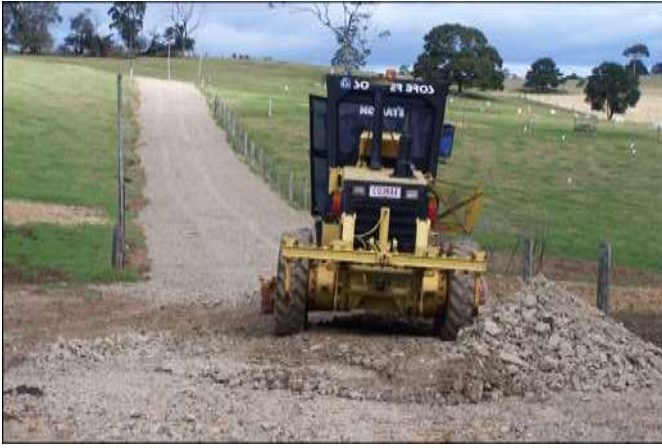
Laneway construction
