Lake
Baroon
Catchment
Care
Group

Projects 2016-17

Clark Creek Off Stream Water Project (Thomas, Barlow & Macleod)

PROJECT PLAN

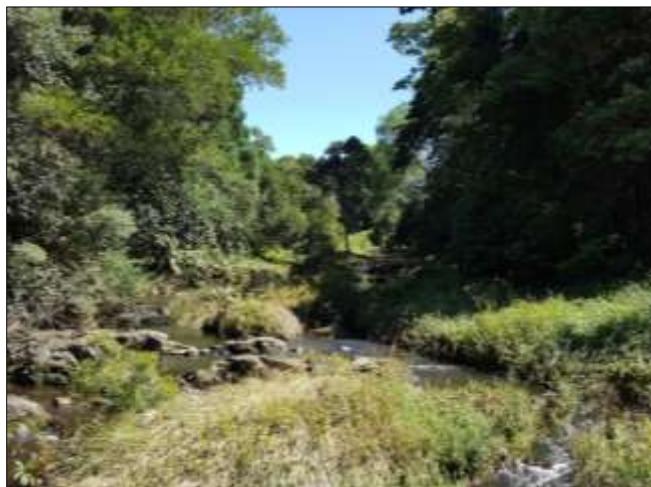
Obi Obi Creek at Aplin Lane.

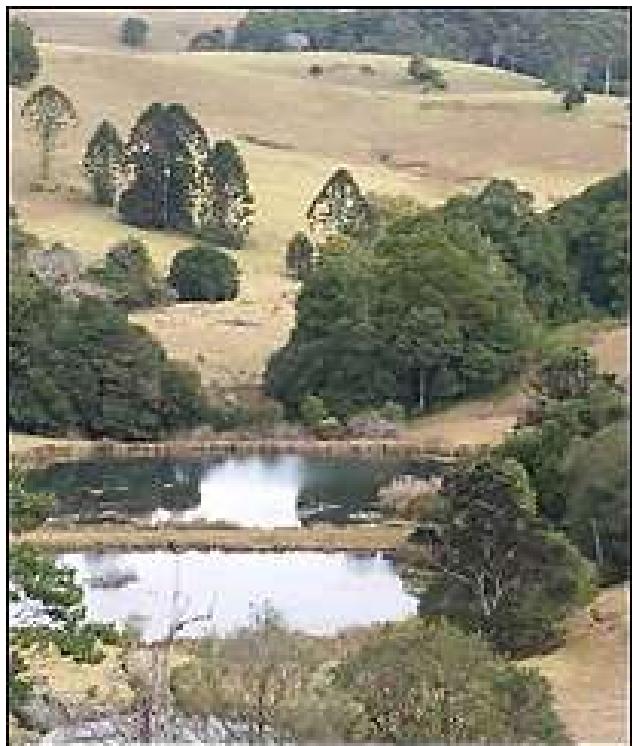
The upper Obi Obi Creek catchment is predominantly cleared with gentle slopes on soils that suit agriculture – particularly grazing. The catchment is dominated by large properties that generate high pollution levels (nutrients).

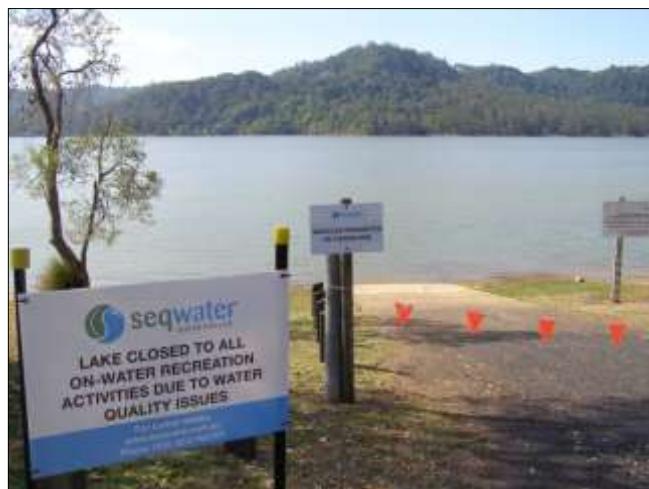
Baroon Pocket Dam in September 2013 (storage remained closed for almost 12 months). Cyanobacteria blooms disrupt recreational use of the storage and create difficulties in the production of potable water.

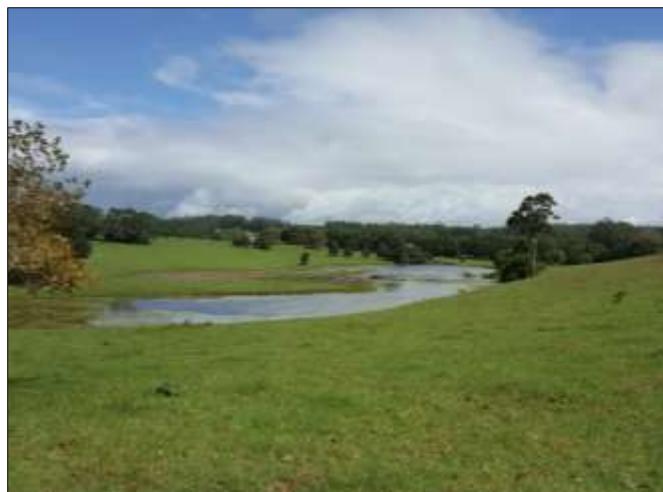
Large farm dam on Thomas property to be fully fenced, including downstream Clark Creek.

Currently the banks and bed of the dam and creek are degraded resulting in erosion and damage to wetland macrophyte vegetation that is essential for filtering polluted stormwater. The fencing of the watercourse will reduce damage to the bed and banks of the creek reducing erosion, nutrient and pathogen inputs and improve the watercourses ability to ‘polish’ pollution originating upstream.

Permanent electric cattle fencing will be installed (timber split posts at ten metre spacings, two plain wires and simple gates).

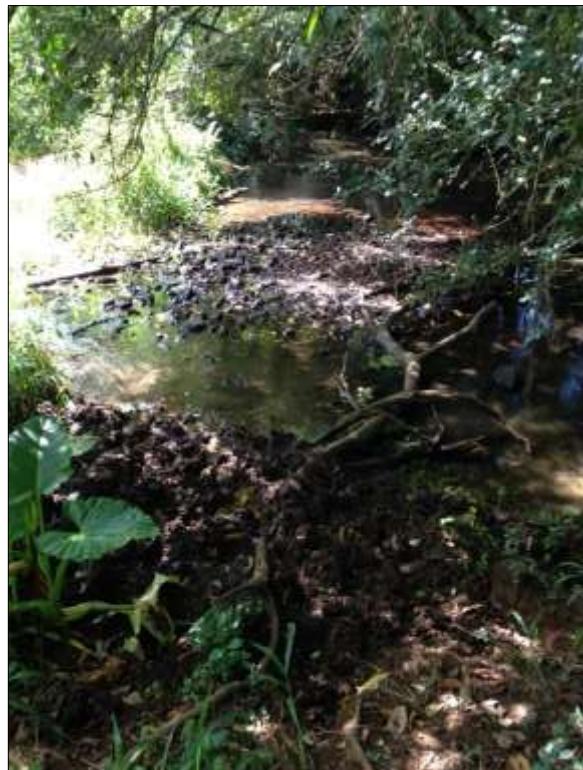
Obi Obi Creek on Macleod property. The impacts of livestock watering here include damage to the bed and banks, erosion and turbidity and damage to native vegetation.

Currently livestock in the western paddock access a short length of Obi Obi Creek for water. This creates management issues as following high flows the cattle can cross the creek and mix with the neighbours cattle. The livestock damage the bed and banks of the creek and can, in low flows, escape or lost from accidents.

Standard cattle fencing will be utilised – timber split posts at four metres, four wires (mix of barb and plain) and steel gates.

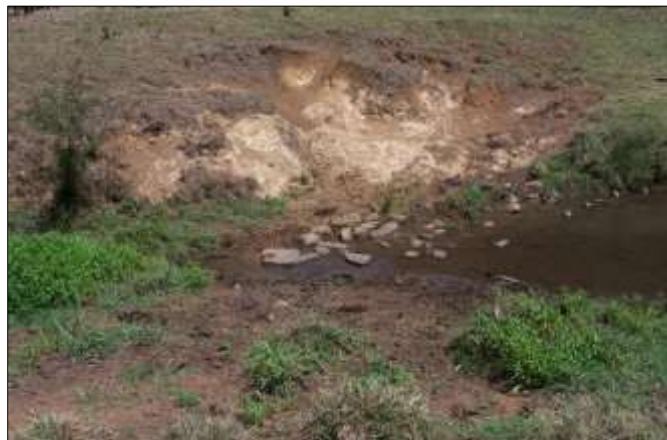
Stream crossing site on Barlow property. Livestock cross at this point on Clark Creek as most of the watercourse is steep or the channel is incised discouraging crossing.

The Barlow property is dissected by several permanent watercourses with an existing crossing over Clark Creek severely degraded from livestock. A low level concrete crossing will reduce erosion and improve livestock management.

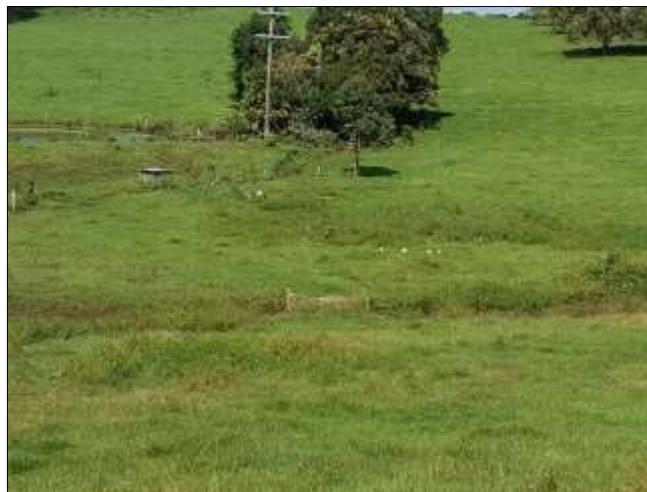
Pipe crossing over Clark Creek on Thomas property. These types of crossings are no longer considered best practice and are not constructed. However this crossing remains in fair condition and can be rehabilitated relatively cheaply and easily.

Two existing crossings on the Thomas property require rehabilitation or repair to ensure long term stability. The large pipe crossing immediately downstream of the farm dam has over time had its gravel surface washed away to the point where it is almost impossible to cross. The crossing requires the replacement of the gravel and

road base along with sufficient compaction. Additionally a spillway will be excavated to the side of the crossing so that high flows are safely directed around the crossing rather than wash over it removing the gravel.

A second pipe and concrete crossing requires minor repair – filling of a narrow but deep channel being cut by high flows around the side.

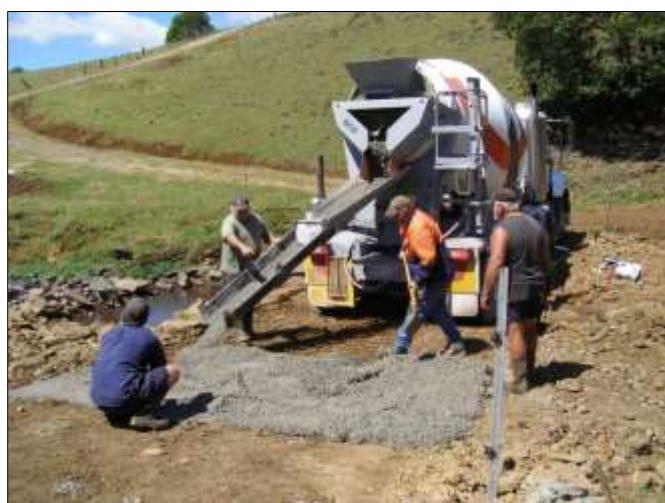
Low level concrete crossing construction

A good crossing is one that serves the purpose for a long time and requires minimal maintenance. The design must allow for a range of flow conditions and sustain as little damage as possible when flooding occurs. It is also essential to ensure that the crossing will have negligible environmental impacts.

Other than providing access across a stream for people, vehicles and livestock, a well-designed crossing provides environmental benefits. Restricting crossings to one point will greatly reduce local erosion and protect riparian vegetation from stock; further stabilising stream banks, and can greatly assist in managing nutrient input to the stream system (Janicke & Murray 2008).

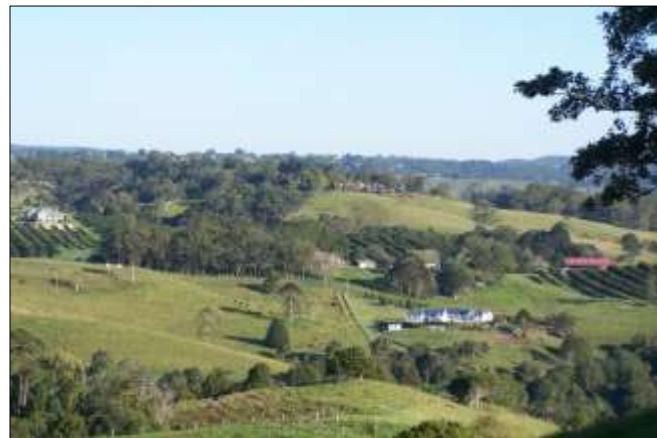
Bridge Creek varies widely in topography, land use and threats to water quality. Upper reaches are largely grazed, mid reaches support a mix of natural bush and rural residential properties with some grazing again in the lower reaches.

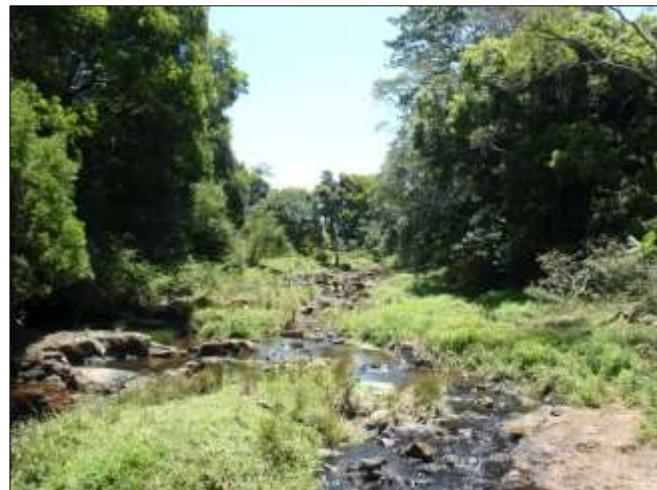
The Aplin Road water quality sampling point in Management Unit OB3. The riparian zone has increasingly improved riparian vegetation cover.

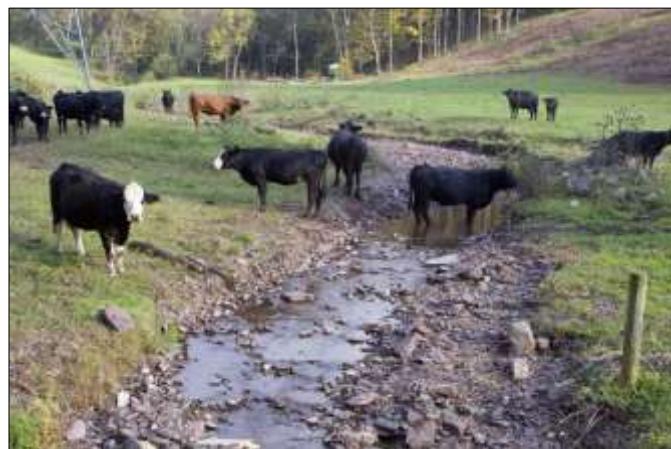
Livestock in waterways are high risk to water quality.

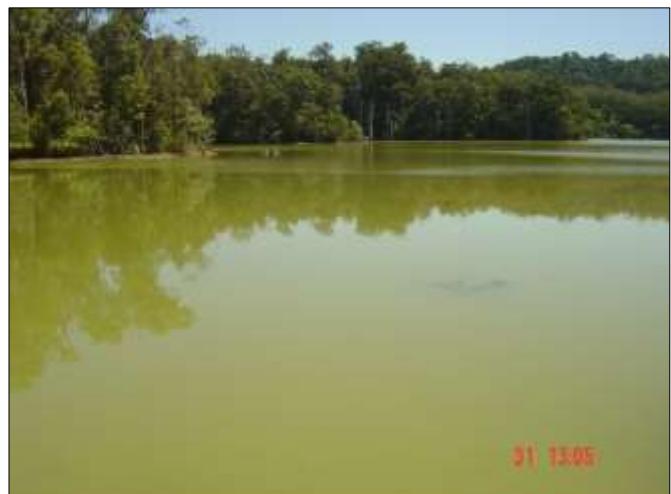
Excessive erosion and nutrients delivered from the catchment contribute to cyanobacteria (blue green algae) blooms in Lake Baroon.
