Lake
Baroon
Catchment
Care
Group

Projects 2015-16

Northern Alcorn Creek (Colley)

PROJECT PLAN

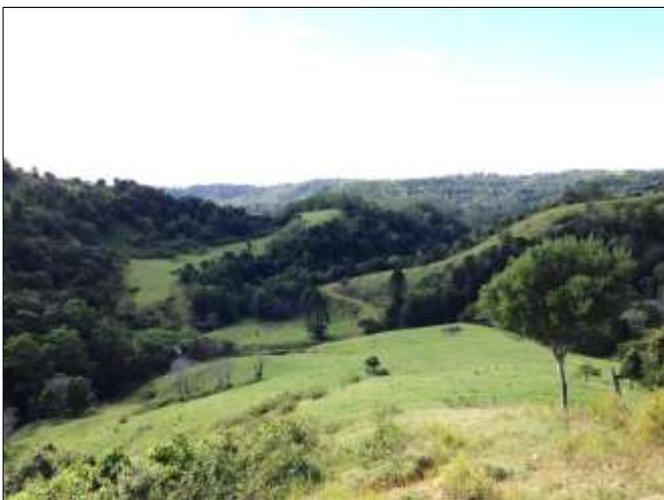
The Colley property – the northern paddocks where the bulk of activities will be implemented.

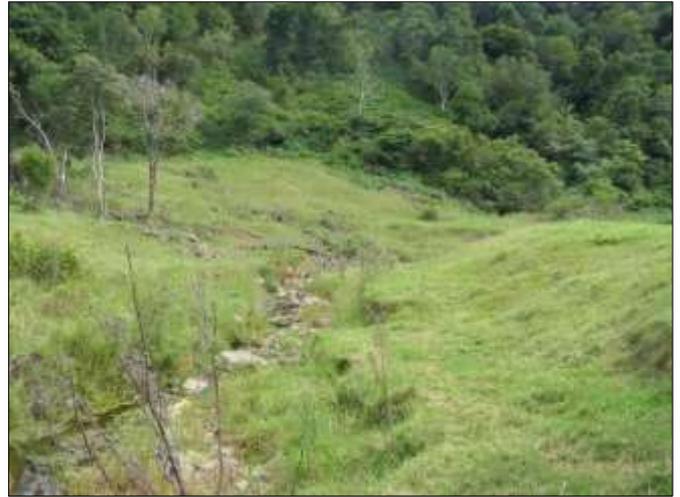
Reach of Alcorn Creek to be fenced.

Livestock have uncontrolled access to Alcorn Creek. This is currently necessary for a water source however the banks and bed of the creek are severely degraded resulting in excessive erosion. The fencing of Alcorn Creek will reduce damage to the bed and banks of the

Fencing will consist of standard cattle fencing – timber ‘split ‘posts at four metre spacings and four strands of barb wire. This may be modified where necessary according to site conditions such as inaccessibility for heavy equipment (tractor).

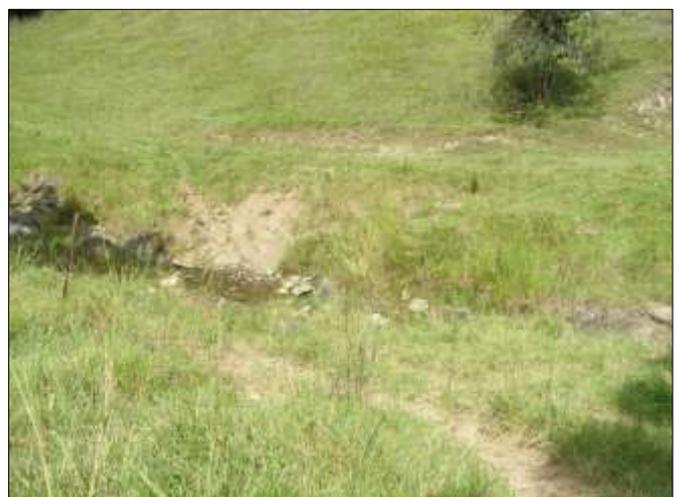
Site for major stream crossing. Note the steep approach on the far bank. The laneway/approach in the background will be modified to reduce steepness.

A low level concrete crossing to replace a failed bridge over Alcorn Creek. The crossing will require significant removal of material on the approach and potentially a thicker than usual concrete base to minimise the steepness into the crossing and allow access for heavy equipment.

The construction of the crossing will permit access to the northern paddocks of the property for the installation of the minor crossing, fencing and off stream watering.

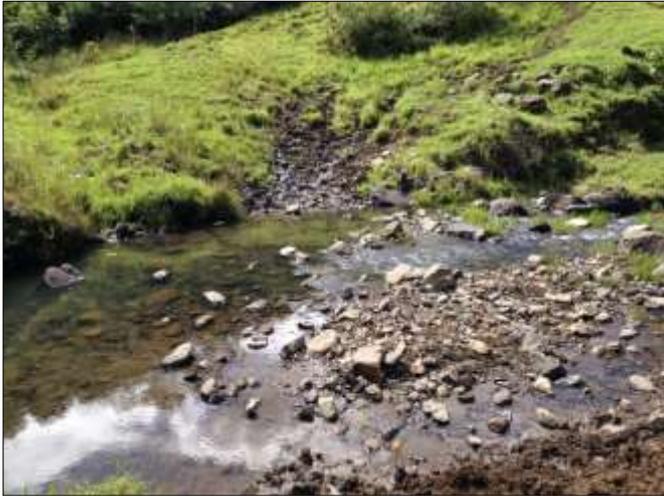
Site for minor stream crossing.

A low level concrete crossing to replace the current degraded informal crossing. This crossing will improve access to the northern paddock reducing the impacts of livestock - primarily erosion, but also direct faecal deposition.

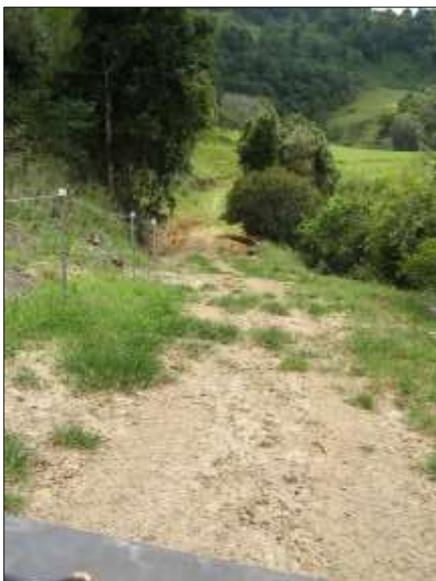
Laneway is narrow, dangerously steep, has sharp humps and when wet is extremely slippery.

Laneways constructed when the property was used for dairy grazing have fallen into disrepair and are eroding during high rainfall events. A short section (100 metres) requires rehabilitation to minimise ongoing sediment loss and allow access for other components of the project, including the Landslide Mitigation Program. The laneway will be widened, profiled and will have the steepness removed to improve safety and reduce erosion.

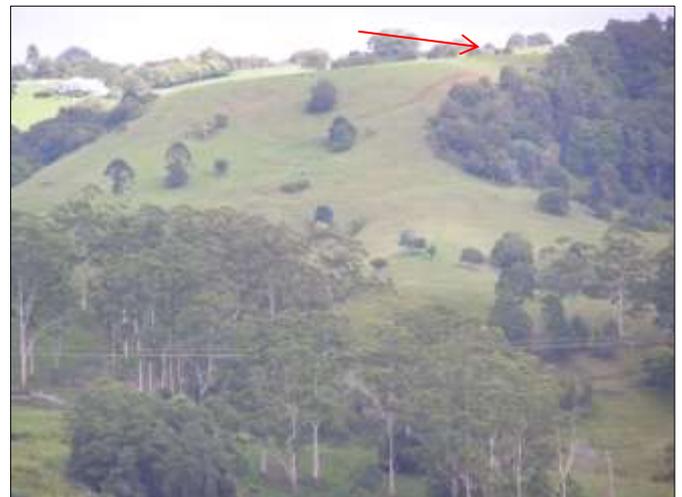
Header tank location for off stream watering system.

An existing OSW system on the property (servicing the southern paddocks) will be accessed and extended to the northern side of the property. Increased header tank storage (23,500 litres), four troughs and approximately 1,500 metres of variously pressure rated poly pipe (to account for a head pressure of approximately 180 metres) is required.

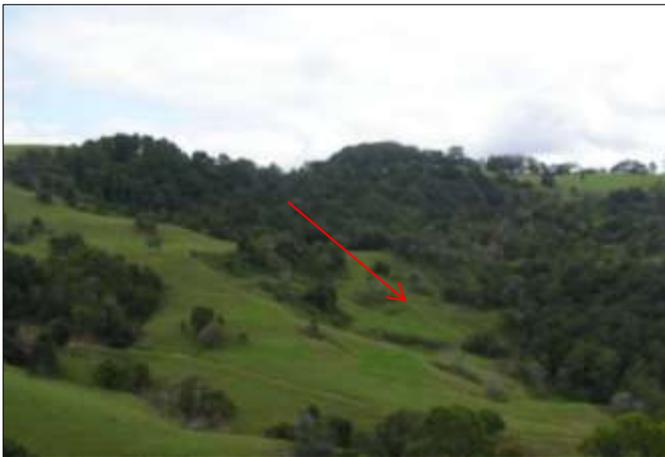
Landslide revegetation area.

There are several approaches to revegetate landslips but the best solution for highly mobile sites and areas required for managed grazing is the planting of local pine species that tolerate moderate soil movement and are unpalatable to livestock once established

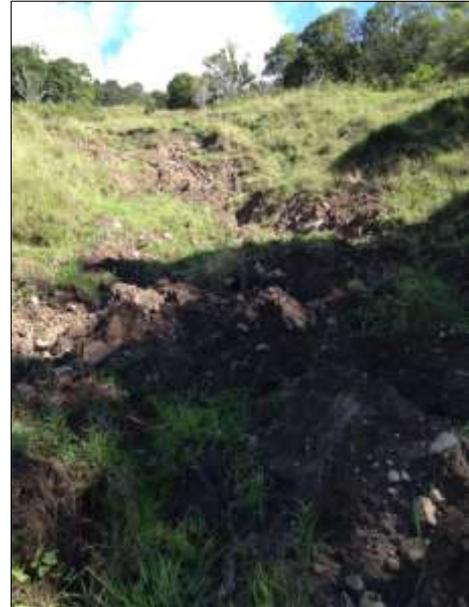
Erosion prone hillslopes require drainage to remove excess water. Pictured above is an area of poorly drained slope that is retaining water as seasonal soaks

Carefully constructed drains can help remove trapped water from the landslip and during heavy rainfall channel flows safely away.

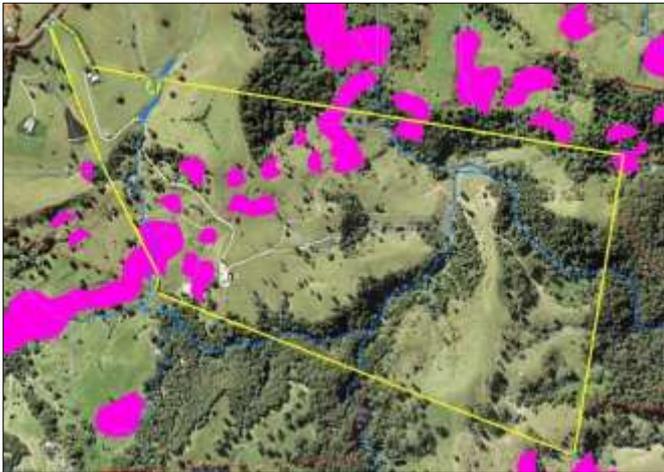
Colley property highlighted with pink areas denoting recognised landslips.

- 55 ha of improved and unimproved pasture (including approximately 9.5 ha of potentially unstable slopes – *see figure below*);
- 16 ha remnant vegetation;
- 18 ha regrowth vegetation (including weeds);
- 1 ha of residential;

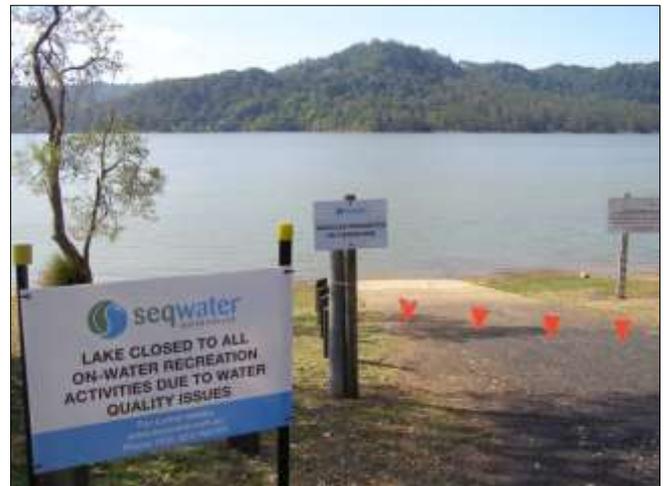
Baroon Pocket Dam in September 2013 (storage remained closed for almost 12 months). Cyanobacteria blooms disrupt recreational use of the storage and create difficulties in the production of potable water.

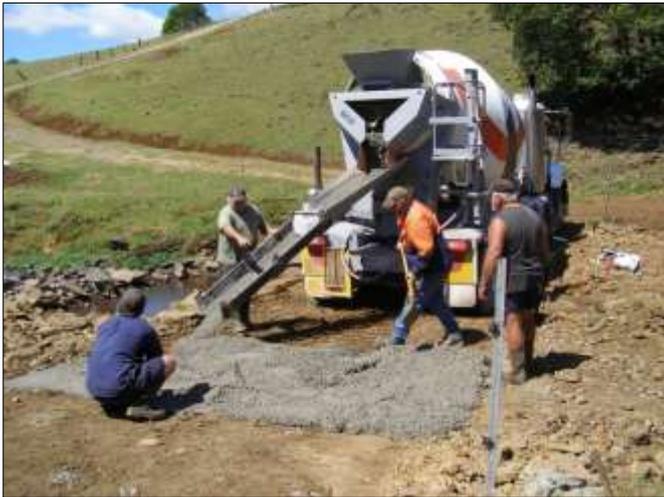
Low level concrete crossing construction

Low level crossings sit at bed level and therefore provide little to no obstruction to water flow and are therefore unlikely to be damaged by floods and/or debris. Furthermore they do not significantly obstruct aquatic passage – relative to natural obstructions commonly found throughout the catchment.

A good crossing is one that serves the purpose for a long time and requires minimal maintenance. The design must allow for a range of flow conditions and sustain as little damage as possible when flooding occurs. It is also essential to ensure that the crossing will have negligible environmental impacts.

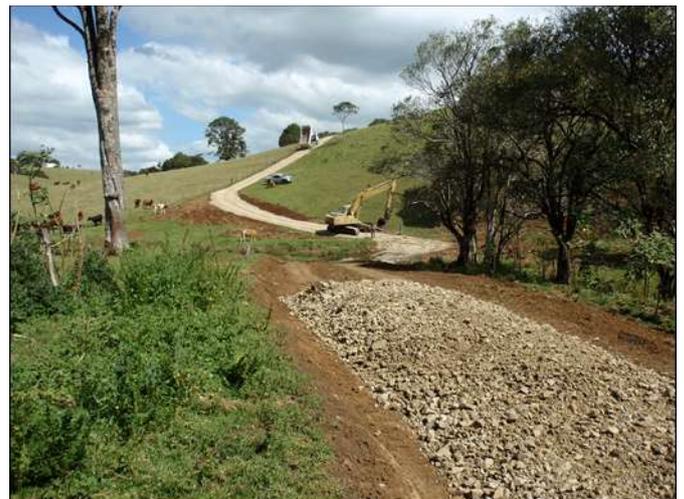
Laneway construction utilising locally sourced road base

Poorly designed or constructed laneways are prone to erosion. The farm environment is greatly improved by hardening laneways, not only because erosion is minimised but also cows tend to move faster between

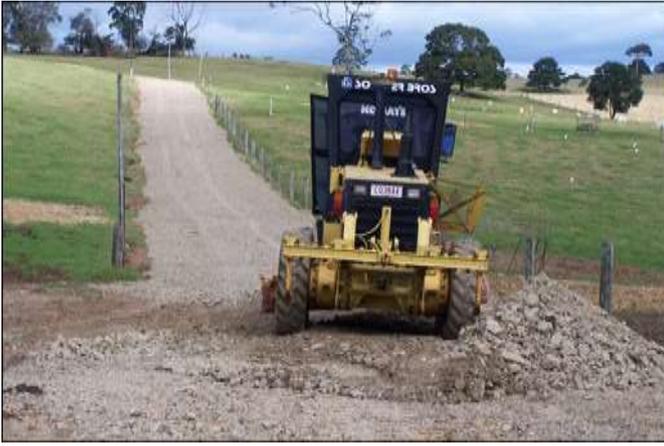
Laneway construction

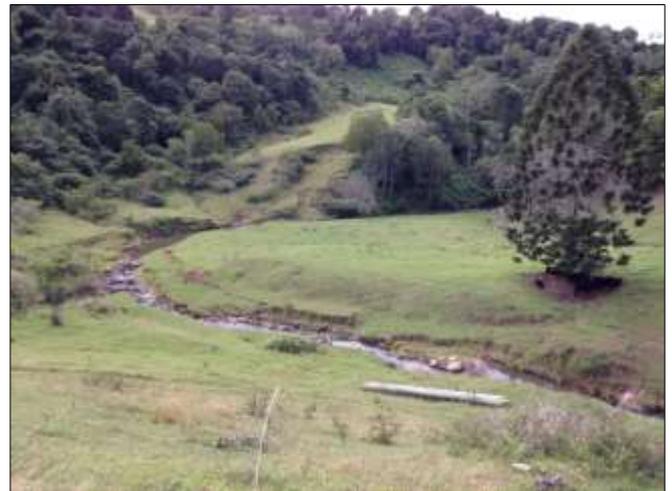
Management Unit BR1 is characterised by intensive beef grazing in the upper catchment on the better soils, to poorer, heavy soils and steep slopes in the lower reaches.

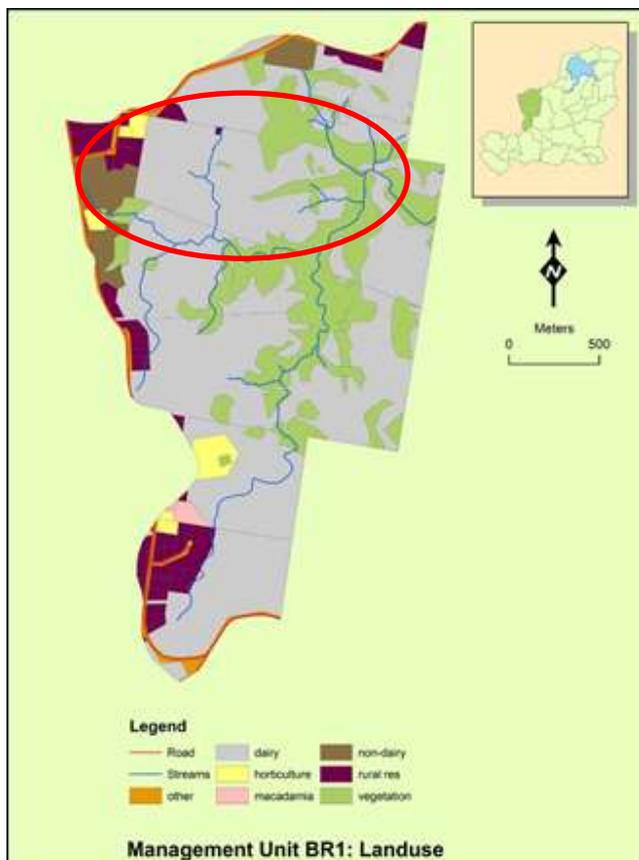
Land use in MU BR1 is overwhelmingly beef grazing, with minor dairying and rural residential. Note the figure above was produced from 2005 data which at that time was inaccurate - overwhelmingly the grey shaded area is actually beef grazing.

Land use in the Management Unit is dominated by beef grazing (85% of the management unit), with dairy grazing (including dry cow grazing) a minor use (7%) with rural residential properties making up the balance of land (6%).

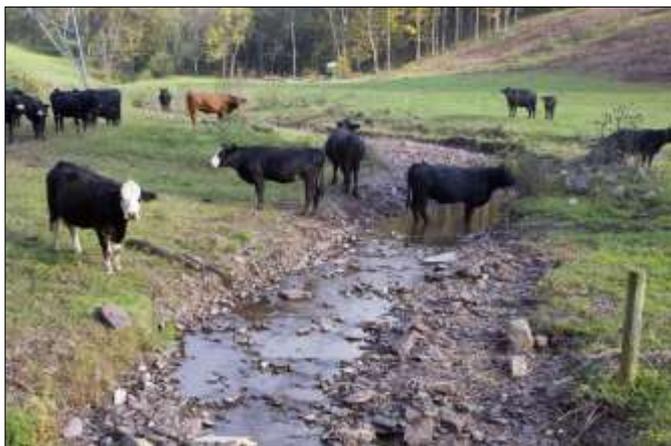
Livestock in waterways are high risk to water quality.

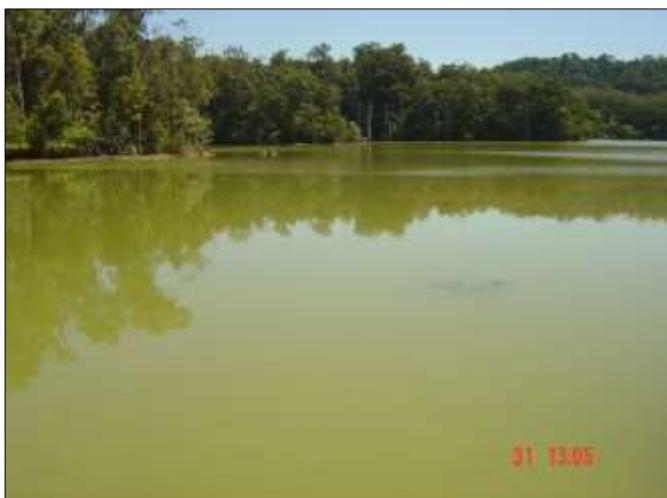
Excessive erosion and nutrients delivered from the catchment contribute to cyanobacteria (blue green algae) blooms in Lake Baroon.
