Lake  
Baroon  
Catchment  
Care  
Group

## Walkers Creek Dairy Project (Muller & Maleny Dairies)

## PROJECT PLAN

Project No. 1516-015

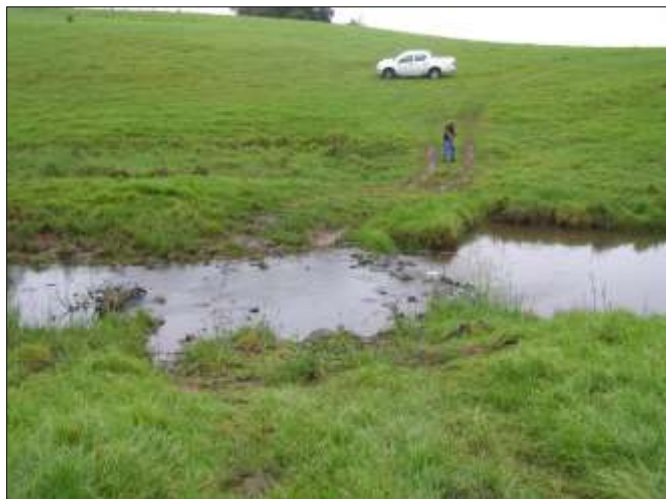
*Proposed stream crossing site on Walkers Creek.*

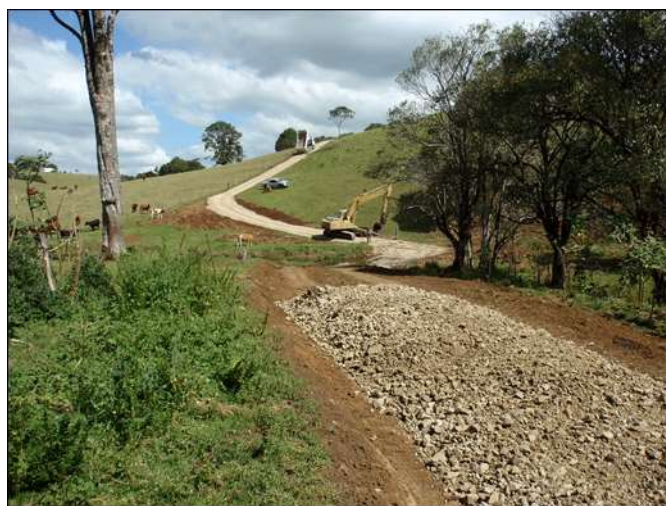
*Laneway construction utilising locally sourced road base*

Poorly designed or constructed laneways are prone to erosion. The farm environment is greatly improved by hardening laneways, not only because erosion is minimised but also cows tend to move faster between

paddock and dairy resulting in less manure deposited on laneways and therefore reduces the risk of faecal material entering drainage lines and watercourses.

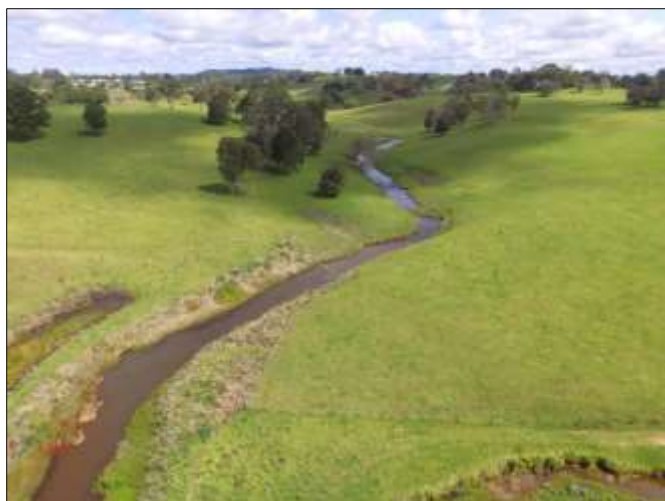
**The Muller property and Walkers Creek**

Walkers Creek enters the property from the west, meandering in and out of the property before splitting the eastern portion of the property in two with a total combined length of approximately 680 metres. The riparian zone is virtually totally devoid of woody vegetation with pasture to the water's edge. Most of the isolated native species scattered over the property are either introduced shade trees or individual remnant species. The sole purpose of these sparse trees is the provision of shade for livestock.

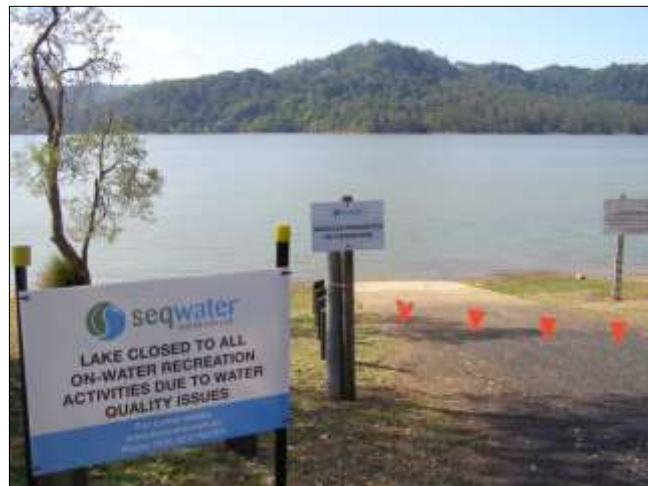
**Baroon Pocket Dam in September 2013 (storage remained closed for almost 12 months). Cyanobacteria blooms disrupt recreational use of the storage and create difficulties in the production of potable water.**

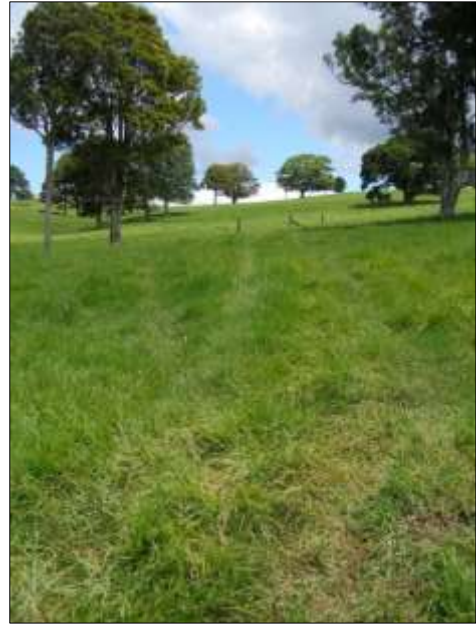
***New laneway alignment***

Maleny Dairies have leased the Muller property, an ex-dairy farm that converted to beef production in around 2000. Maleny Dairies will continue to use their milking facility however there are no laneways between the two properties. Therefore an entirely new laneway is required to enable efficient movement between the two properties (approximately 1,300 metres) and the rehabilitation of a further 600 metres of degraded laneway (part of the old Muller dairying).

A grader is necessary to achieve the correct profile and on steeper sections (and near watercourses) diversion banks (whoa-boys) are inserted into the laneway to ensure run off is diverted to pasture areas and not permitted to flow directly to watercourses. Additionally this will prevent erosion of the laneway surface.

It is essential the road-base is compacted with a suitable heavy roller while sufficiently damp to achieve adequate compaction. Compaction using tracked earthmoving equipment is not acceptable.

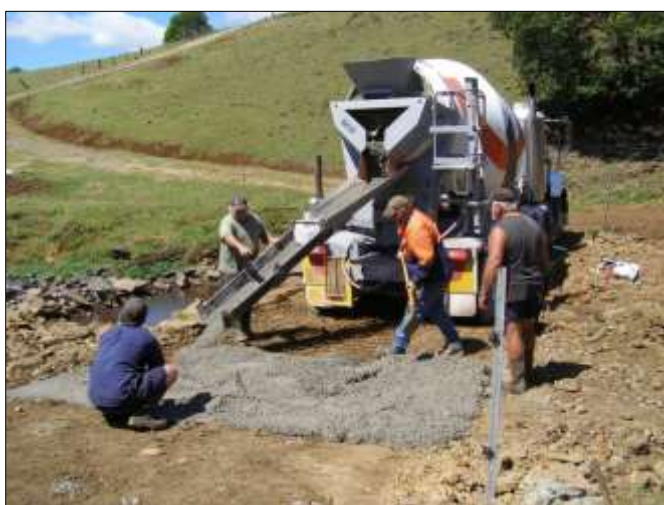
***Low level concrete crossing construction***

Installation of a stream crossing will reduce risks to water quality, reducing nutrient, sediment, pathogen, and organic matter loads to streams. A formal crossing will also reduce streambank and streambed erosion. Stream crossings can provide cattle with improved access to pastures thereby improving grazing distribution while reducing the likelihood that cattle will be injured. Stream crossings also improve vehicle access for weed management, pasture improvement, erosion management and other activities that influence the quality of water flowing off properties. Stable stream crossings can help prevent farm equipment damage by providing a smooth entrance and exit.

A good crossing is one that serves the purpose for a long time and requires minimal maintenance. The design must allow for a range of flow conditions and sustain as little damage as possible when flooding

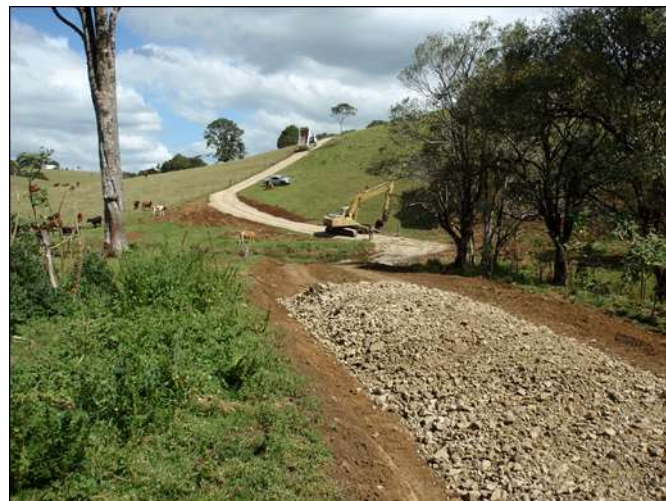
***Laneway construction utilising locally sourced road base***

Poorly designed or constructed laneways are prone to erosion. The farm environment is greatly improved by hardening laneways, not only because erosion is minimised but also cows tend to move faster between

paddock and dairy resulting in less manure deposited on laneways and therefore reduces the risk of faecal material entering drainage lines and watercourses. Rehabilitated laneways significantly reduce erosion in high stock traffic areas resulting in less sediment run-off. Carefully designed laneways are shaped with strategic cross drainage (whoa-boys) to shed water to the sides (onto pasture) and direct run-off contaminated with faecal material (nutrients) to

pasture that can trap and filter nutrients, rather depositing directly to watercourses.

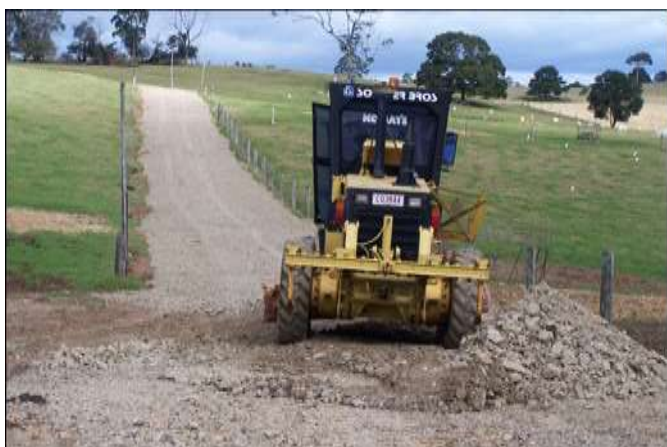
**Laneway construction**

Mud from boggy laneways pose health risks for the dairy herd and for raw milk and must be washed from udders before milking, requiring increased labour and water use. Boggy laneways increase the time taken (and energy expended) to travel between the paddock and dairy (for cows and vehicles). Poor access to grazing pastures, particularly during wet periods, limits efficient pasture use which can have a detrimental effect on run-off (overgrazed paddocks increase nutrient and sediment run-off).

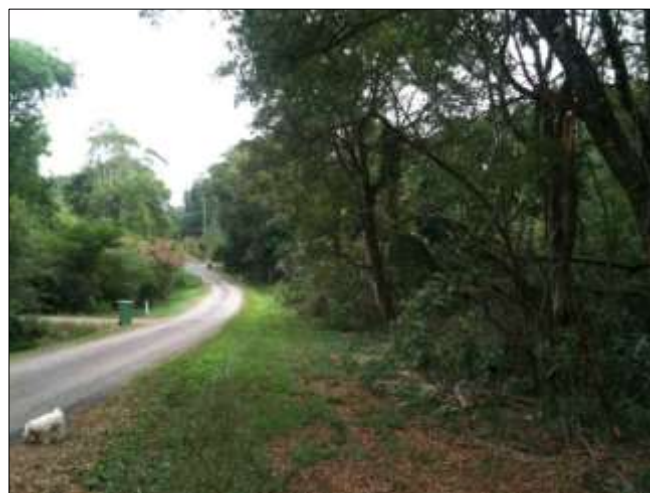
***The Walkers Creek catchment has a high proportion of rural residential properties with associated wastewater systems, roads and stormwater infrastructure – all likely contributing to the poor water quality results.***

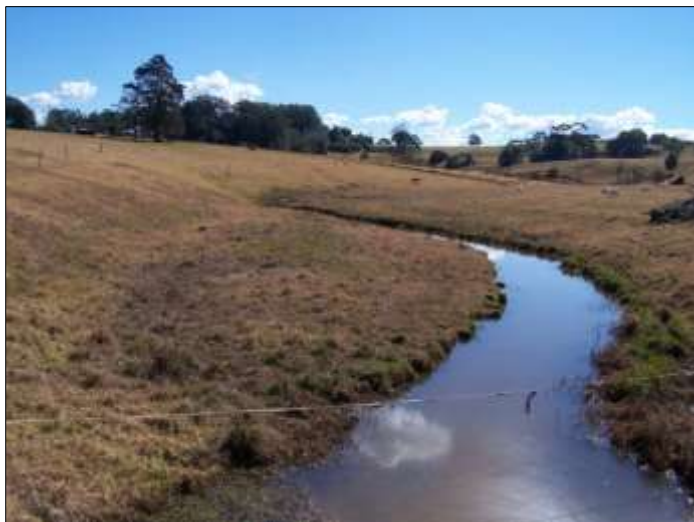
**Walkers Creek on Maleny Dairies. This is largely typical of the MU – little to no riparian vegetation.**

Riparian vegetation is virtually absent alongside the waterway length, and what is present is largely degraded by environmental weeds.

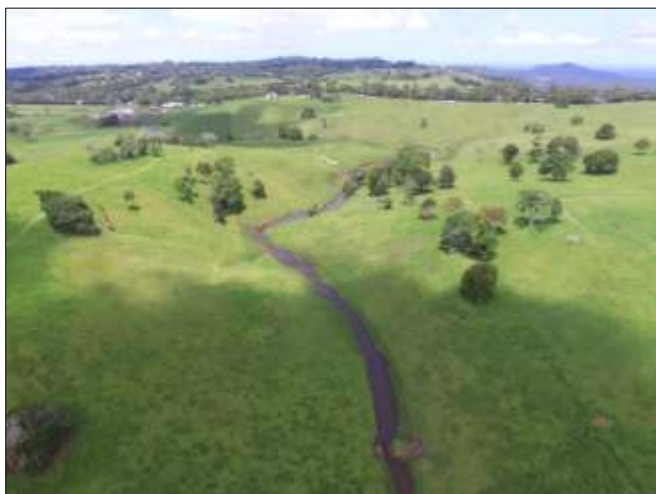
**Walkers Creek virtually devoid of any native vegetation. There is however a good coverage of pasture grass protecting the banks.**

There is no fencing on either Walkers Creek or other drainage lines on the property. Despite this all watercourses have a dense coverage of pasture grasses and the lack of steep banks results in stable bed and banks. It must be noted however that Gavin Muller operated an exceptional farm and with the change in management could result in a change in conditions.

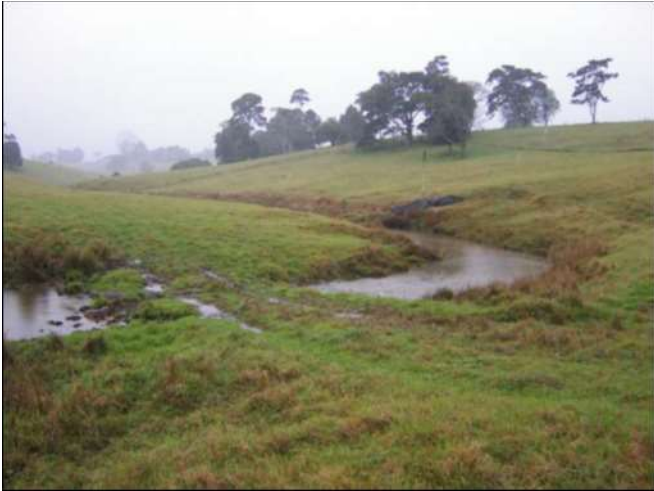
**Muller monitoring point. The property changed from dairying to beef during the sampling period however there was little change in water quality. Note the lack of riparian vegetation and fencing.**

The raw data shows significant levels of Nitrates, Ammonia and Total Phosphorus and a concerning level of Faecal Coliforms which is consistent with land use on the property and upstream (grazing and non-sewered residential). Best practice management involves excluding stock from riparian zones and improving land management practices.

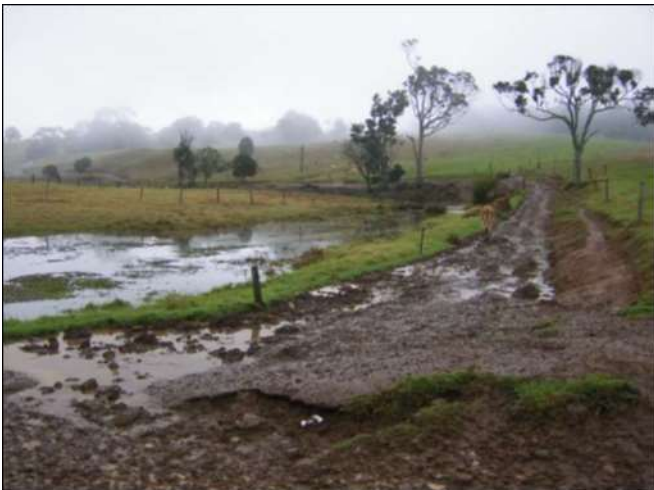
**Hoppers Crossing No. 2 monitoring point. The property remains a dairy but LBCCG has been active on the property implementing activities to reduce risk to water quality.**

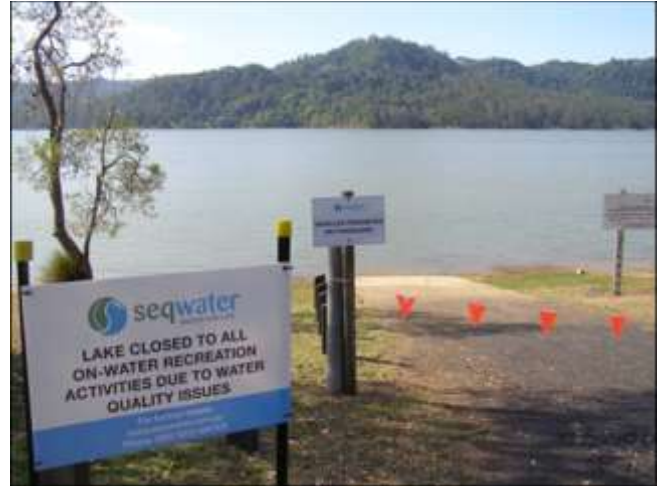
**Excessive erosion and nutrients delivered from the catchment contribute to cyanobacteria (algae) blooms in Lake Baroon.**
