Lake
Baroon
Catchment
Care
Group

Projects 2015-16

Walkers Creek Rehabilitation & Enhancement (Quick & Gray) Year 2

PROJECT PLAN

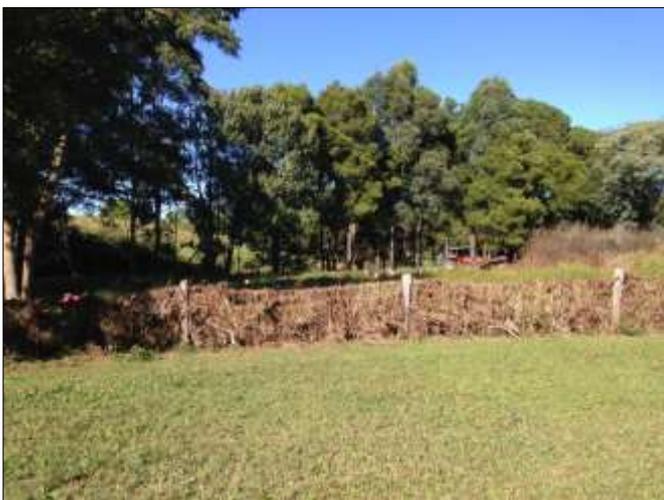
Fencing being installed. Note the fence (to be removed) in the foreground with debris from a flooding event experienced in April 2015.

Riparian fencing was completed as planned and within budget.

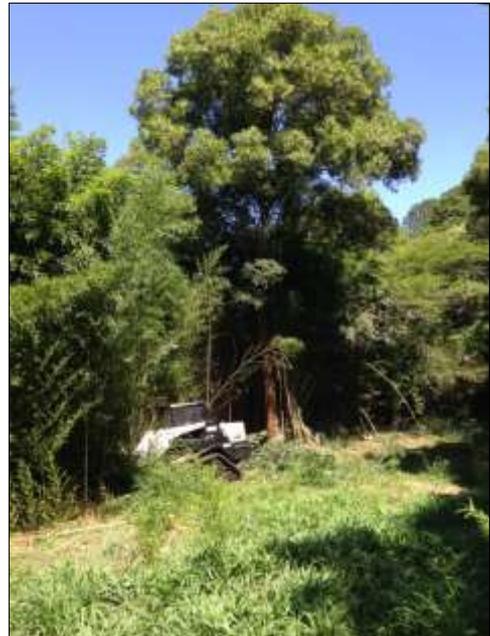
Posi-track mulcher slashing bamboo at ground level and mulching.

Several methods of weed management have been utilised. A posi-track mulcher was used to slash the running bamboo and mulch into a coarse ground covering layer. When the bamboo re-shot it was sprayed. It was initially expected the bamboo would require up to two years of respraying to control, however it appears to have taken far less.

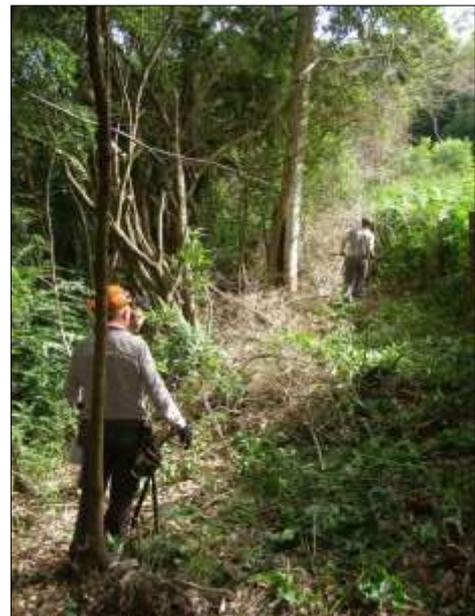
Totem Fauna & Flora clearing privet and lantana (and other environmental weeds) from the Walkers Creek riparian zone.

Privet and lantana was removed in the planting areas however it has been retained on the water's edge to provide protection for the freshly planted tubestock,

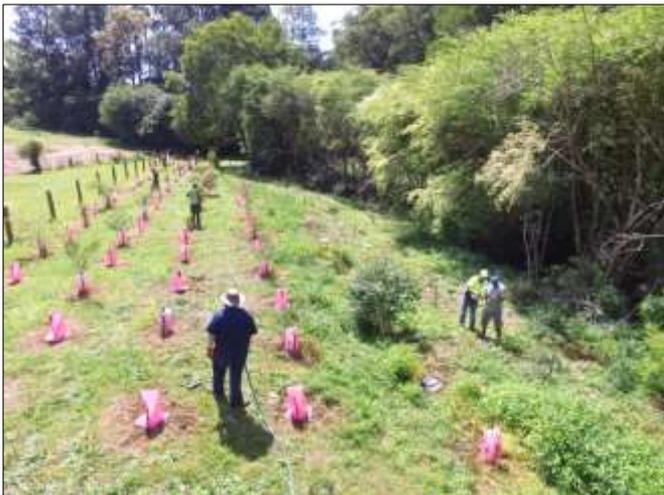
East Coast TAFE in-fill planting.

Several methods of revegetation have been used. Stems planted higher up the bank have utilised corflute guards and Recover weed mat. These are unlikely to be washed away in a flood event.

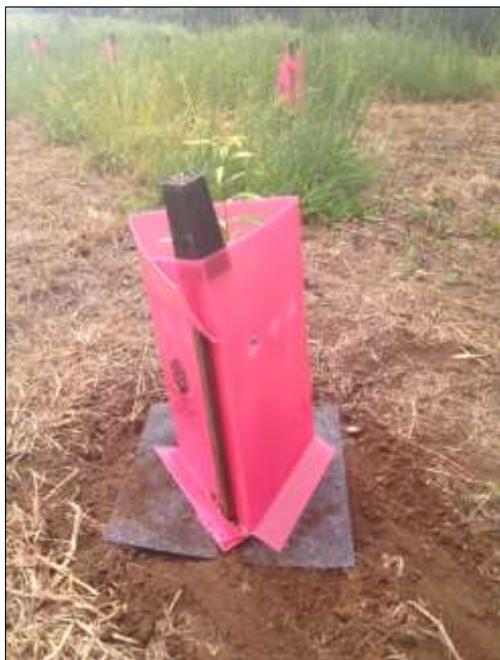
Plants unlikely to be severely affected by flooding were protected by corflute guards.

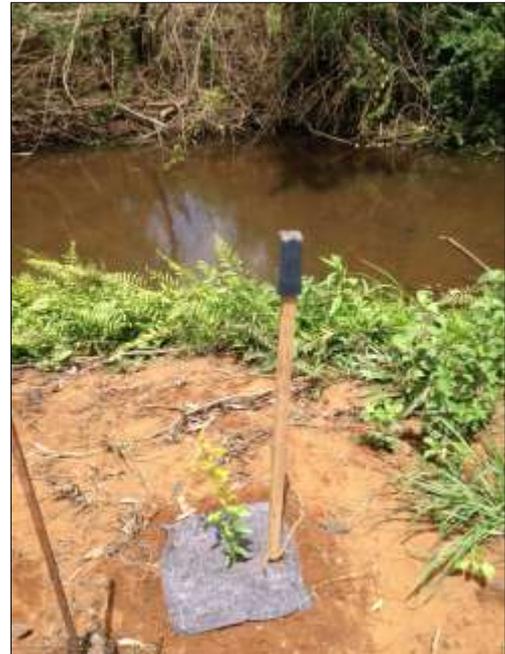
Plants on the lower bank do not have guards but rather have a 'flood' stake installed to catch debris during flood events.

Stems planted on the lower bank have not been guarded but have had a Recover weed mat pinned down with a 25 mm x 25 mm flood stake installed immediately on the upstream side. The stake will collect any debris during a flood event protecting the freshly planted stem.

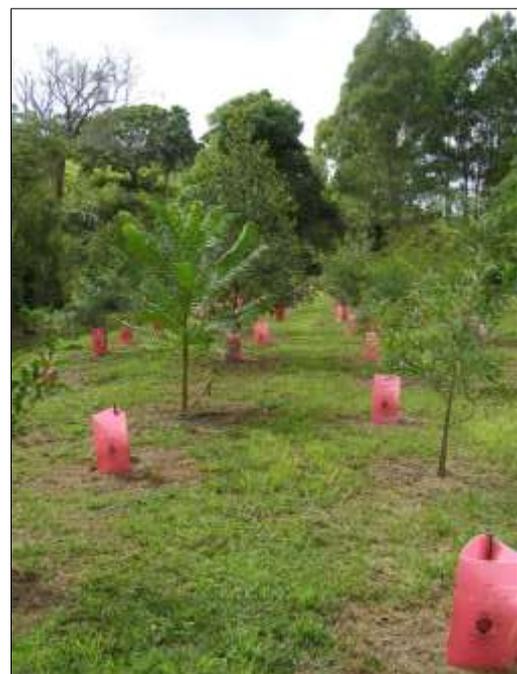
Revegetation twelve months from planting. Pioneer species planted to shelter the slower growing long-lived species have performed very well.

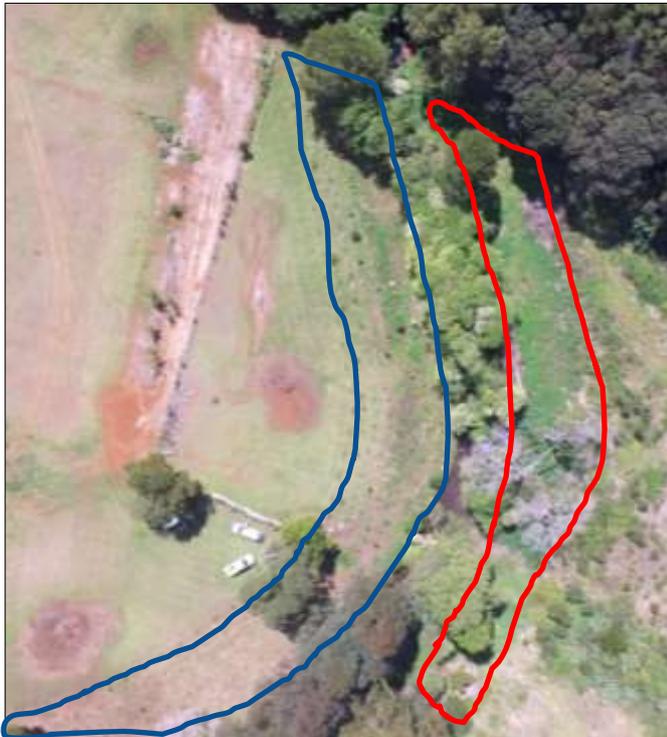
Quick property with areas marked for revegetation in 2015/16. Red area is eastern bank. Blue area is completion of in-fill on the western bank.

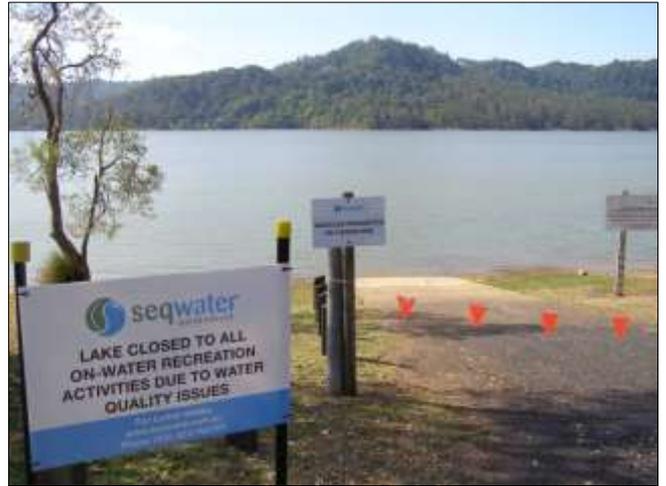
Baroon Pocket Dam in September 2013 (storage remained closed for almost 12 months). Cyanobacteria blooms disrupt recreational use of the storage and create difficulties in the production of potable water.

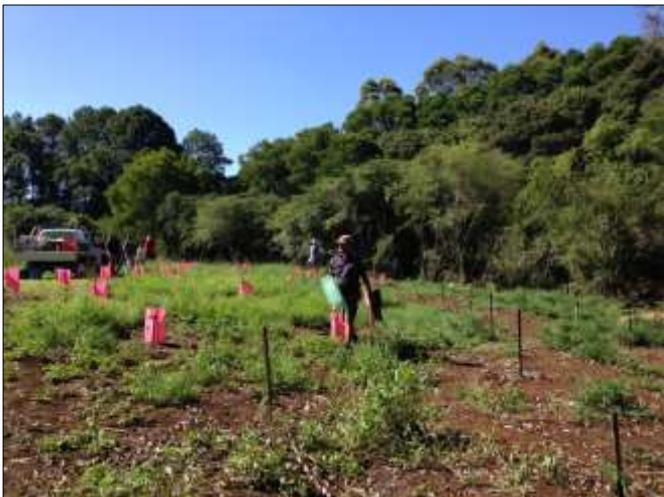
Stage 1 of revegetation was completed in 2014/15 (double spacing of predominantly 'pioneer' and frost tolerant species in preparation for Stage 2 where longer lived species are planted under the protective canopy).

Stage 1 of the planting program consisted of the double spacing of 450 stems on the eastern side of Walkers Creek. These fast growing pioneer species including a high proportion of frost tolerant species are intended to provide a protective canopy from the risk of frost. Stage 2 will involve planting longer lived more desirable species (that generally have little frost tolerance) in between to eventually provide a sustainable and effective riparian buffer.

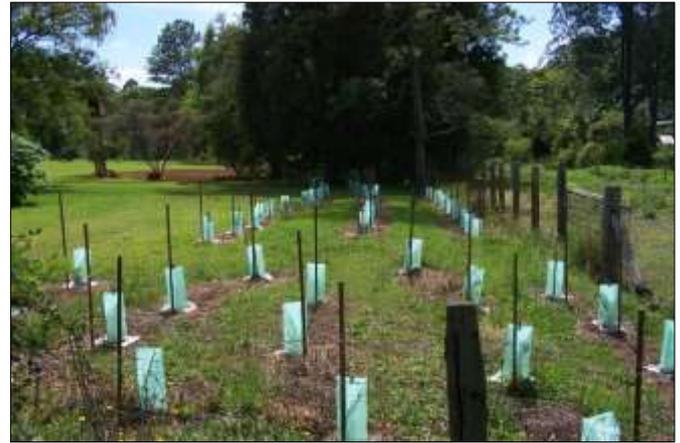
Revegetation on the Gray property was completed in 2014/15 with minor infill planting throughout 2015/16 by the landholder. No further revegetation is necessary or planned.

Completed revegetation on Gray property.

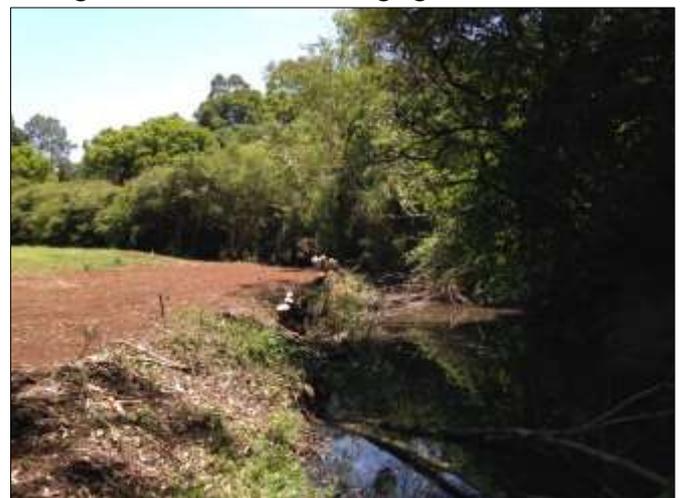
The removal of privet has been a gradual process particularly those trees that form part of the bank of Walkers Creek. These tweed trees are essential for the maintenance of bank stability, providing habitat for aquatic species (the root systems have created overhanging, diverse bank structure), and also keep the water shaded (maintaining water quality).

Riparian zone on Quick property.

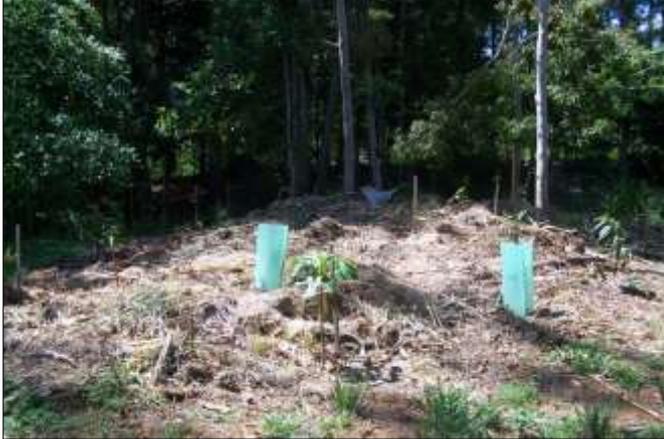
Mulched clumping bamboo on Gray property with revegetation.

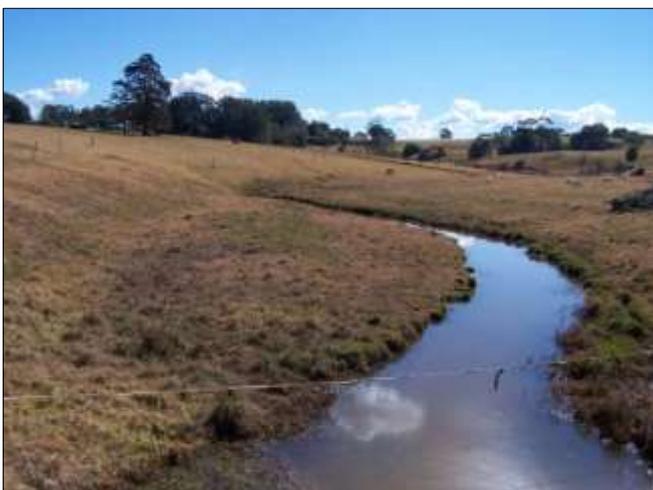
Walkers Creek on Maleny Dairies. This is largely typical of the MU – little to no riparian vegetation.

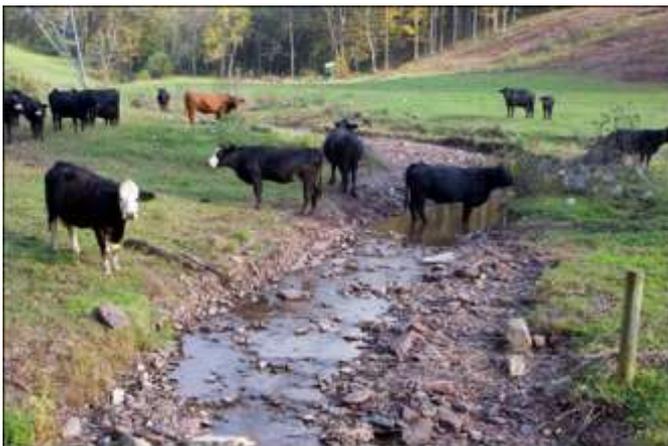
Livestock in waterways are high risk to water quality.

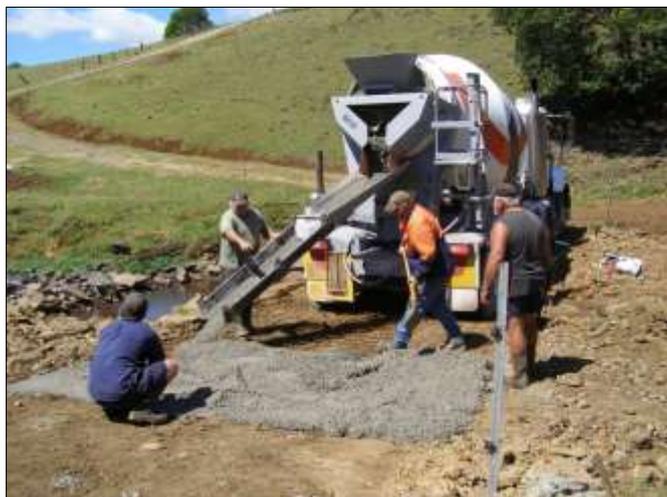
Low level concrete crossing construction

Installation of a stream crossing will reduce risks to water quality, reducing nutrient, sediment, pathogen, and organic matter loads to streams. A formal crossing will also reduce streambank and streambed erosion. Stream crossings can provide cattle with improved access to pastures thereby improving grazing distribution while reducing the likelihood that cattle will be injured. Stream crossings also improve vehicle access for weed management, pasture improvement, erosion management and other activities that influence the quality of water flowing off properties. Stable stream crossings can help prevent farm equipment damage by providing a smooth entrance and exit.

A good crossing is one that serves the purpose for a long time and requires minimal maintenance. The design must allow for a range of flow conditions and sustain as little damage as possible when flooding occurs. It is also essential to ensure that the crossing will have negligible environmental impacts.
