Lake
Baroon
Catchment
Care
Group

Projects 2016-17

Walkers Creek Rehabilitation & Enhancement (Quick & Gray) Year 3

PROJECT PLAN

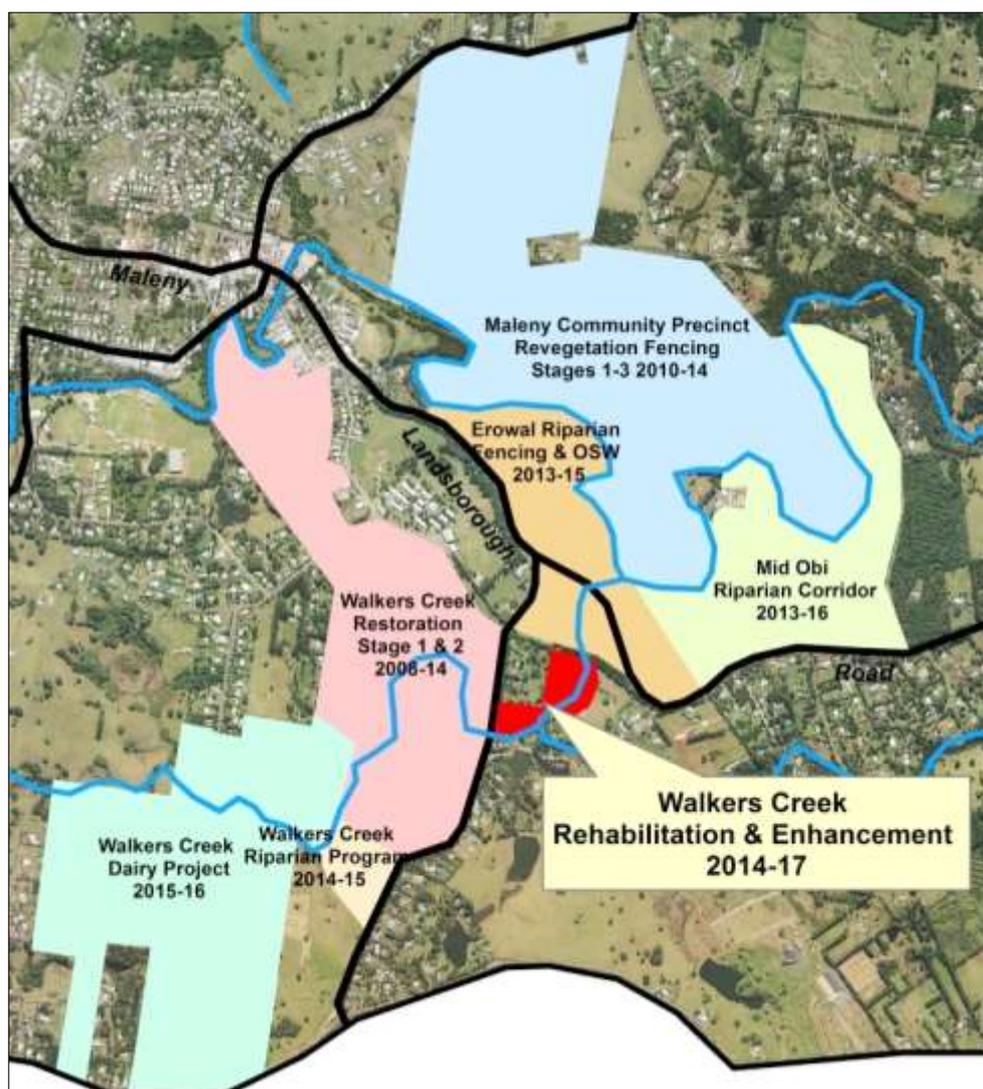
LBCCG projects since 2008 in the immediate area of the proposed project. Note the figure indicates the property individual projects occurred – not the actual on-ground activity. Does not include multiple Weed Programs. Current project is identified by red.

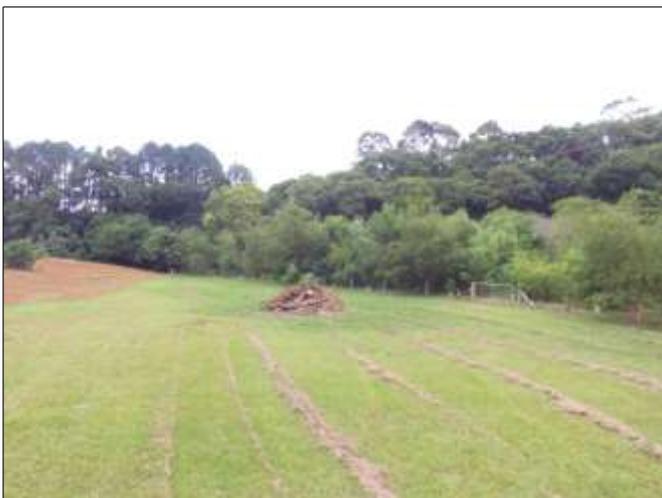
Fencing was installed in 2015 and is functioning as intended.

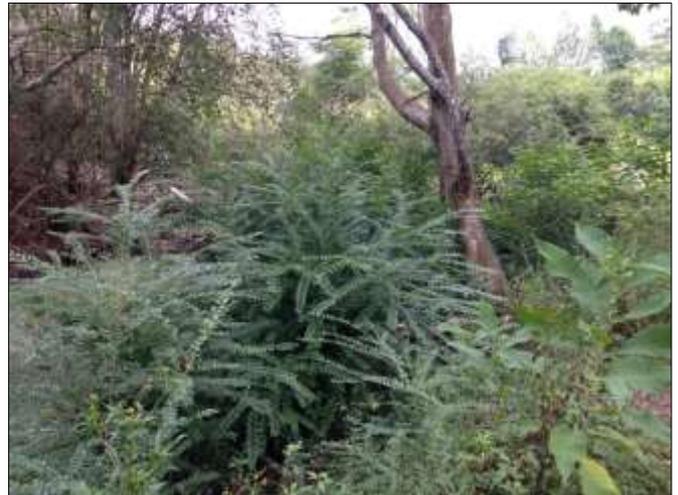
Privet has been managed in stages to retain as much groundcover as possible. Most of the remaining privet (and other woody environmental weeds) will be removed by TAFE in mid 2017.

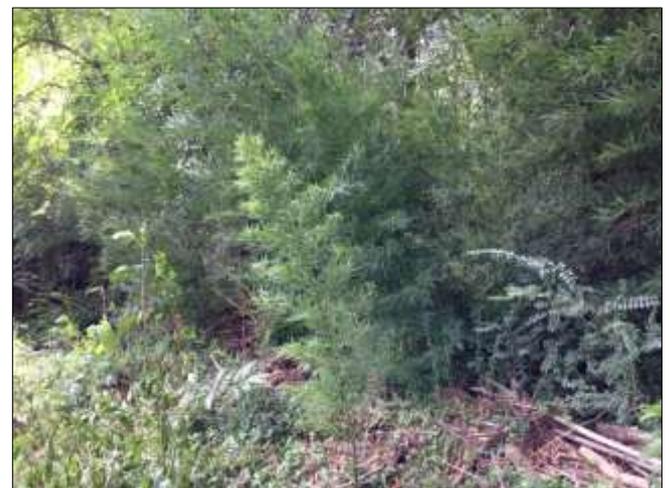
Running bamboo on the adjoining downstream property will be treated by TAFE in mid-2017. This will ensure the bamboo does not reinfest the Quick property.

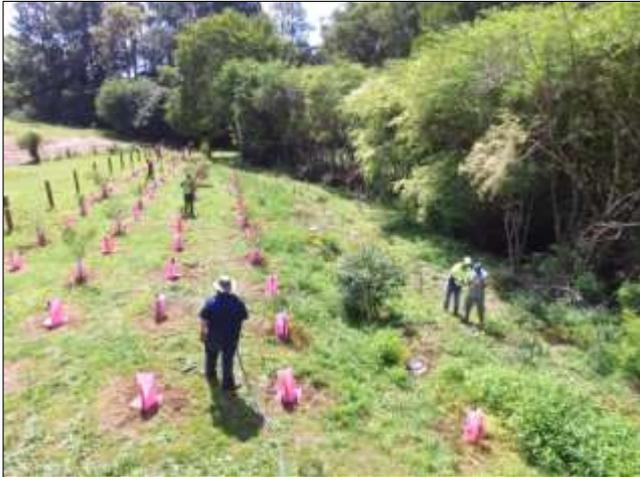
East Coast TAFE in-fill planting.

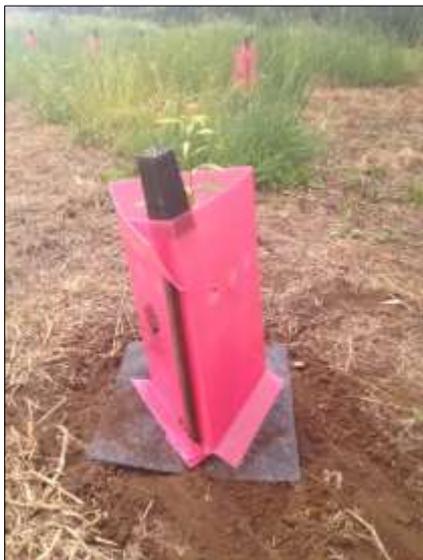
Several methods of revegetation have been used. Stems planted higher up the bank have utilised corflute guards and Recover weed mat. These are unlikely to be washed away in a flood event.

Plants unlikely to be severely affected by flooding were protected by corflute guards.

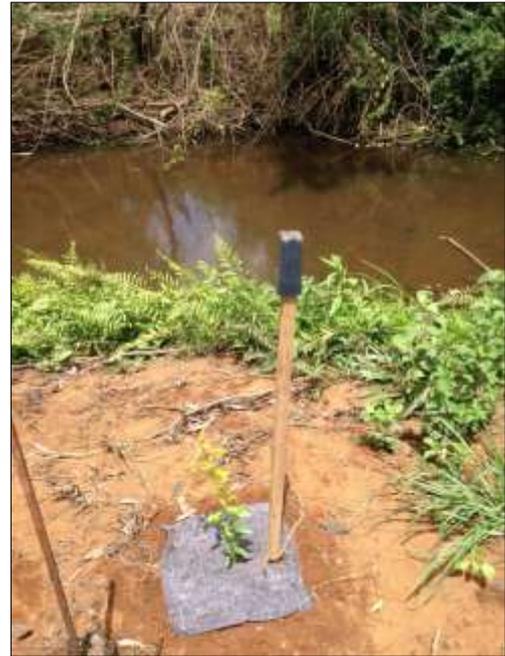
Stems planted on the lower bank have not been guarded but have had a Recover weed mat pinned down with a 25 mm x 25 mm flood stake installed immediately on the upstream side. The stake will collect any debris during a flood event protecting the freshly planted stem.

Plants on the lower bank do not have guards but rather have a 'flood' stake installed to catch debris during flood events. This has resulted in very few losses from flooding.

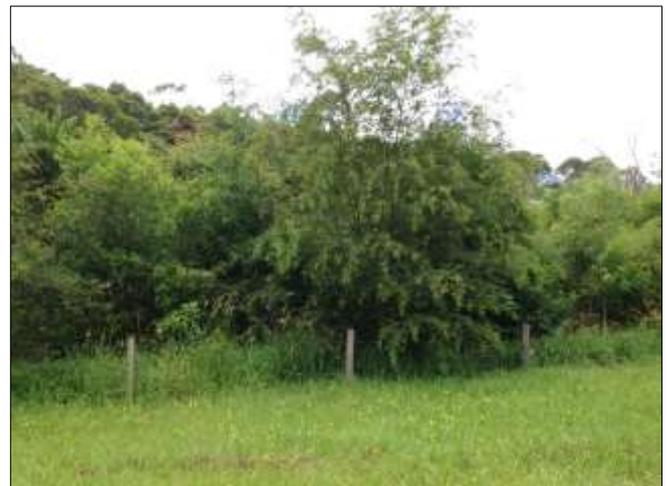
Revegetation two years after planting. Pioneer species planted to shelter the slower growing long-lived species have performed very well. Some of the wattle species are being managed to ensure damage to fences and other more desirable trees is minimised.

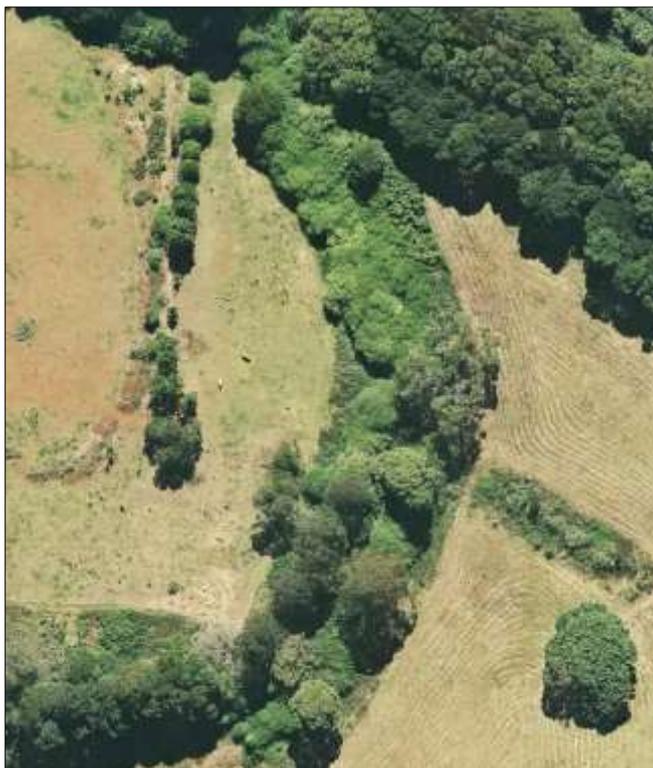
Quick site in 2013 – pre project. The riparian zone is dominated by weeds and livestock have access to the creek.

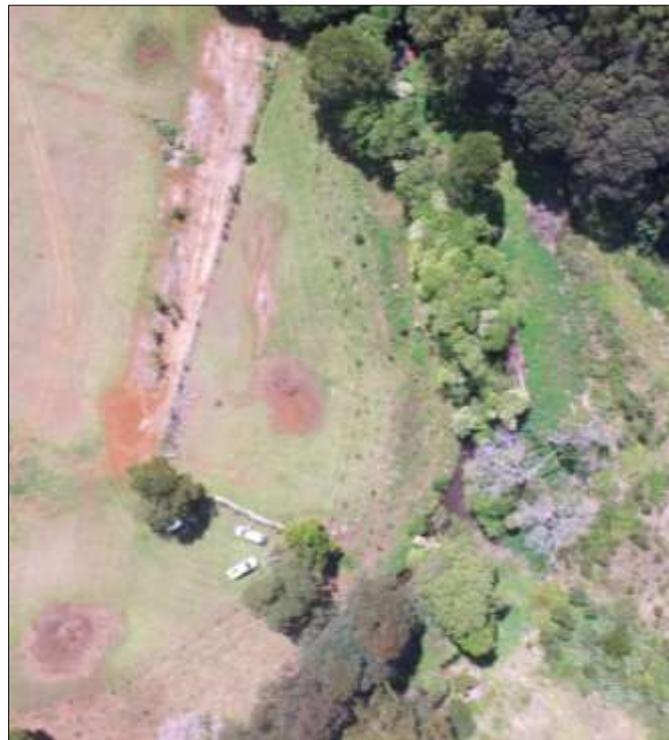
Quick property following first stage of weed management, fencing and revegetation (2014).

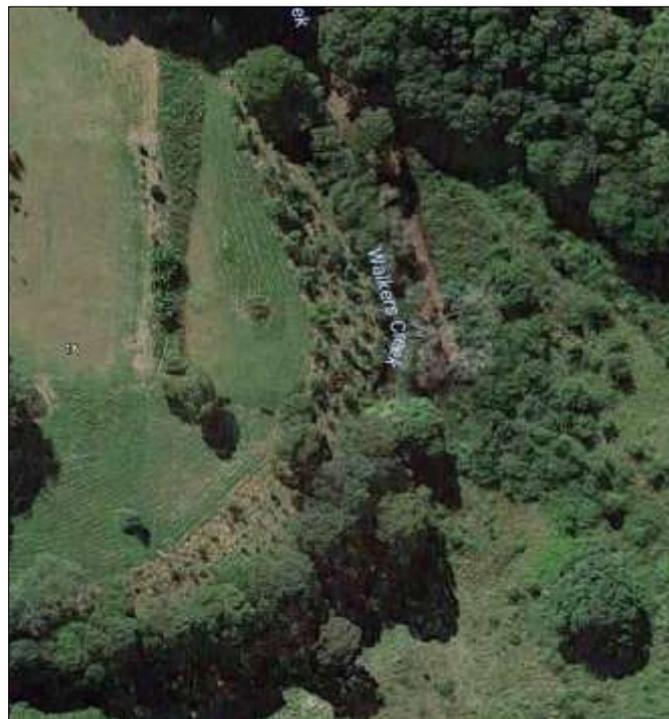
Revegetation establishing (2016).

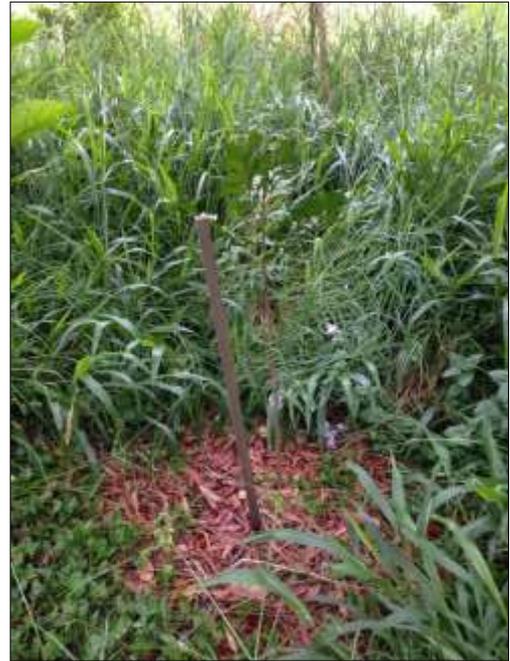
Revegetation maintenance is primarily concerned with providing the conditions for the planted trees to establish. Heavy grass cover is ideal as it provides soil surface protection and stability during floods, provides a buffer to overland flows and provides habitat for a variety of native wildlife. The area around the planted tree is kept clear to minimise competition.

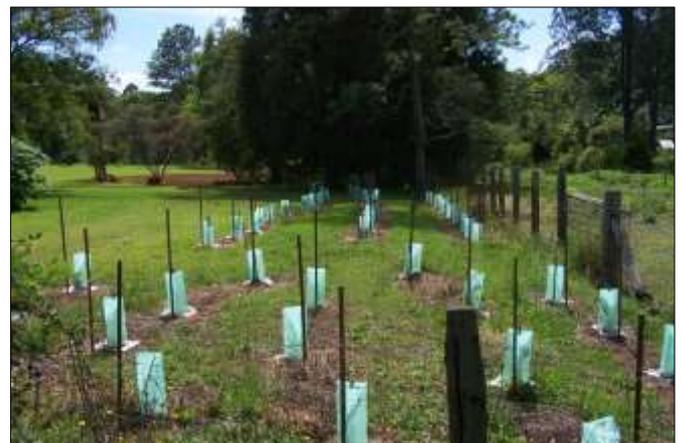
Completed revegetation on Gray property.

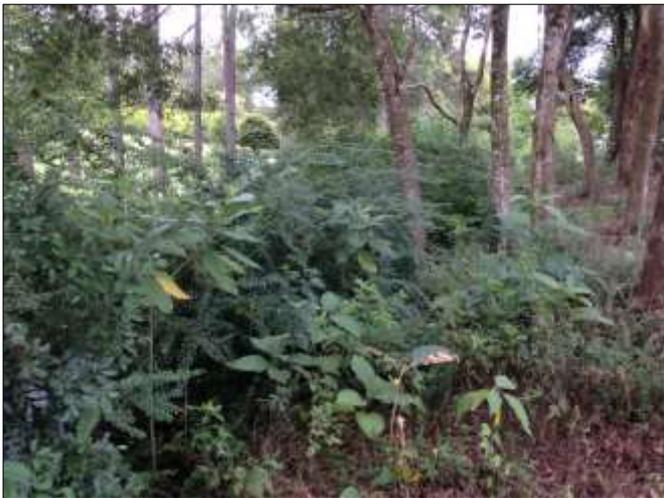
Riparian zone on Quick property. Woody weeds have been retained until 2017 to shelter regenerating native species. Careful hand removal is planned for May 2017.

The majority of remaining privet will be removed in May 2017 by TAFE. Small weeds will be cut and painted with larger weed trees stem injected and allowed to decompose in situ (privet will decompose rapidly and are unlikely to fall into the waterway in large chunks).

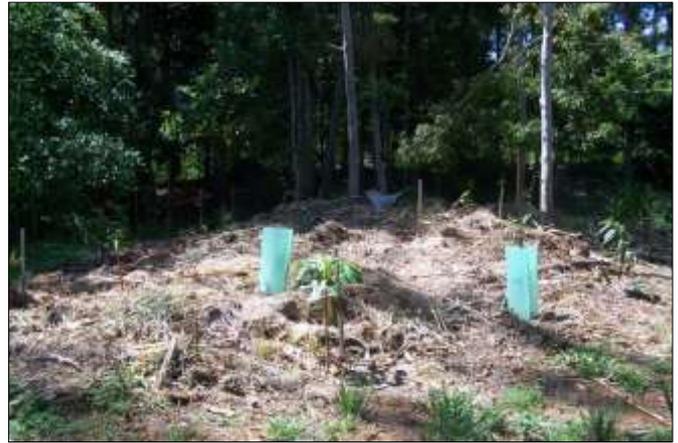
Mulched clumping bamboo on Gray property with revegetation.

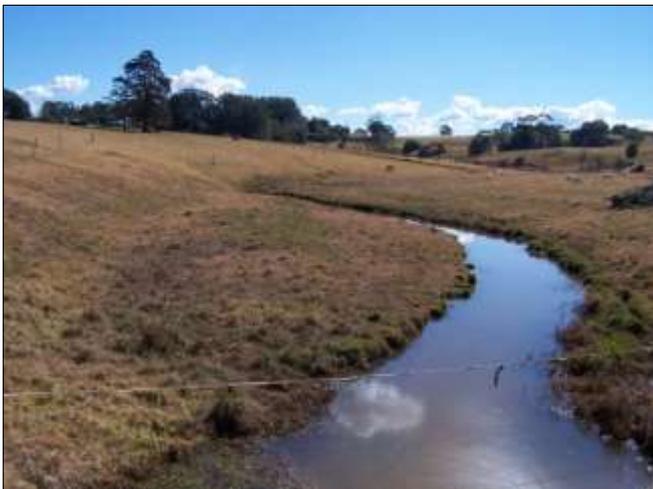
Walkers Creek on Maleny Dairies. This is largely typical of the MU – little to no riparian vegetation.

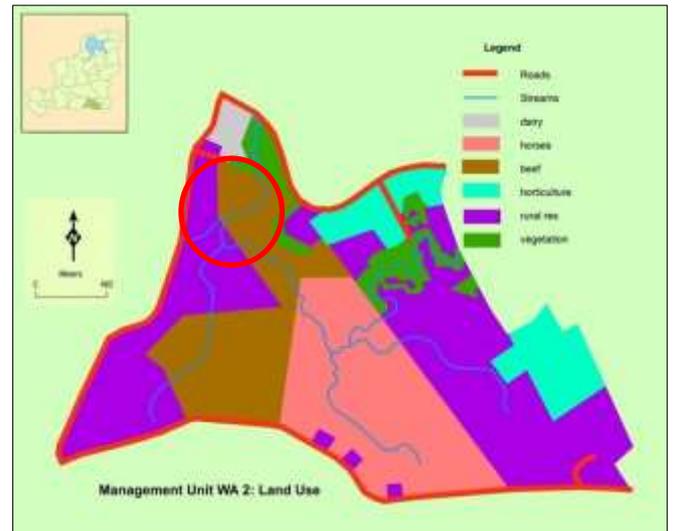
Land use in Management Unit WA2 with the Quick and Gray properties circled.

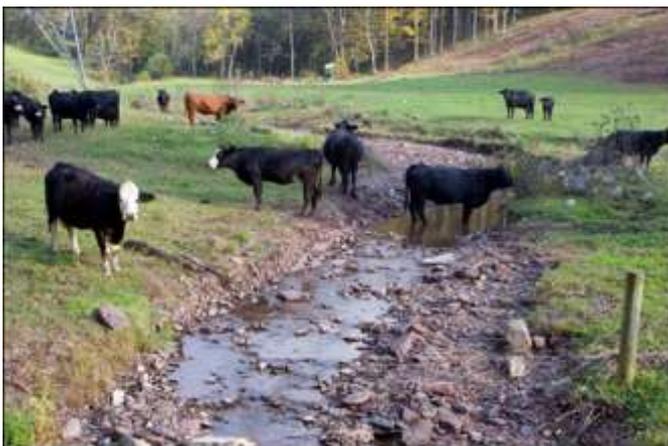
Livestock in waterways are high risk to water quality.
