Lake
Baroon
Catchment
Care
Group

Falls Creek Revegetation Stage 2

PROJECT PLAN

Project No. 2122-003

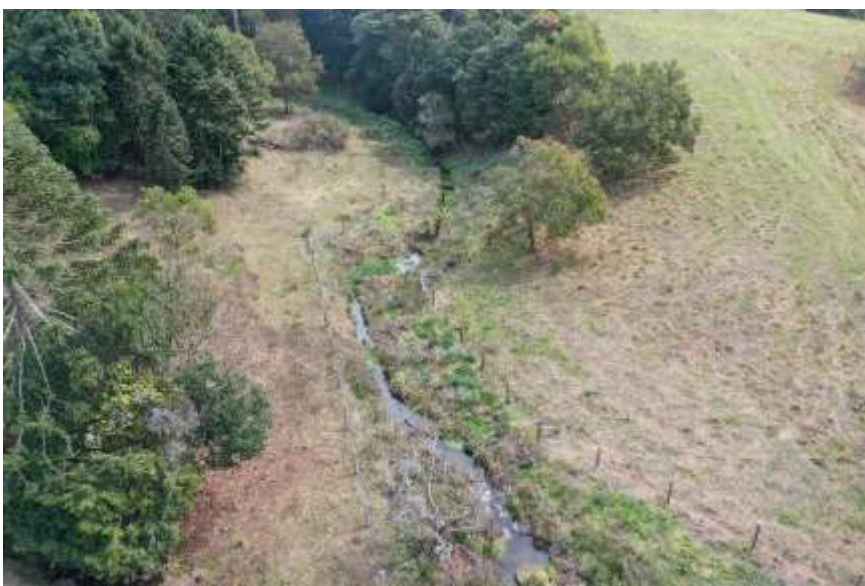
Left: A section of the proposed planting site along Falls Creek. The tree planting inside the riparian fencing will improve the health of the riparian buffer and will link in with existing remnant and regrowth vegetation present along the creek.

Revegetation will occur inside the riparian fencing along Falls Creek on Greg Willims property, resulting in the revegetation of approximately 400 m of the creek. This planting will provide a buffer to Falls Creek with 700 trees being planted, and will not only have a positive impact by improving water quality, but will also provide a significant wildlife habitat corridor, linking with remnant and regrowth forests.

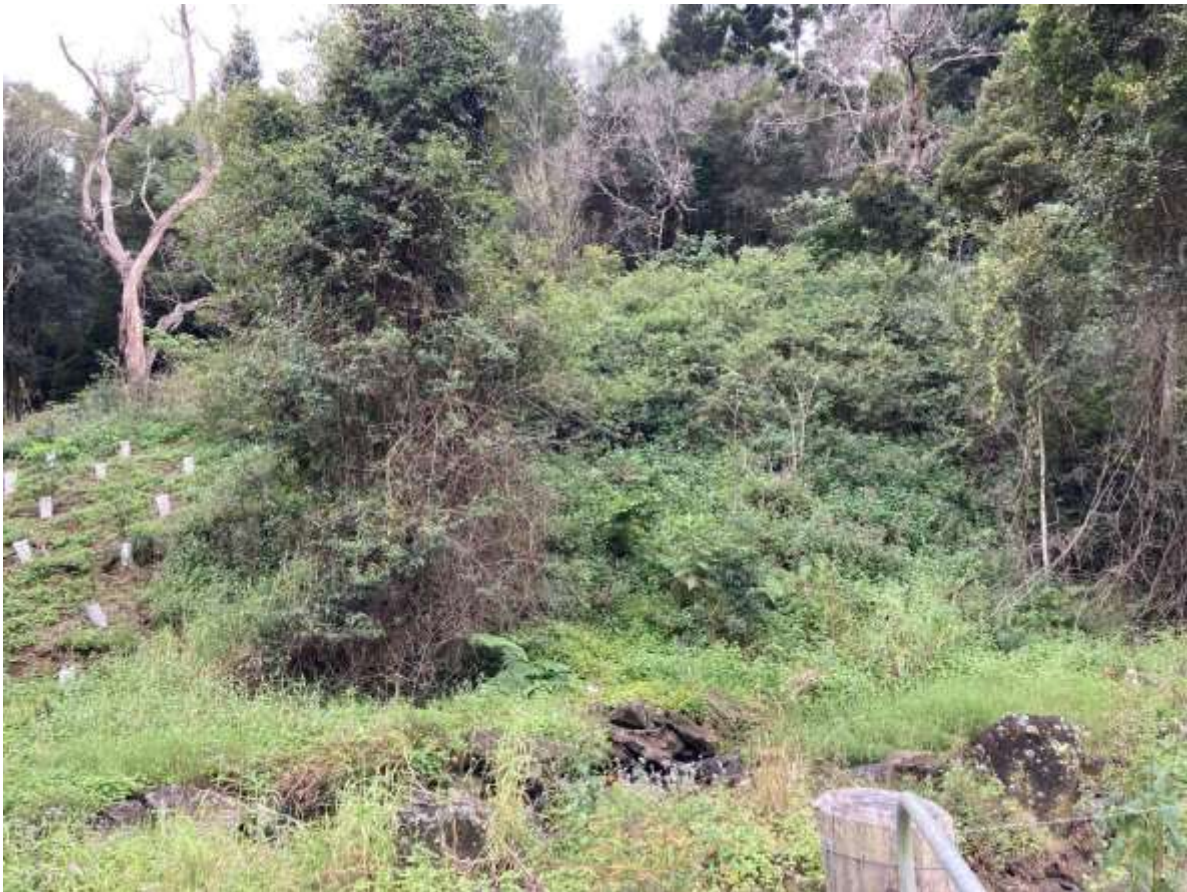
Riparian vegetation along Falls Creek is impacted by woody weeds (primarily lantana, privet, camphour laurel, yellowberry and blackberry). Mulching of the lantana, yellowberry and blackberry, will be undertaken by the landholder. This will then be followed up with spraying once the weeds reshoot, this is the most cost-effective way to control the weeds on the site.

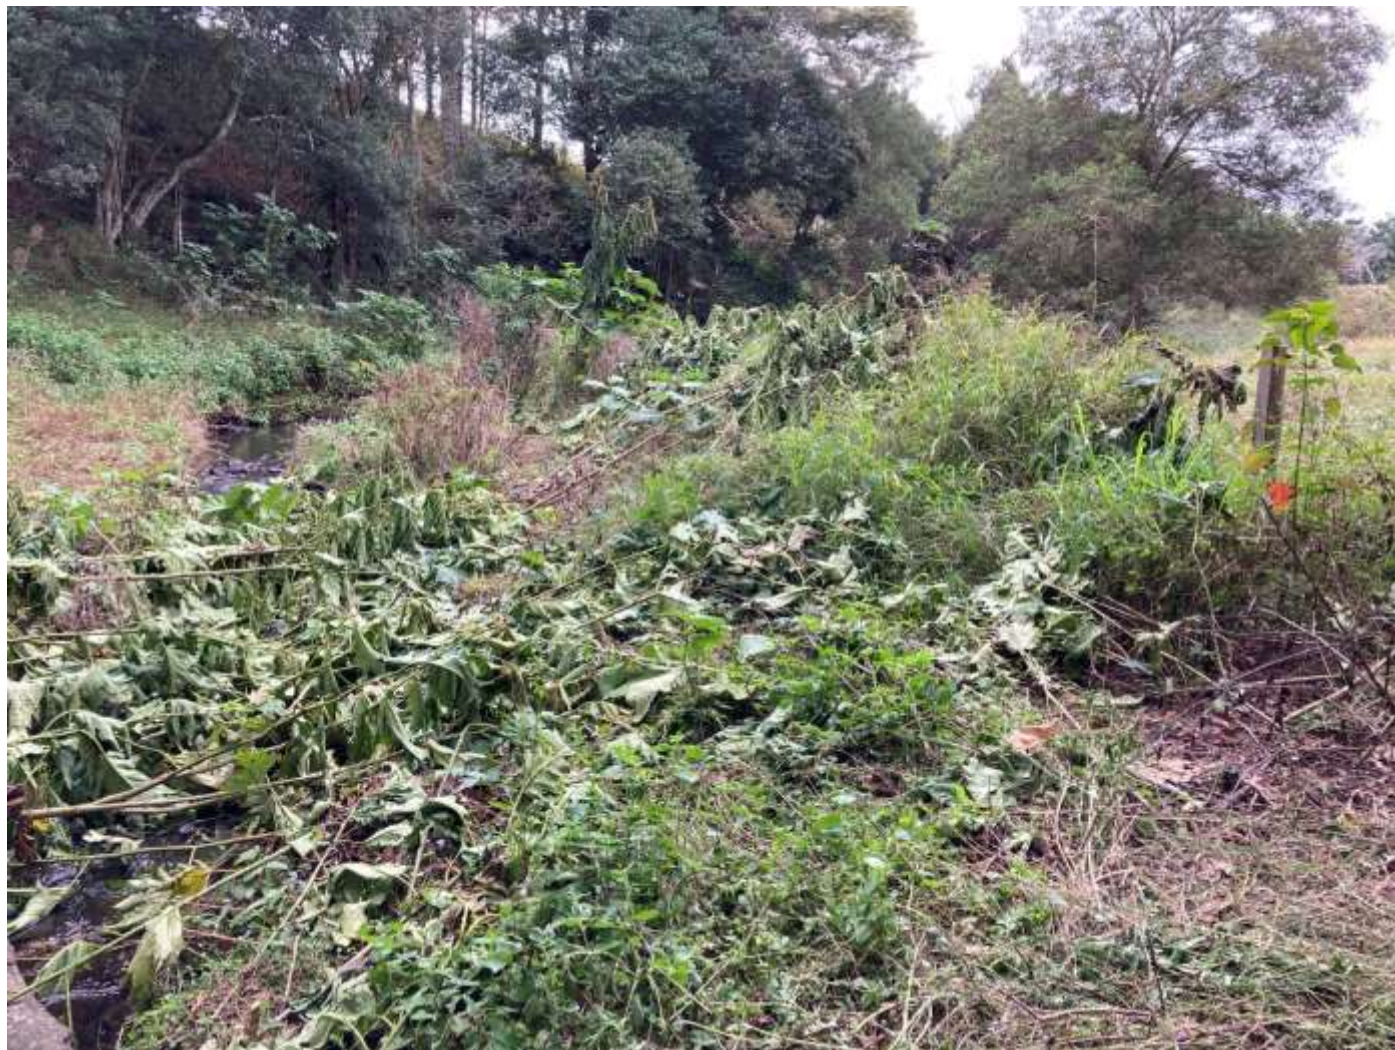
Greg Willims has continued controlling the weeds inside the fenced riparian zone, assisting the preparations for planting along Falls Creek. The devils fig has been cut and pasted, opening up the planting area.

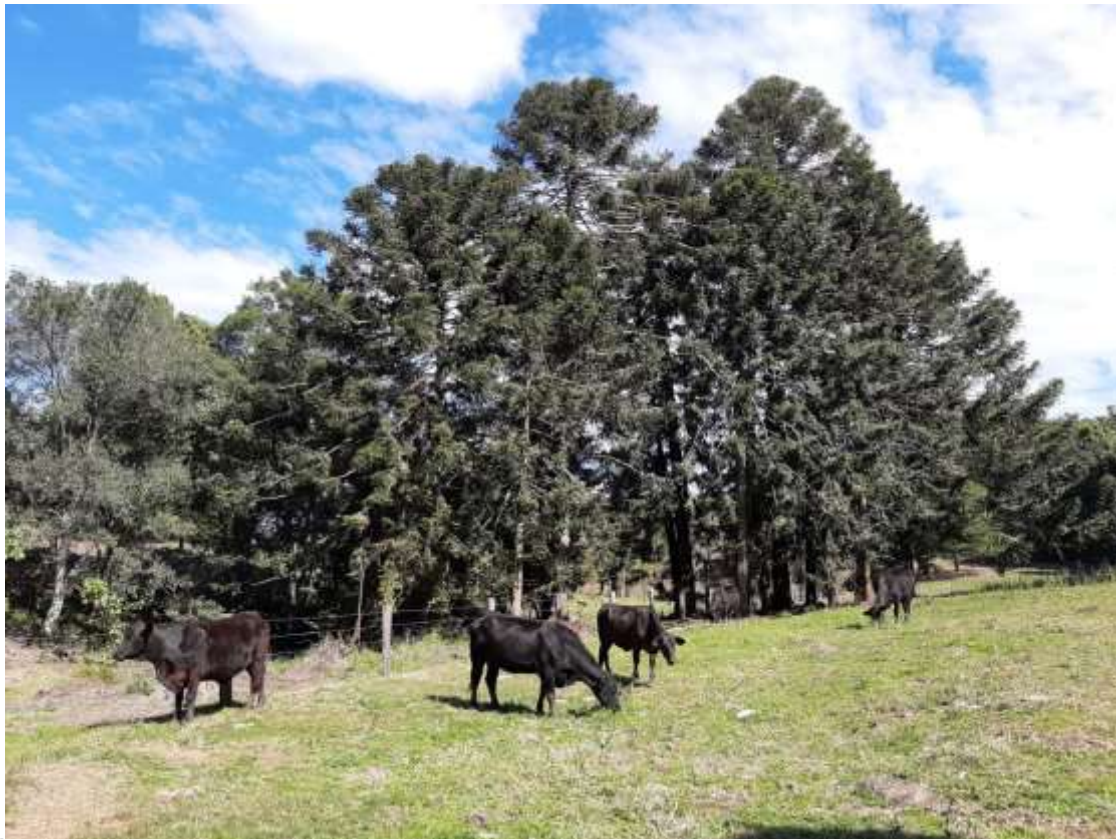
Above: Riparian fencing along Falls Creek was completed in Stage 1 2017/18. The fencing has allowed the landholders to exclude livestock from the riparian zone, strengthening the riparian buffer.

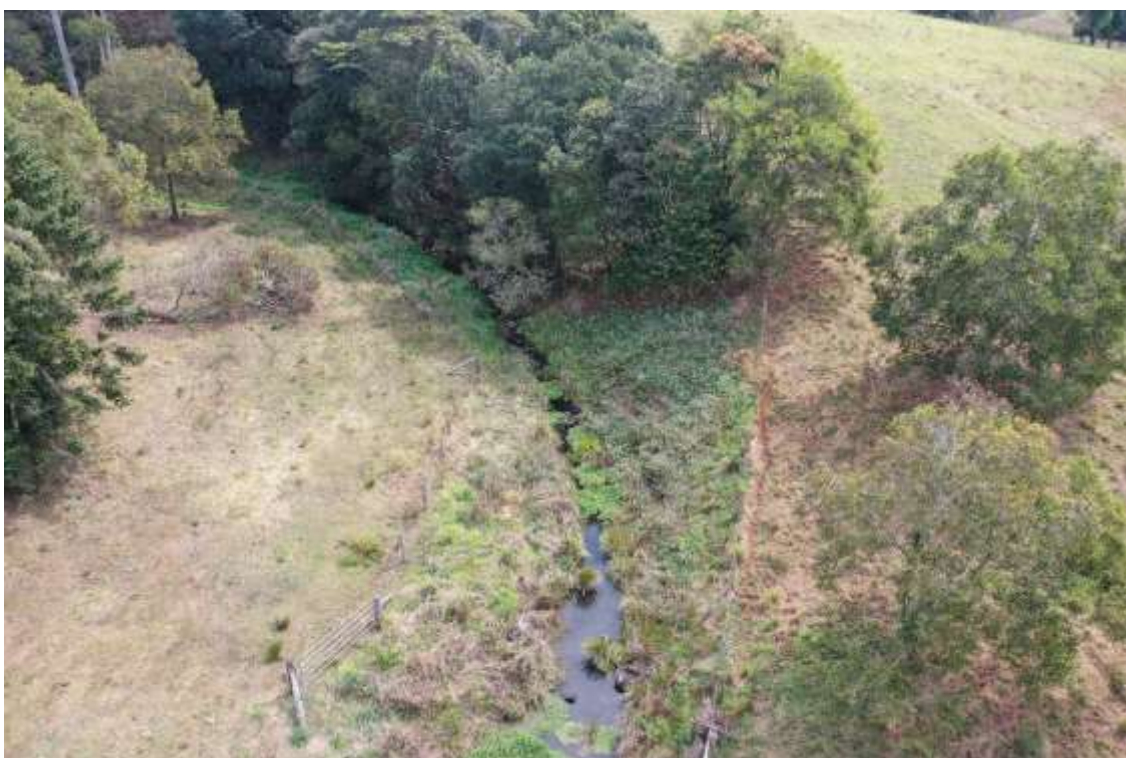
Below: Falls Creek riparian zone fenced with high quality materials will provide protection of the riparian zone for 30 plus years.

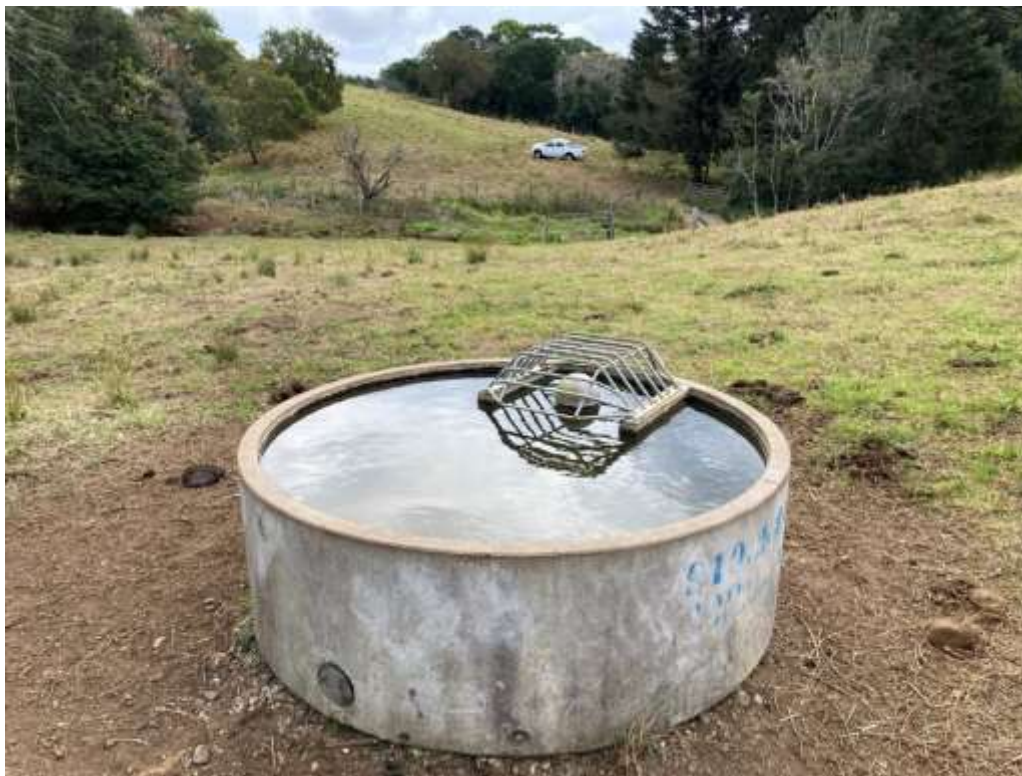
Above: Two troughs and 600 m of poly pipe were installed and connected to the existing off stream watering system. With the installation of riparian fencing excluding livestock from the waterways, the off stream watering system removes the reliance of accessing water from the creeks.

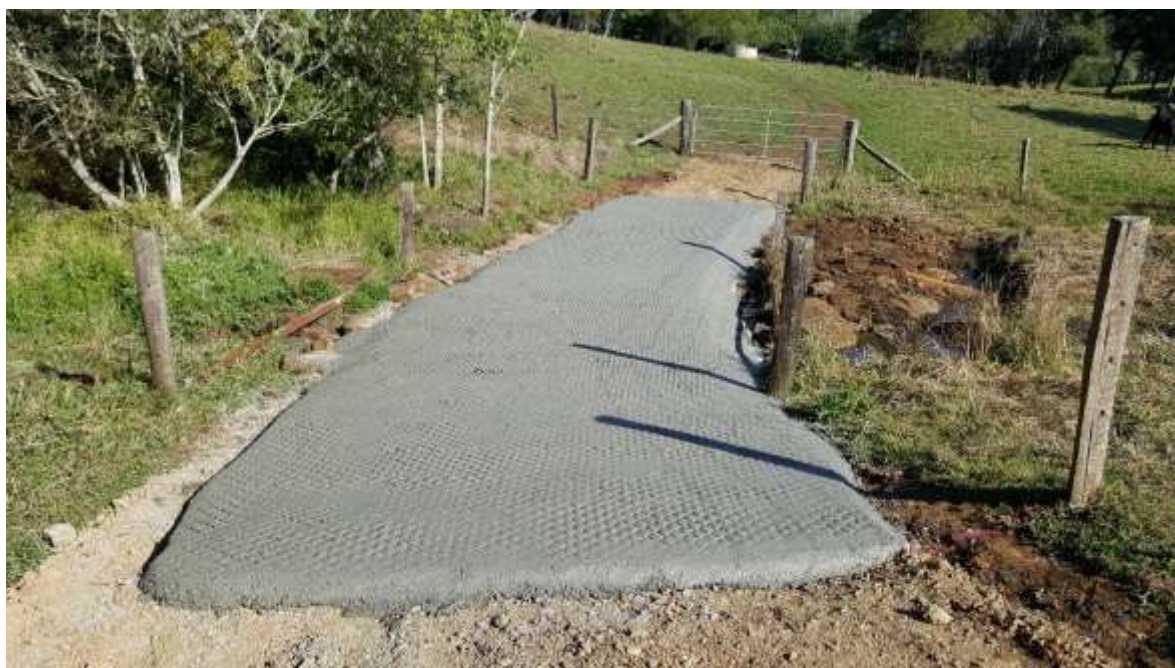
Above: The concrete crossing installed as part of Stage 1, 2017/18. Formalised crossings protect livestock and watercourses from the issues associated with unrestricted access, they improve water quality by limiting sedimentation and nutrient enrichment.

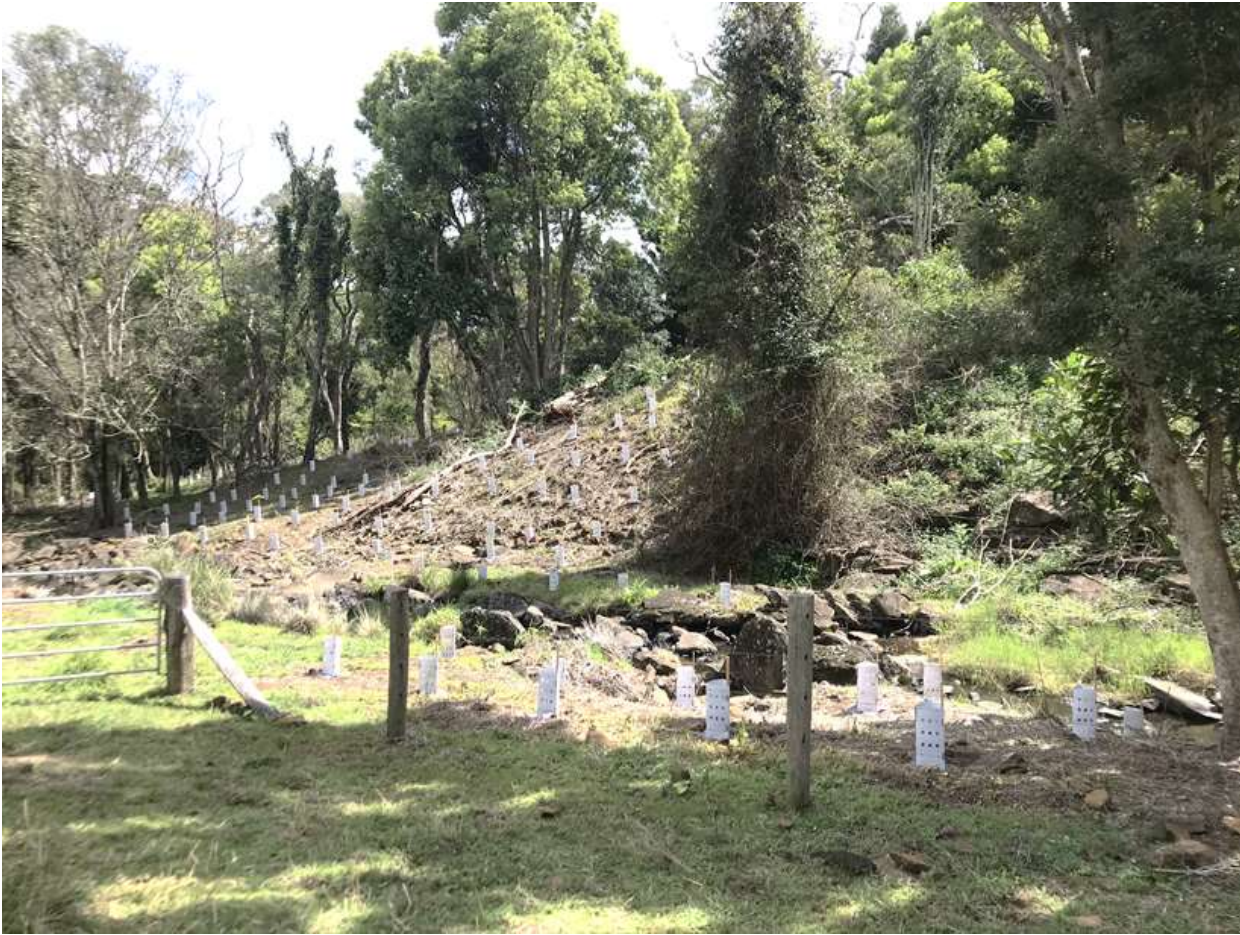
Above: The revegetation of Upper Falls Creek, was successfully completed in October 2020. 400 trees were planted in the fenced riparian zone.

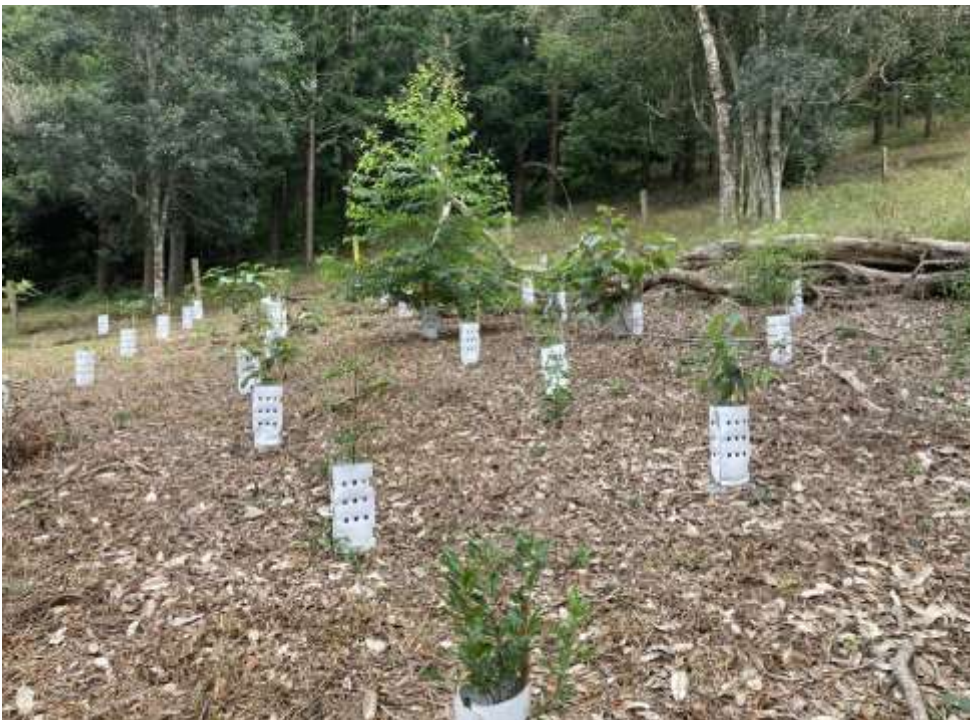
Below: After less than a year the trees are very well established, with some species well over 2 m tall. The soil along the creek is very fertile, and will provide perfect conditions for tree establishment and growth, ultimately leading to a healthy vegetated riparian buffer which will improve the water quality of Falls Creek quality by limiting sedimentation and nutrient enrichment.
