Lake  
Baroon  
Catchment  
Care  
Group

## Falls Creek Riparian Fencing & Off Stream Watering, Stage 2

Project No. 2122-012

## 2122-012 Falls Creek Riparian Fencing & Off Stream Watering, Stage 2

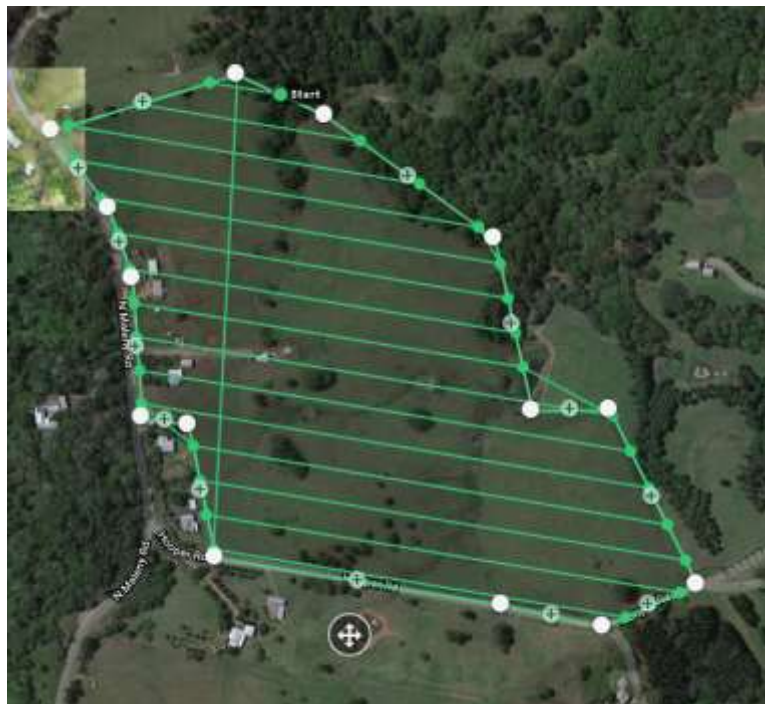
*Figure 1. An example of the mapping of the Ferriday's property using the drone which will be used for monitoring the project.*

Data will be collected at the beginning of the project to establish a baseline that will allow for future monitoring of the project. Photo point monitoring and mapping will be carried out at the beginning and completion of the project. Photo point and mapping will then be undertaken annually for 3 years. Footage will provide valuable evidence of works completion, a record of changes over time, and provide an important assessment tool to evaluate the project.

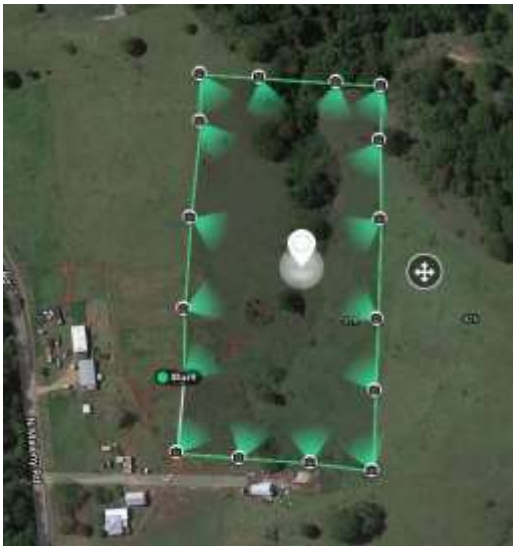
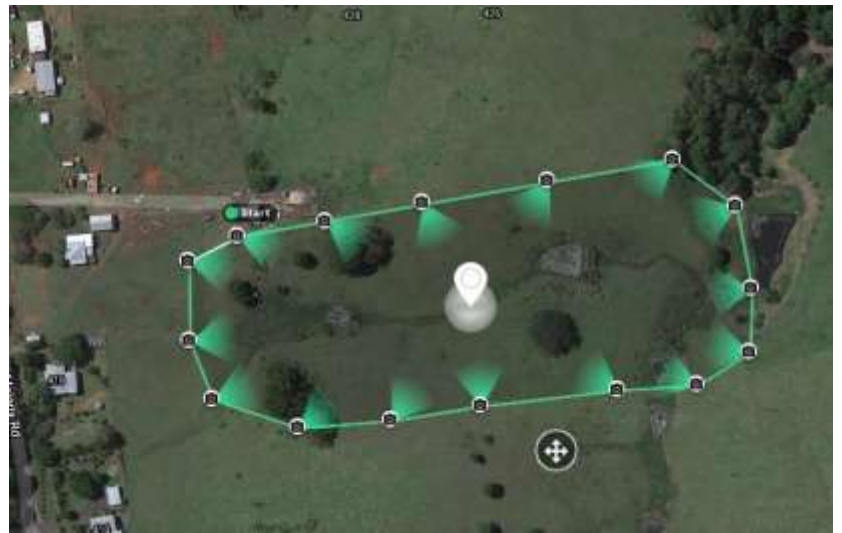
Figure 2,3 & 4. Show the three different photo monitoring areas, displaying the individual points established for each of the tributaries on Ferriday's property.

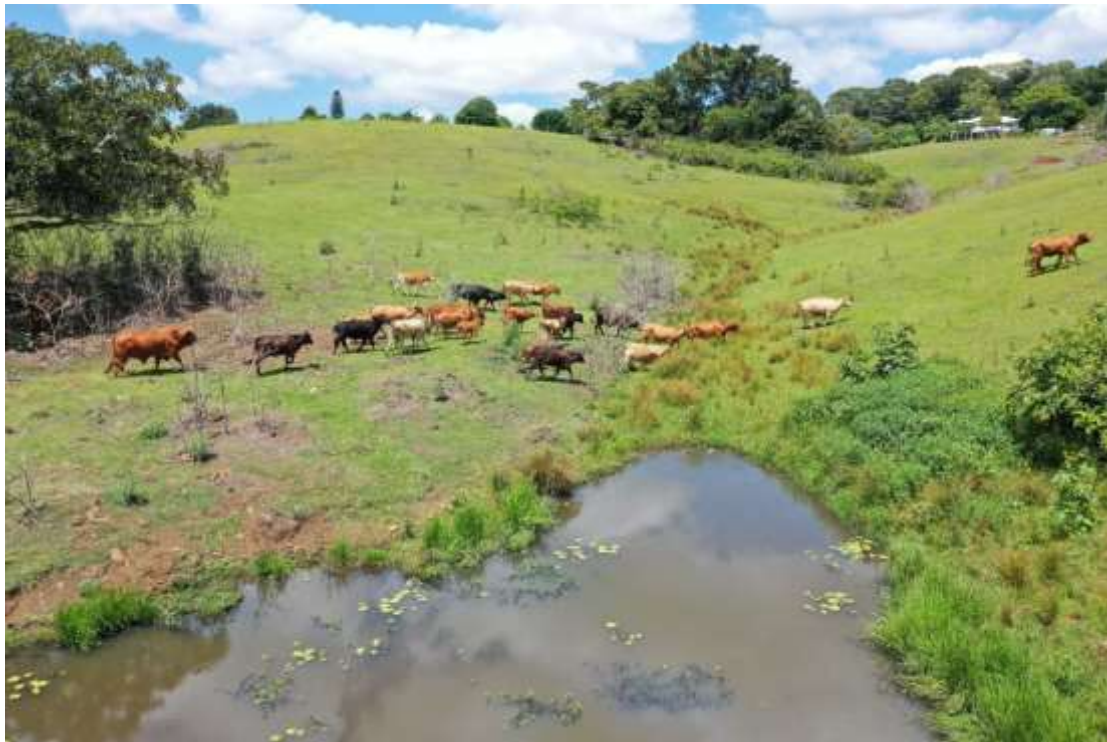
*Above: Cattle on the Ferriday farm are free to graze and move through the riparian areas as they please. Riparian fencing combined with off stream watering will improve the management of cattle in the riparian zone, decreasing the risk to water quality.*

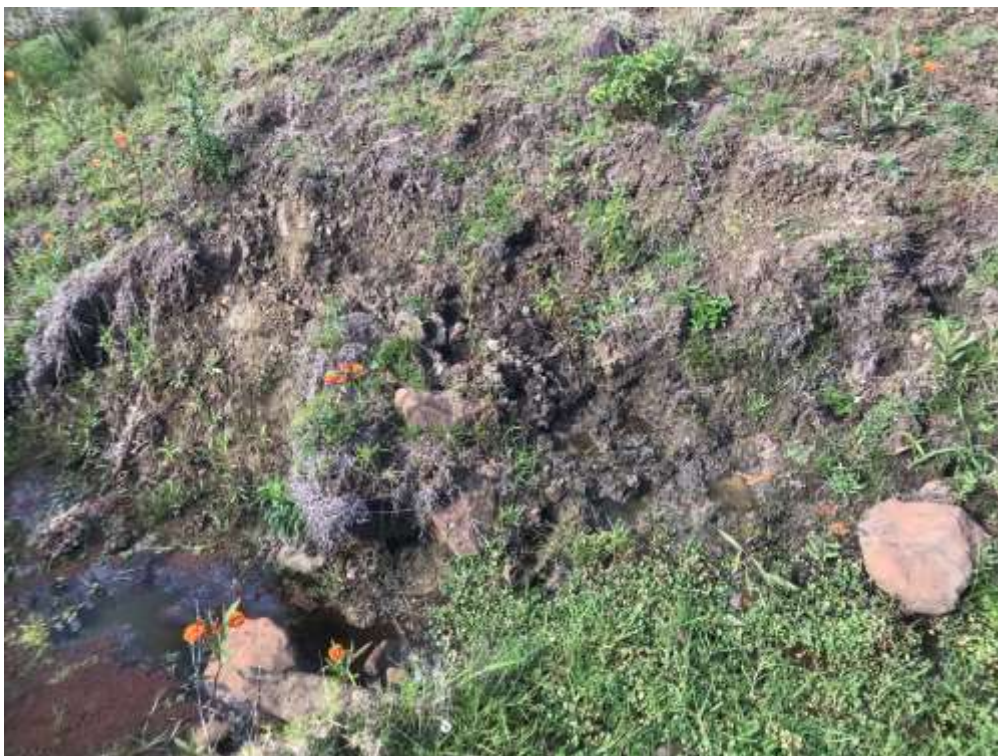
*Below: Currently cattle have unrestricted access to the waterways, and as a result erosion and the destabilization of stream banks is occurring.*

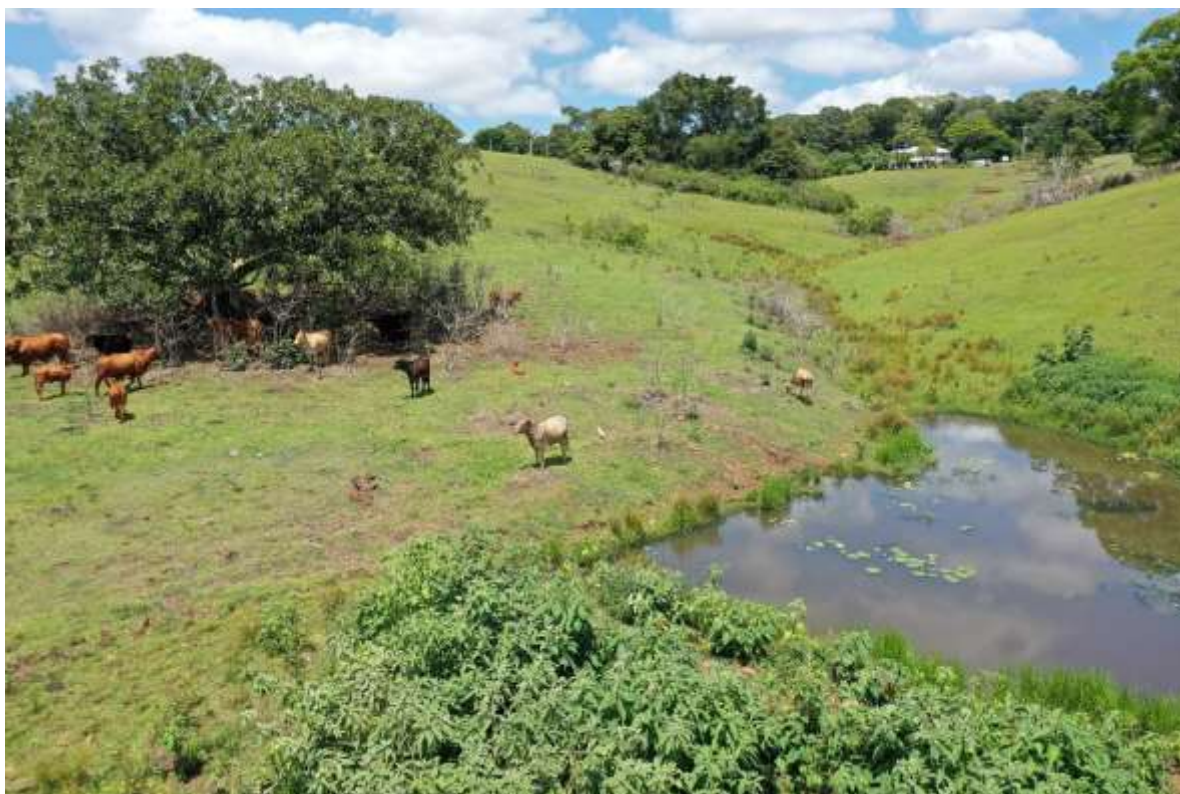
*Above: Riparian vegetation on along the waterways on Ferriday's block is impacted by woody weeds (primarily lantana, wild tobacco, yellowberry and blackberry).*

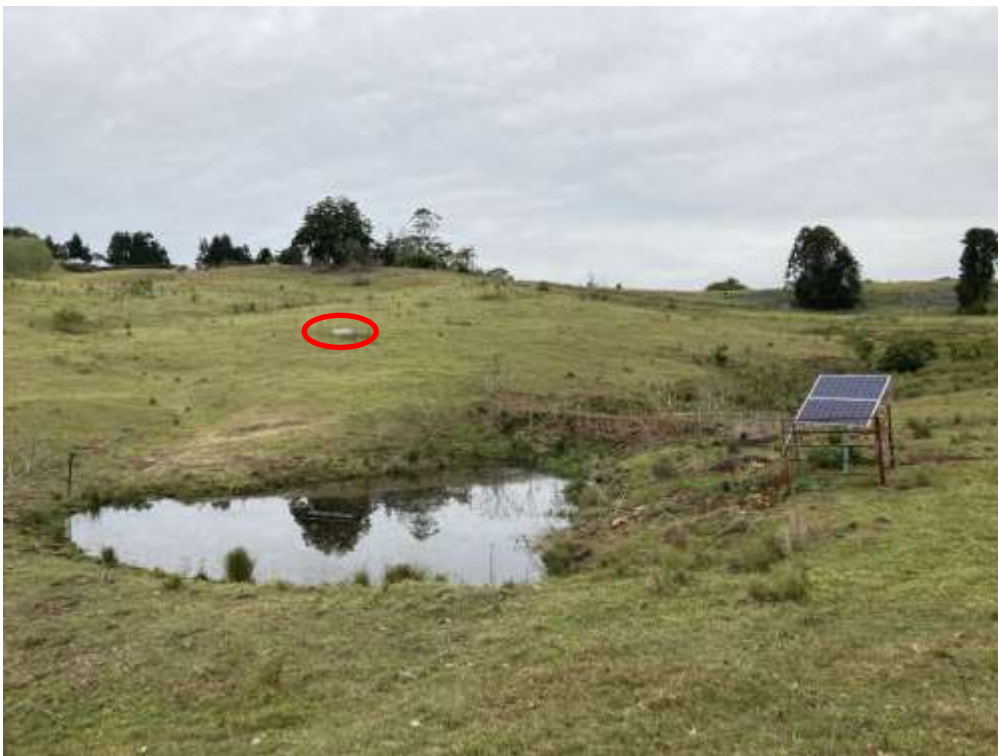
*Above: The solar pump installed, which lifts water to a header tank. The water is then gravity fed to four water troughs. A trough is highlighted that will provide water for livestock, following the fencing of the riparian zone.*

**Off Stream Watering** – Solar pump, header tank and 4 water troughs installed and completed, December 2020.

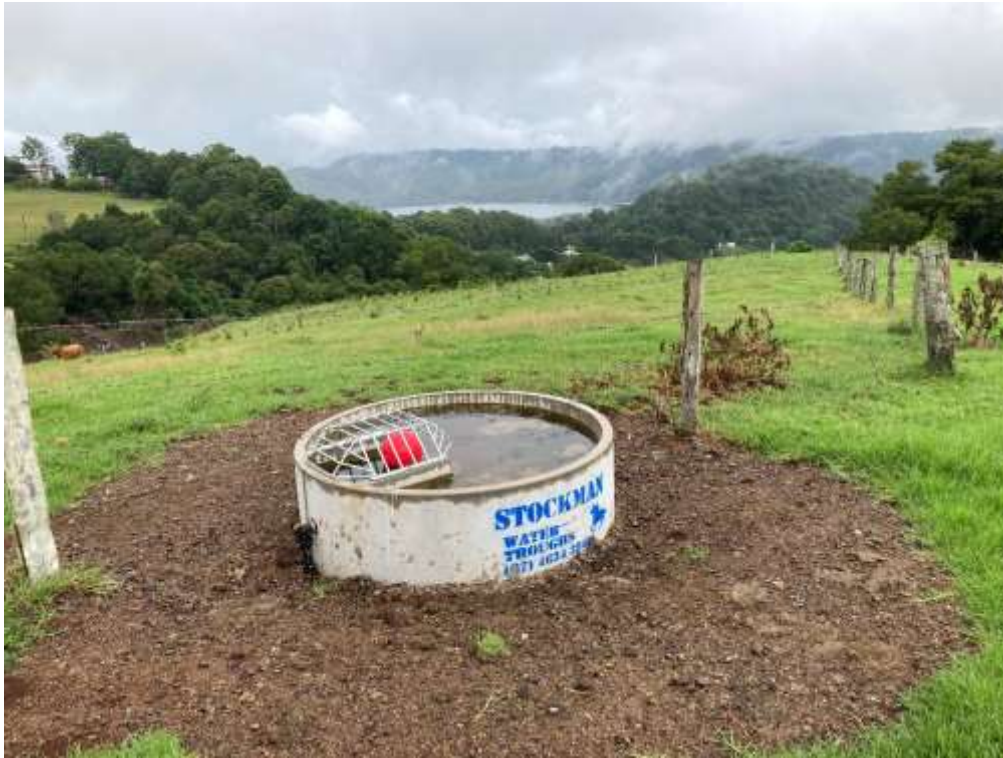
*Above: One of the four water troughs installed. All troughs have road base around the troughs to prevent bogging.*

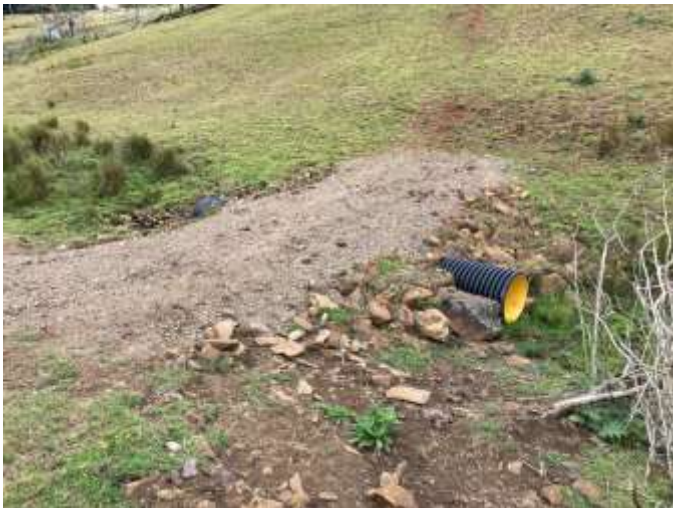
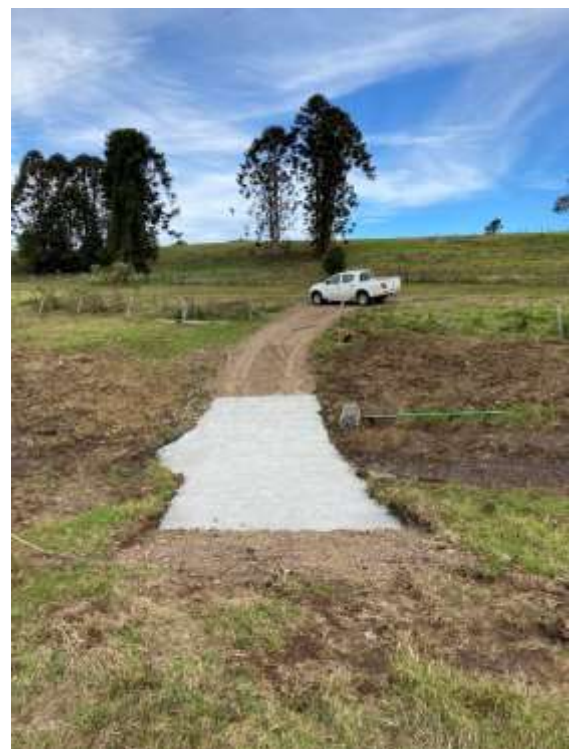
*Above & Left: Formalised crossings protect livestock and watercourses from the issues associated with unrestricted access, they improve water quality by limiting sedimentation and nutrient enrichment. When the crossings are installed in conjunction with riparian fencing the risk to water quality is significantly reduced.*

**Concrete Crossing** – One concrete crossing has been installed, which will assist livestock and vehicle movements between paddocks, once the riparian fencing is installed in Stage 2. Another crossing was improved with gravel, and a third piped crossing was installed to assist landholder access to their paddocks.

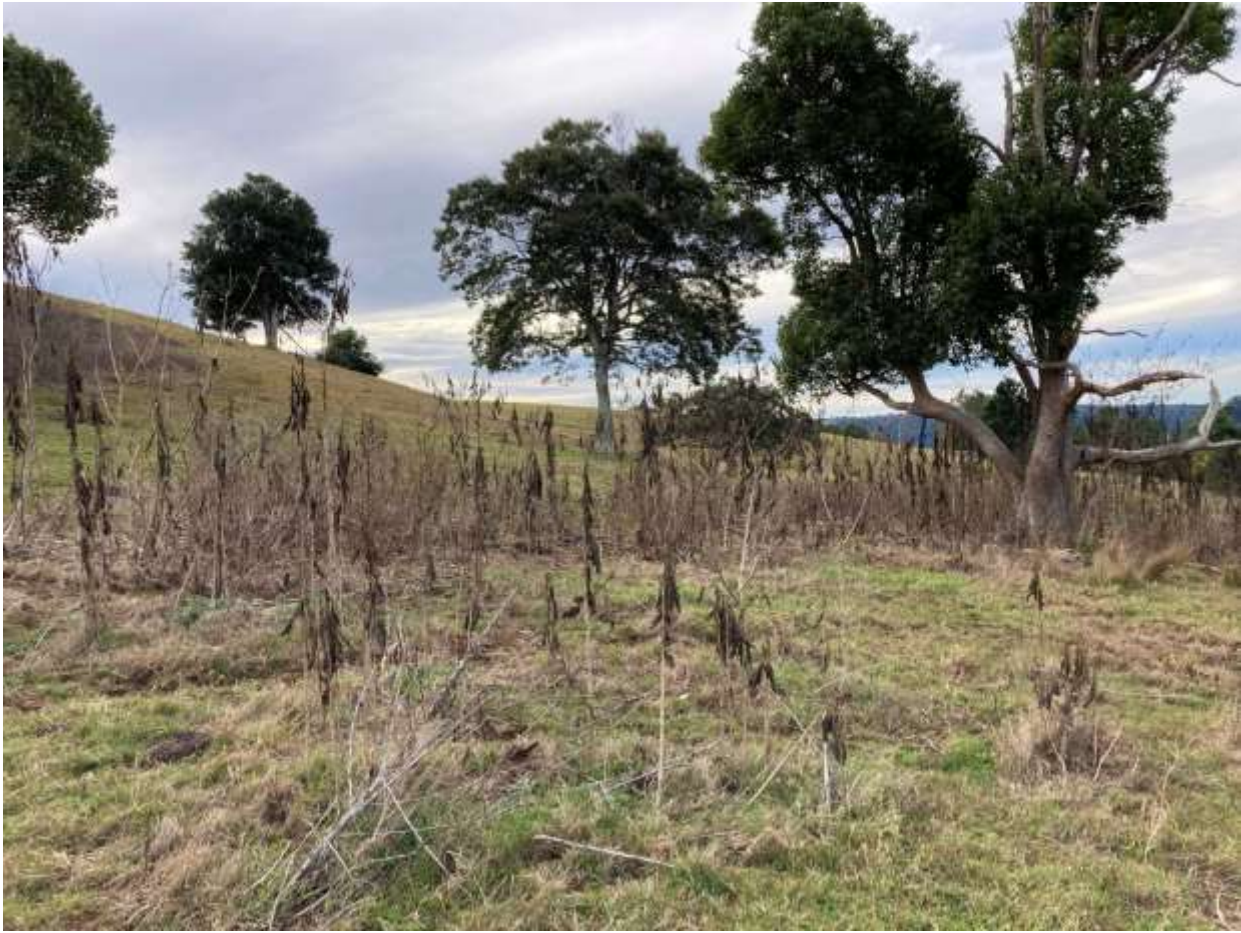
*Above: Fred Ferriday has continued to carry out weed control over his property targeting lantana, wild tobacco and devils fig.*
