Riparian Condition Improvement, Agricultural Practice Improvement Report 8th February 2024

Lake
Baroon
Catchment
Care
Group

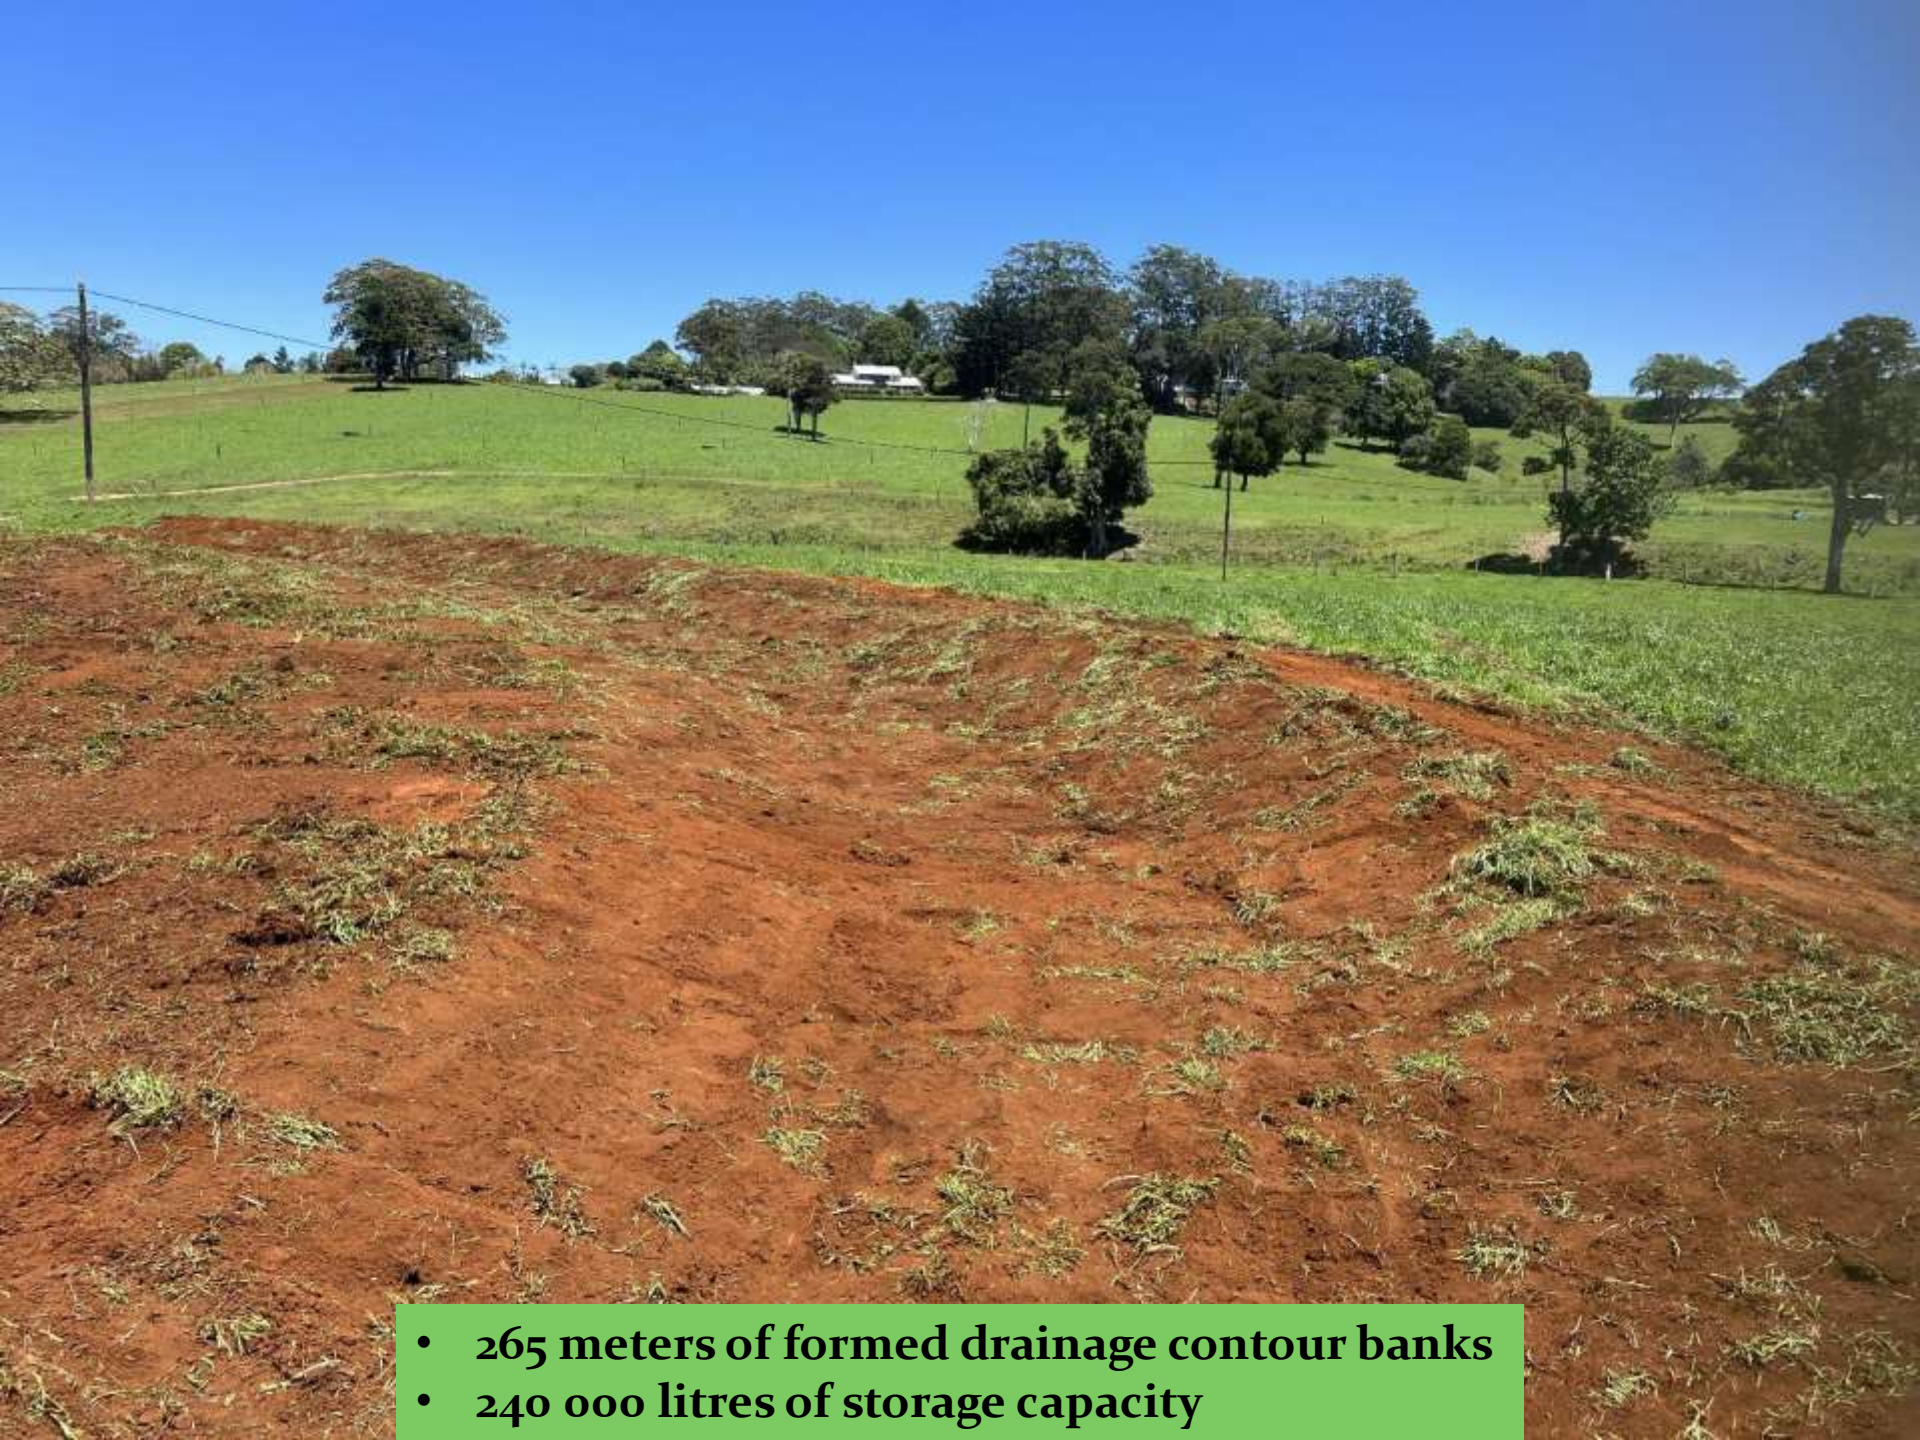
- 265 meters of formed drainage contour banks
- 240 000 litres of storage capacity

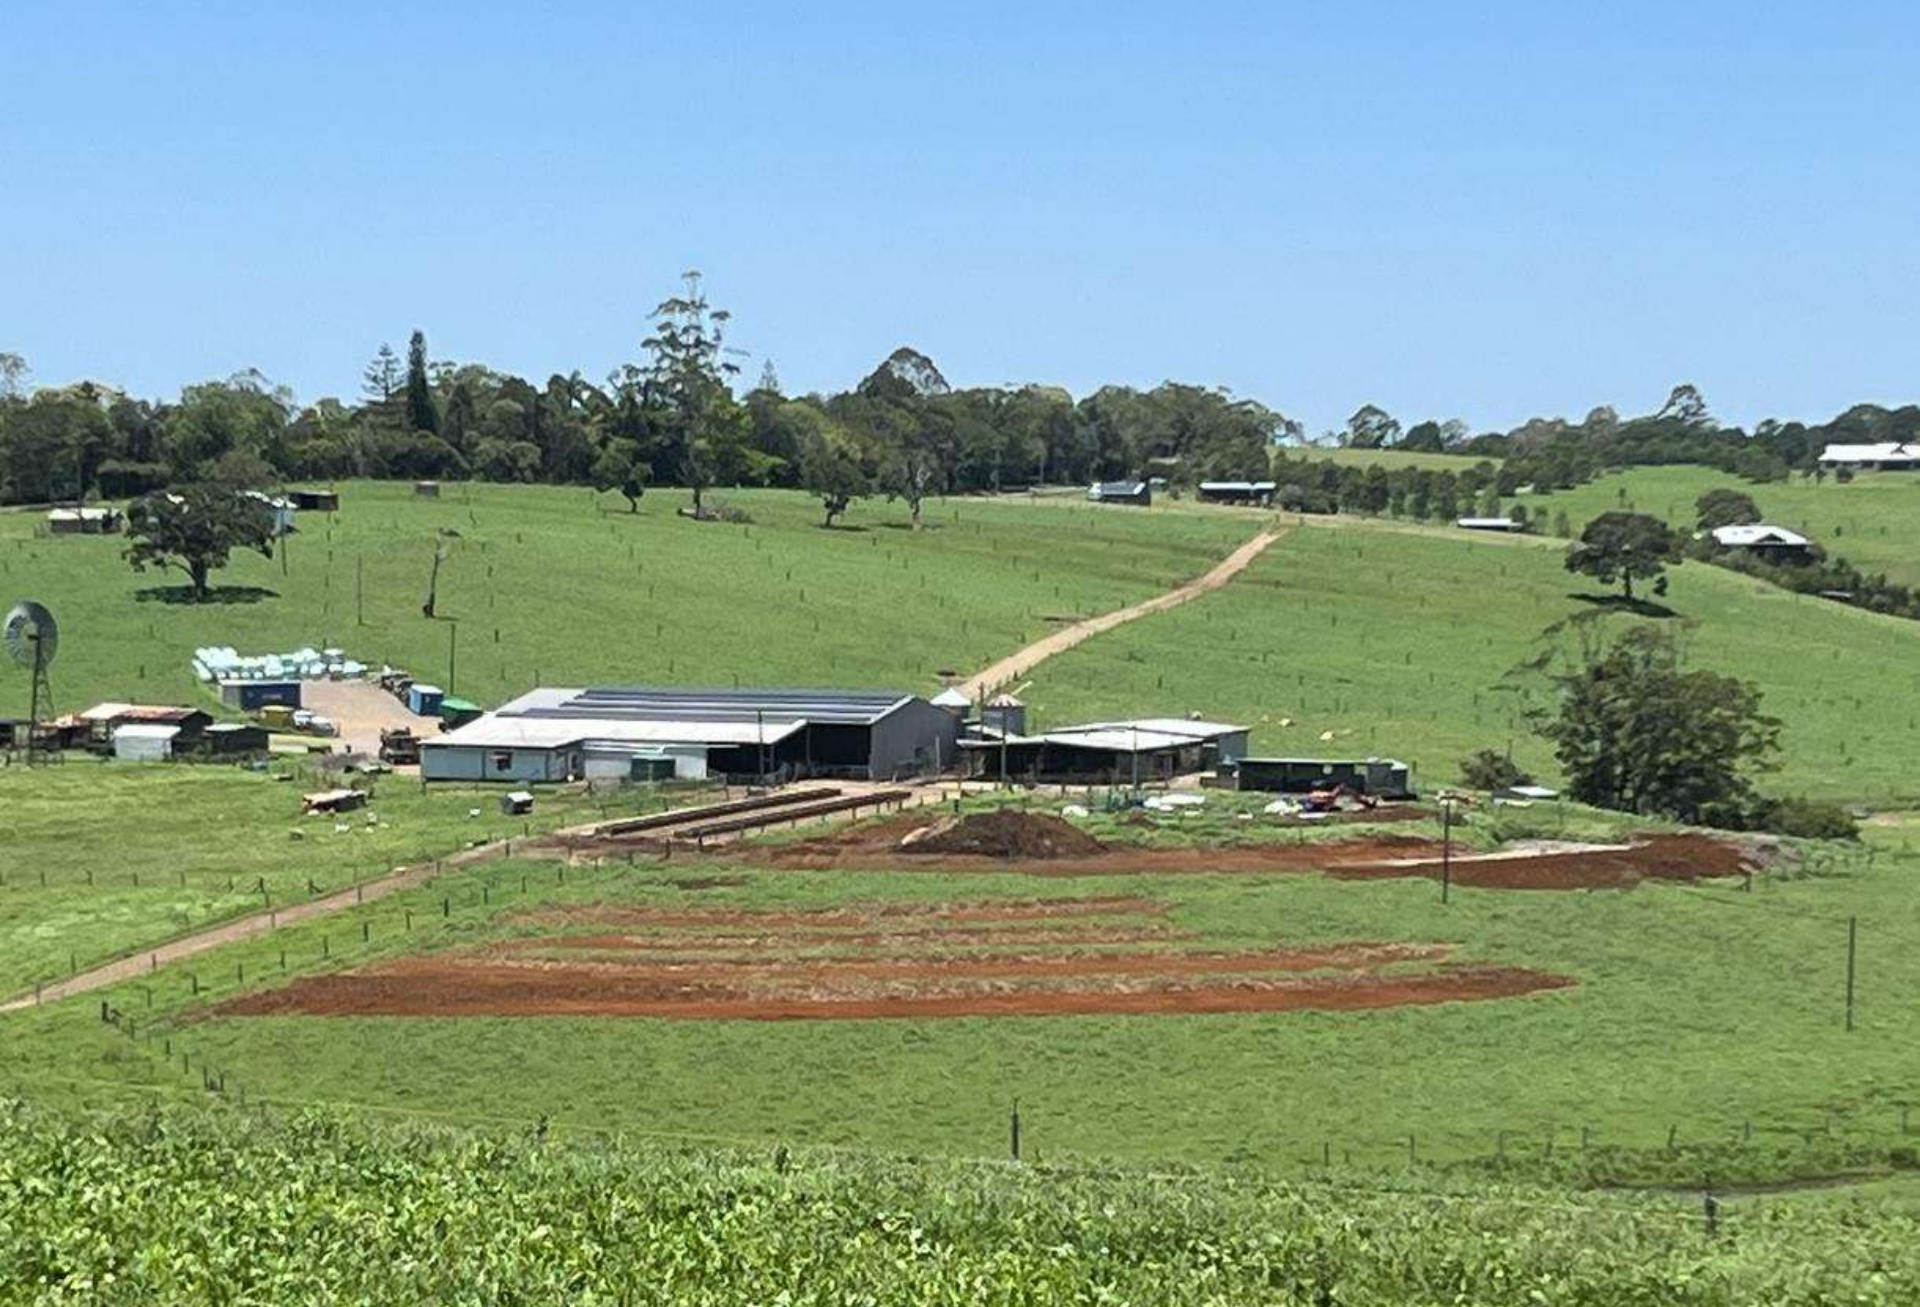
- **New effluent system now has a total holding capacity of 740 000 litres**
- **Pond overflow now travels 345 Meters to reach Walkers Creek**

**2nd January 200mm of rainfall
Contours ponds withstood event**

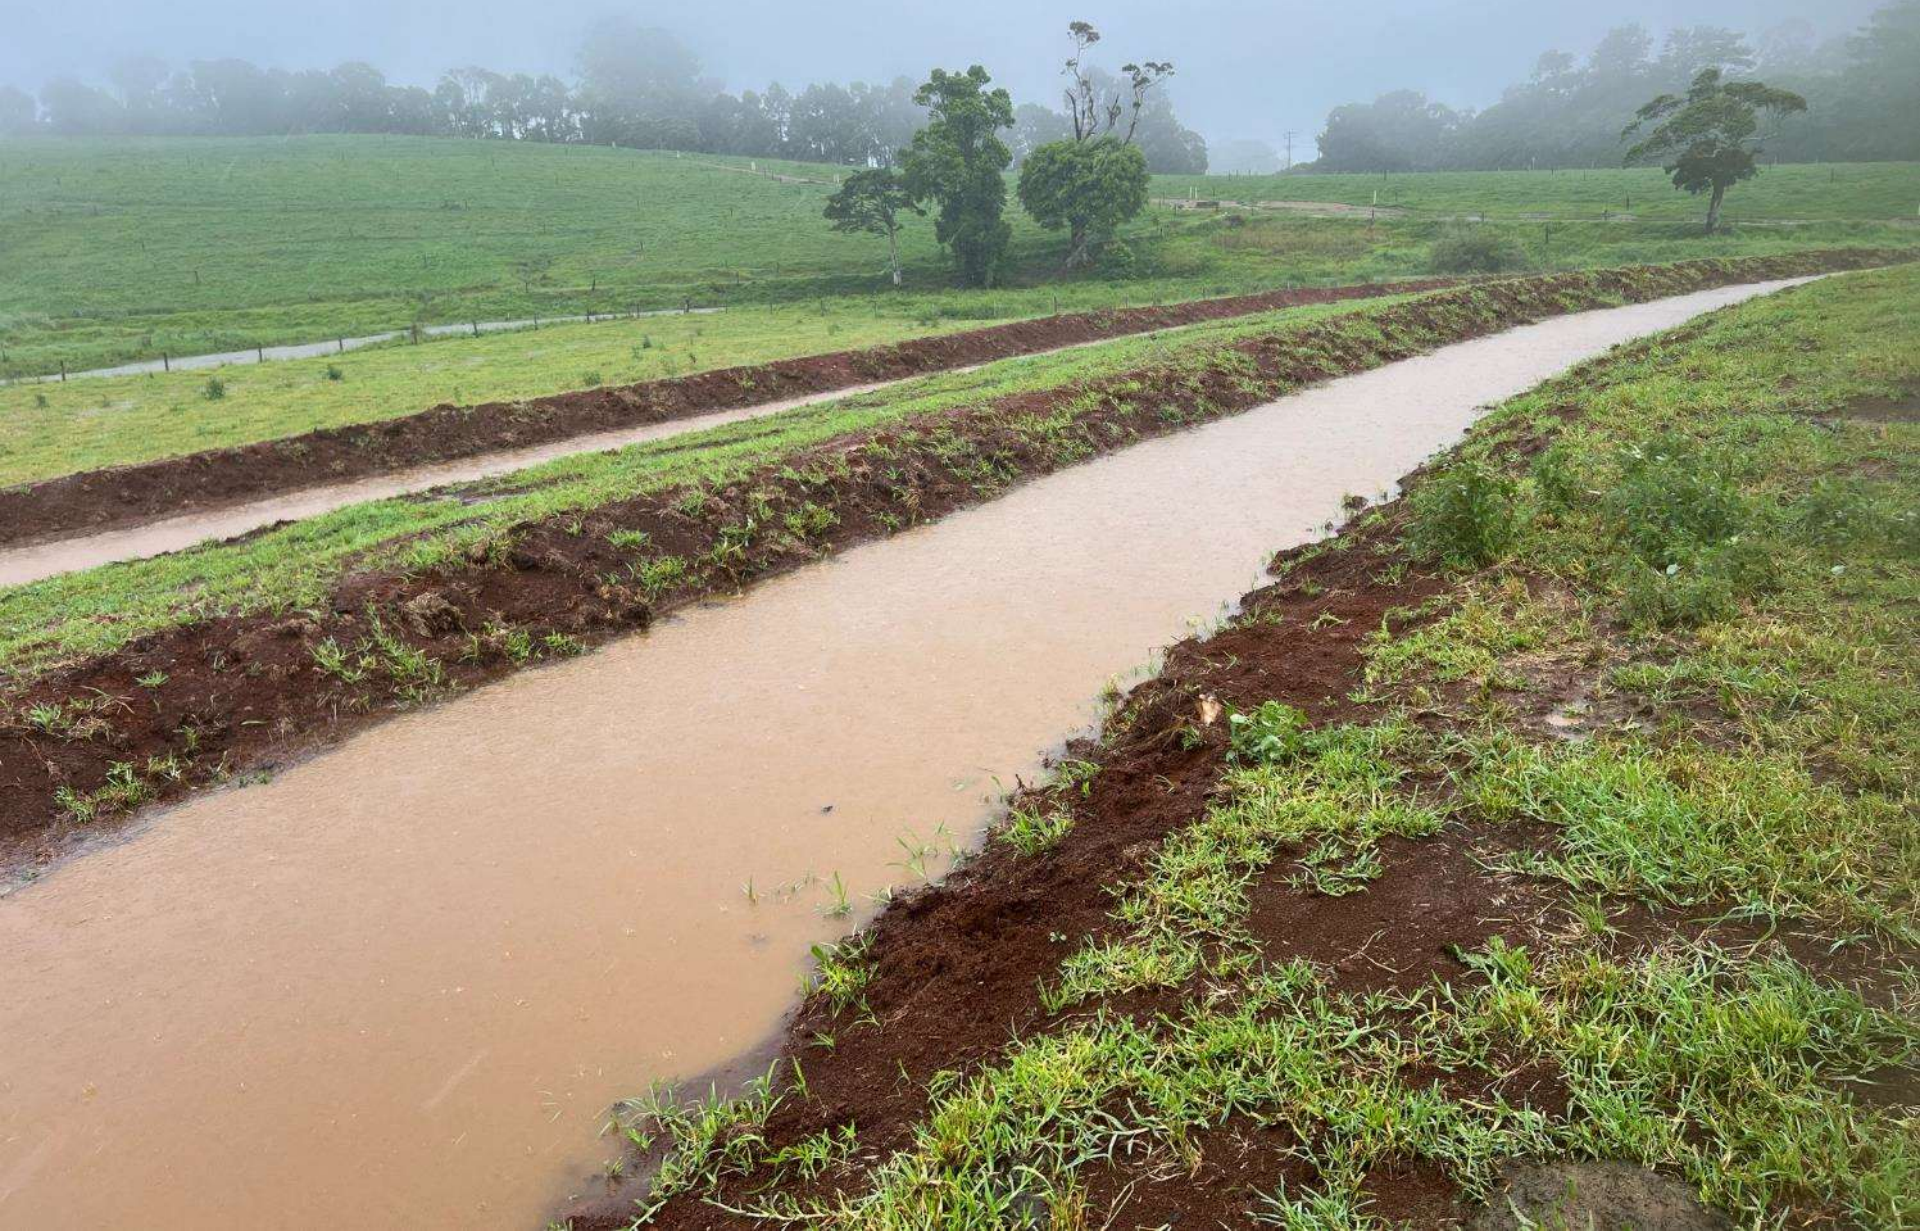
16th January 101 mm of rainfall
Contours held entire effluent overflow

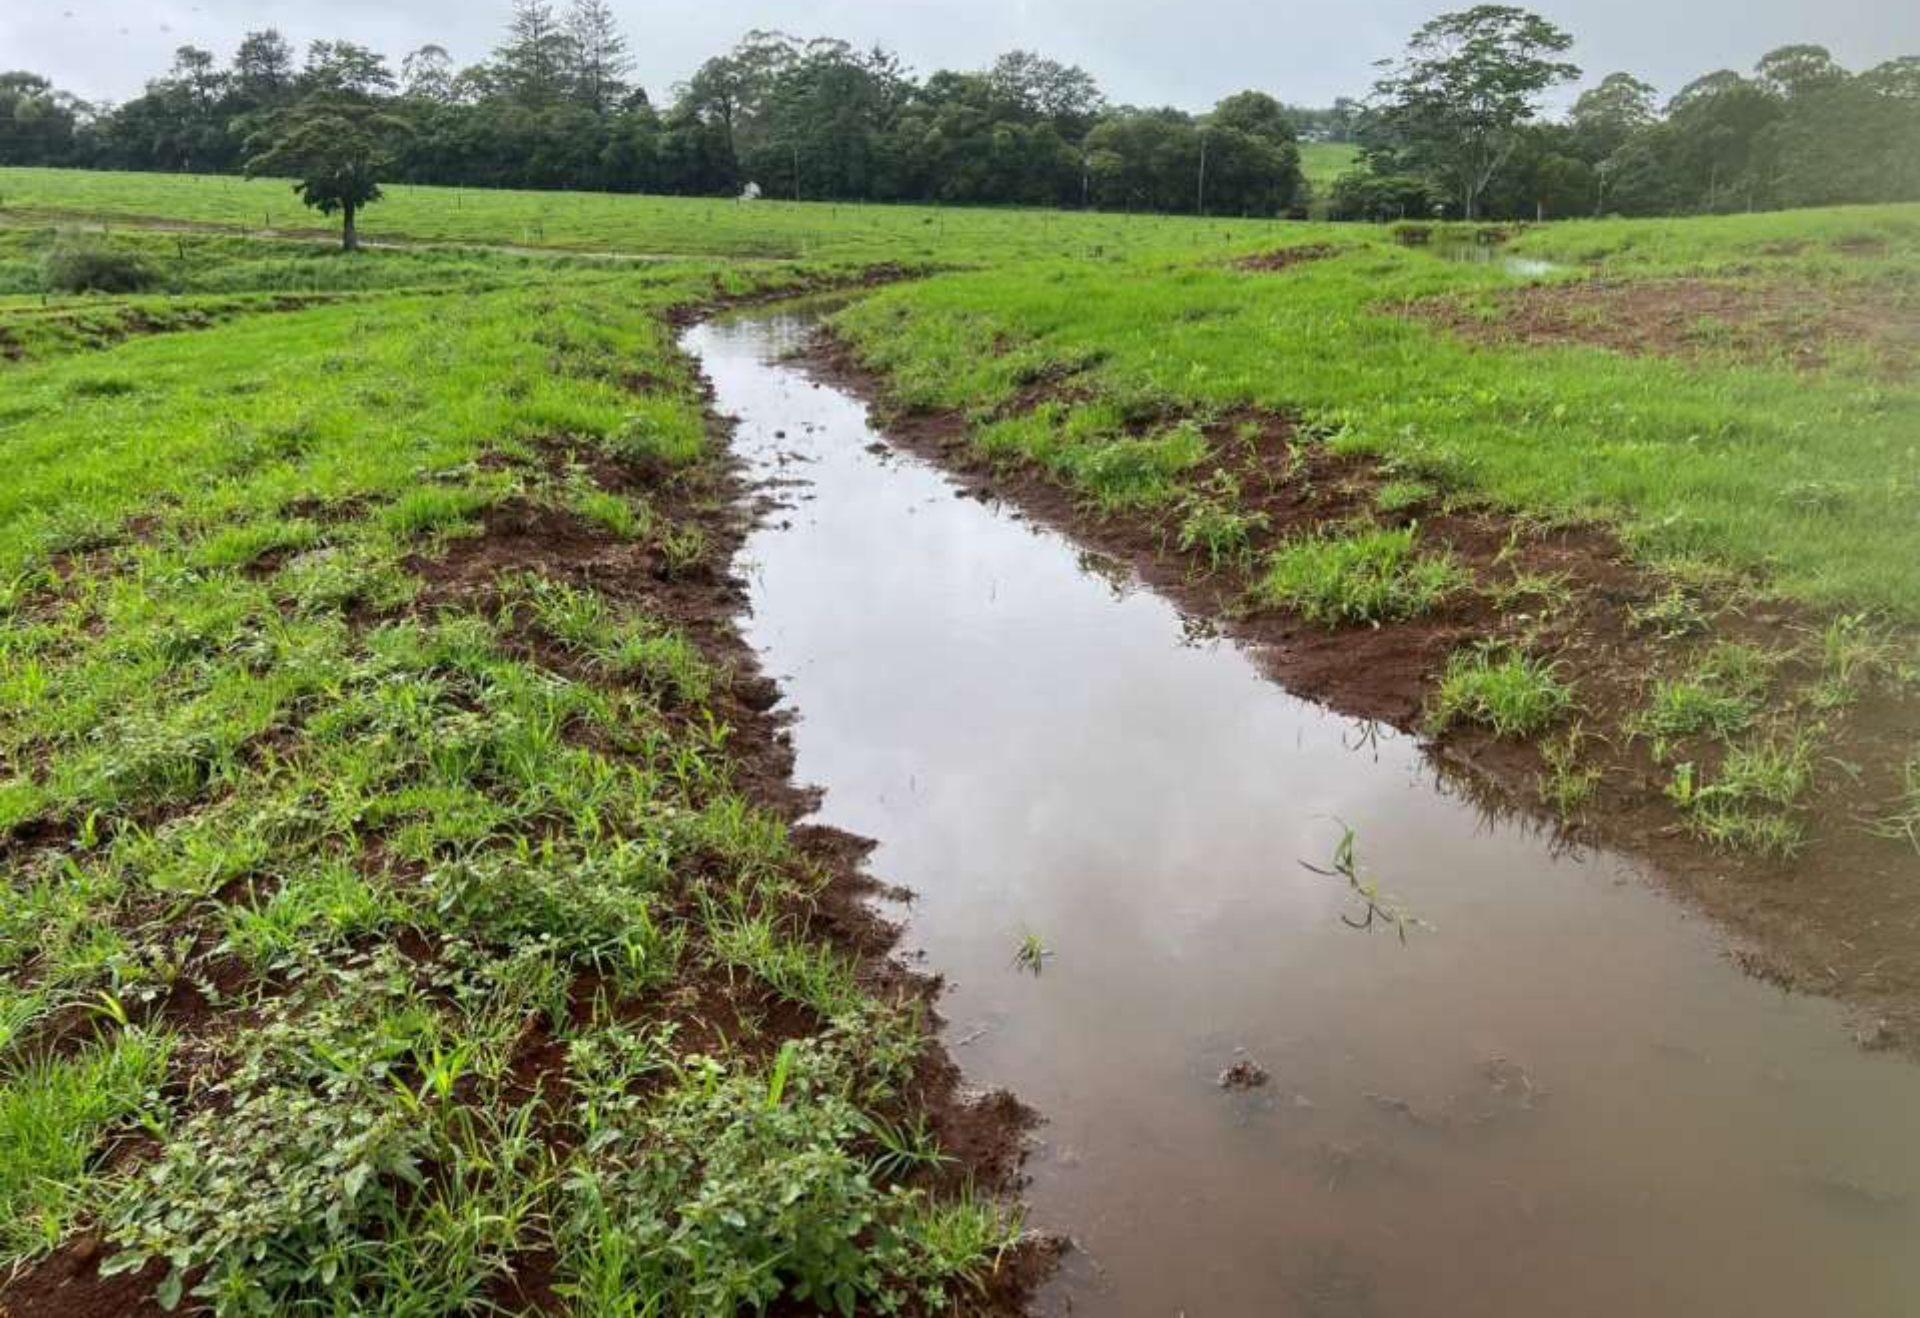
Bottom two contours had already absorbed overflow water

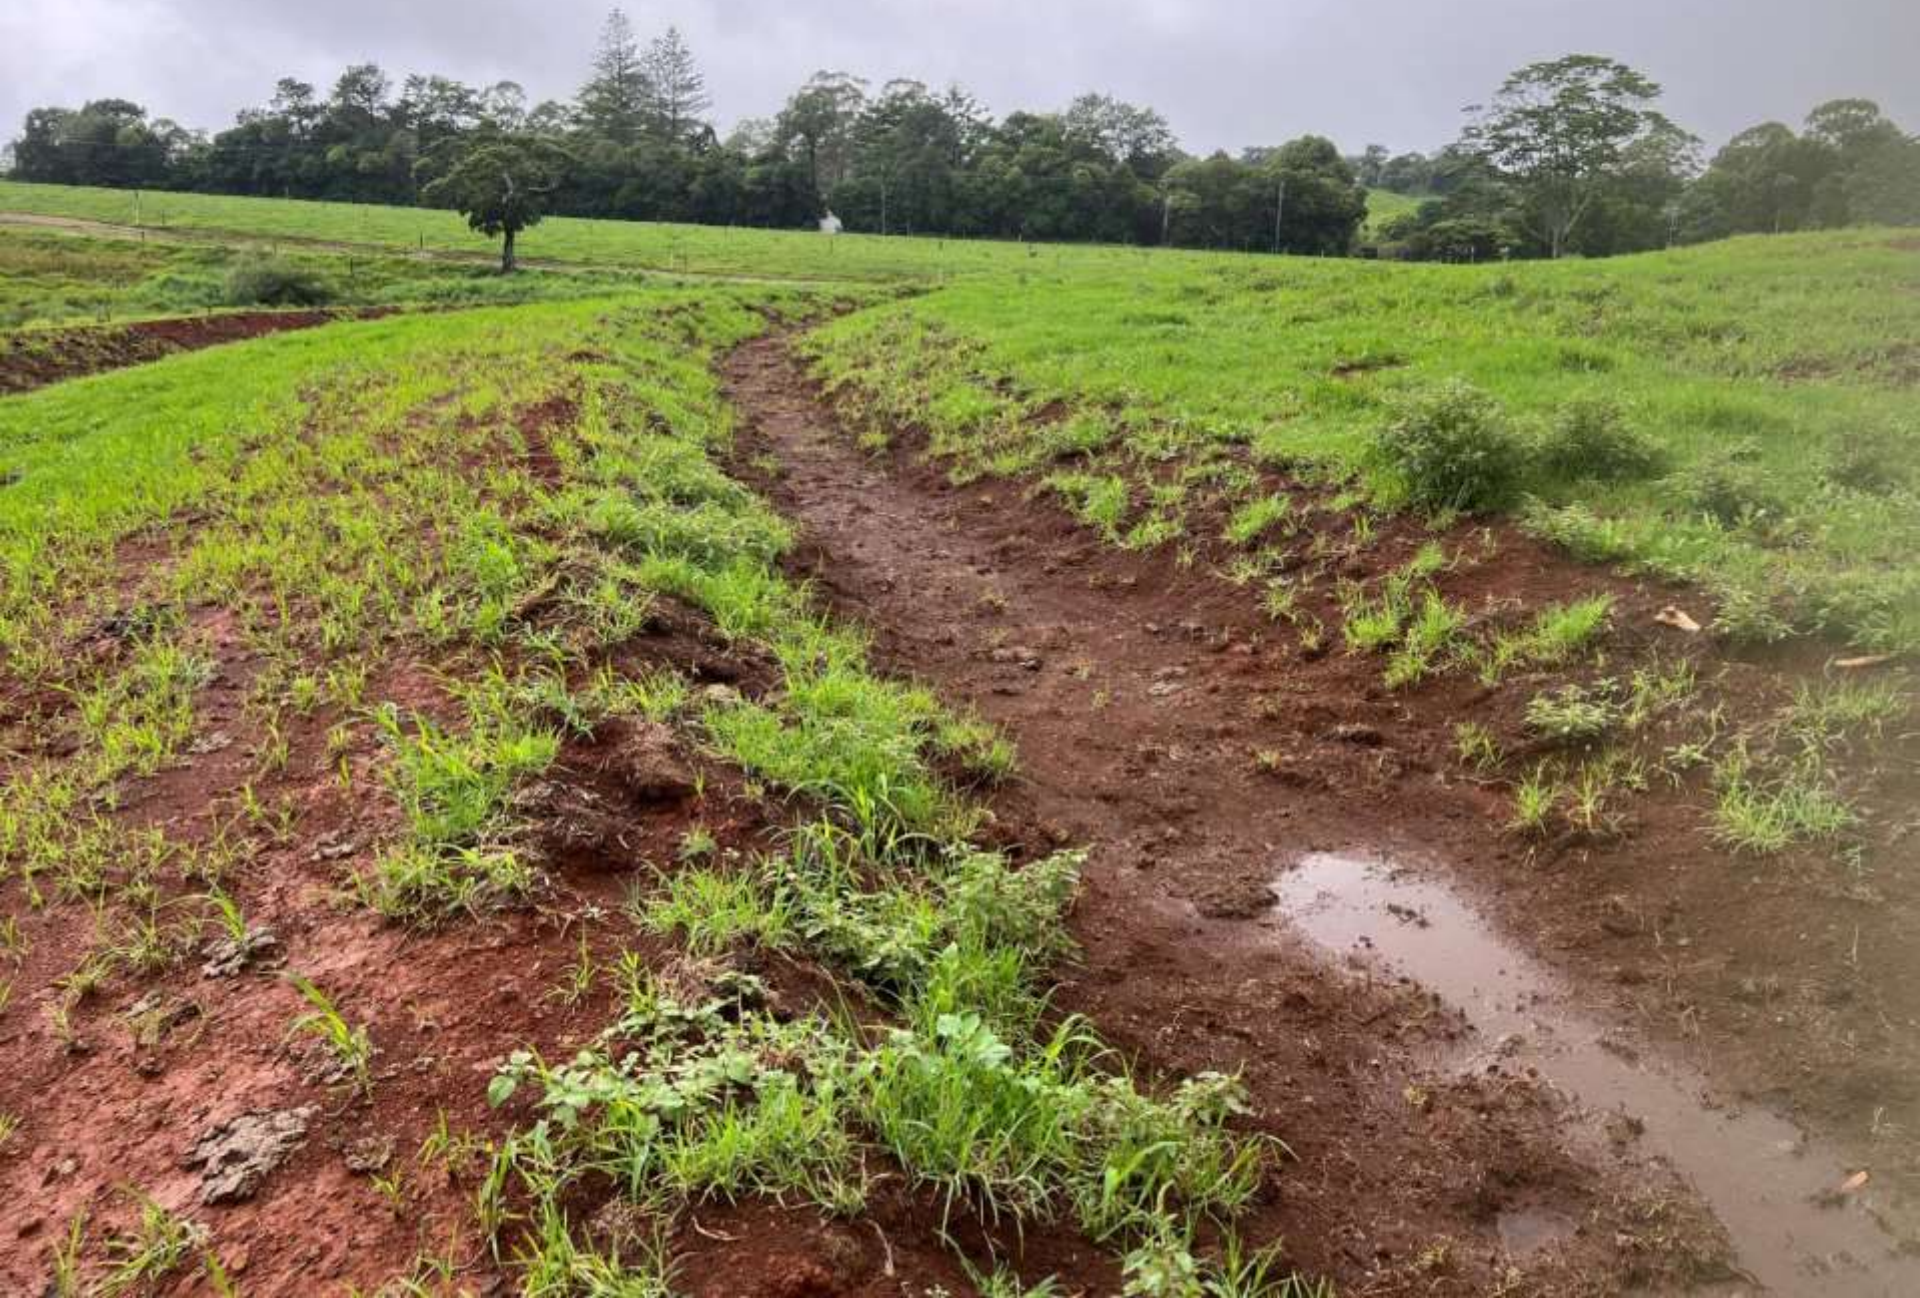
Bottom contour had not reached capacity

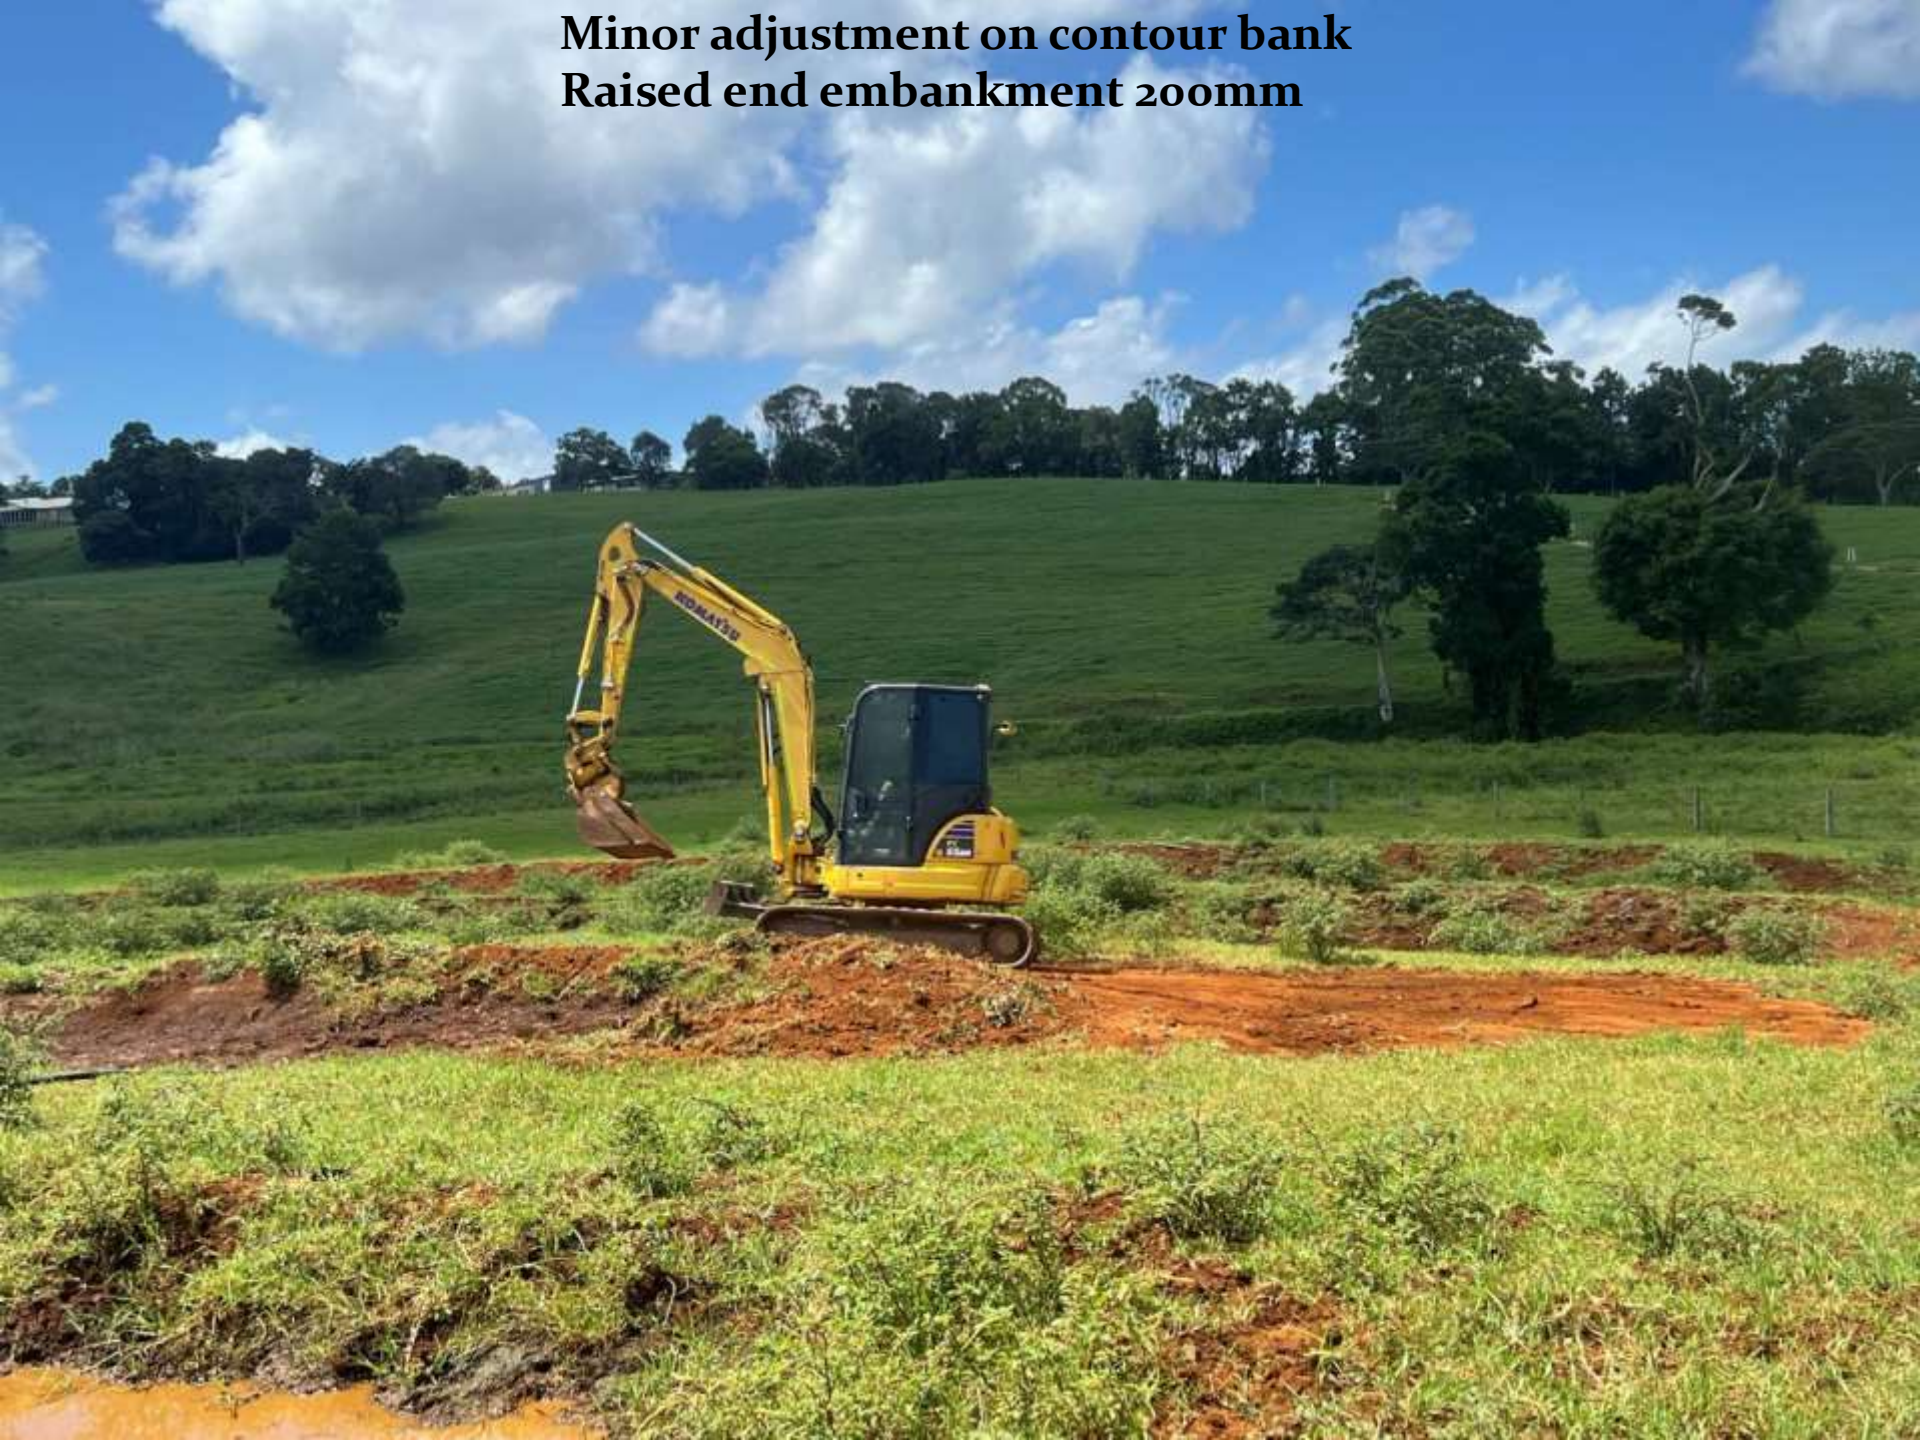
- Ruddle Dairy and Nash Excavations
- Extra troughs installed prior to Xmas heat

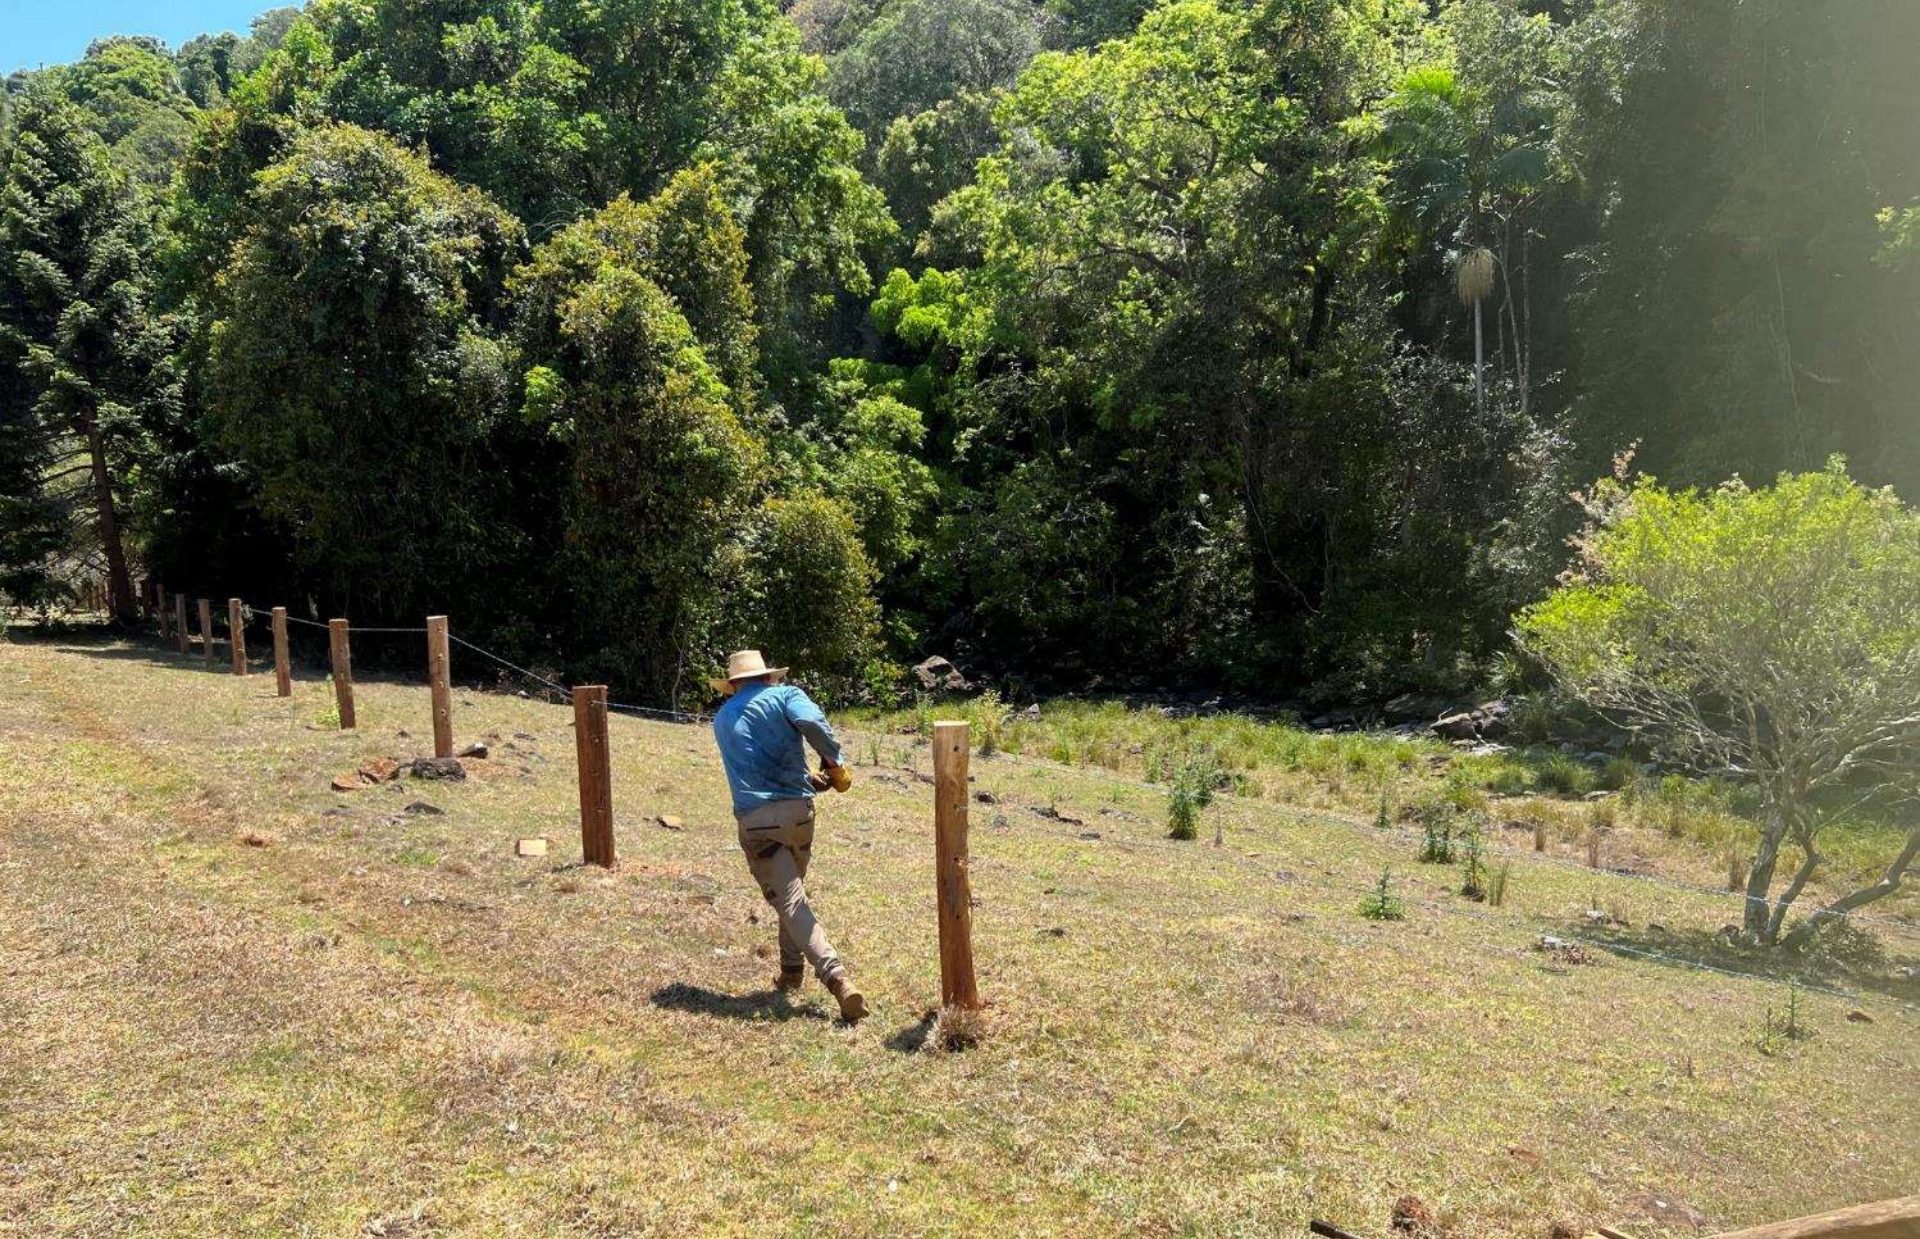
- Riparian fencing commenced along Obi Obi Creek
- Stage two of the Landholder Project
- Tim Davies TAG Rural Fencing

- **Riparian fencing project**
- **Continuing up the ridge line**
- **8 Hectares of remnant protected**

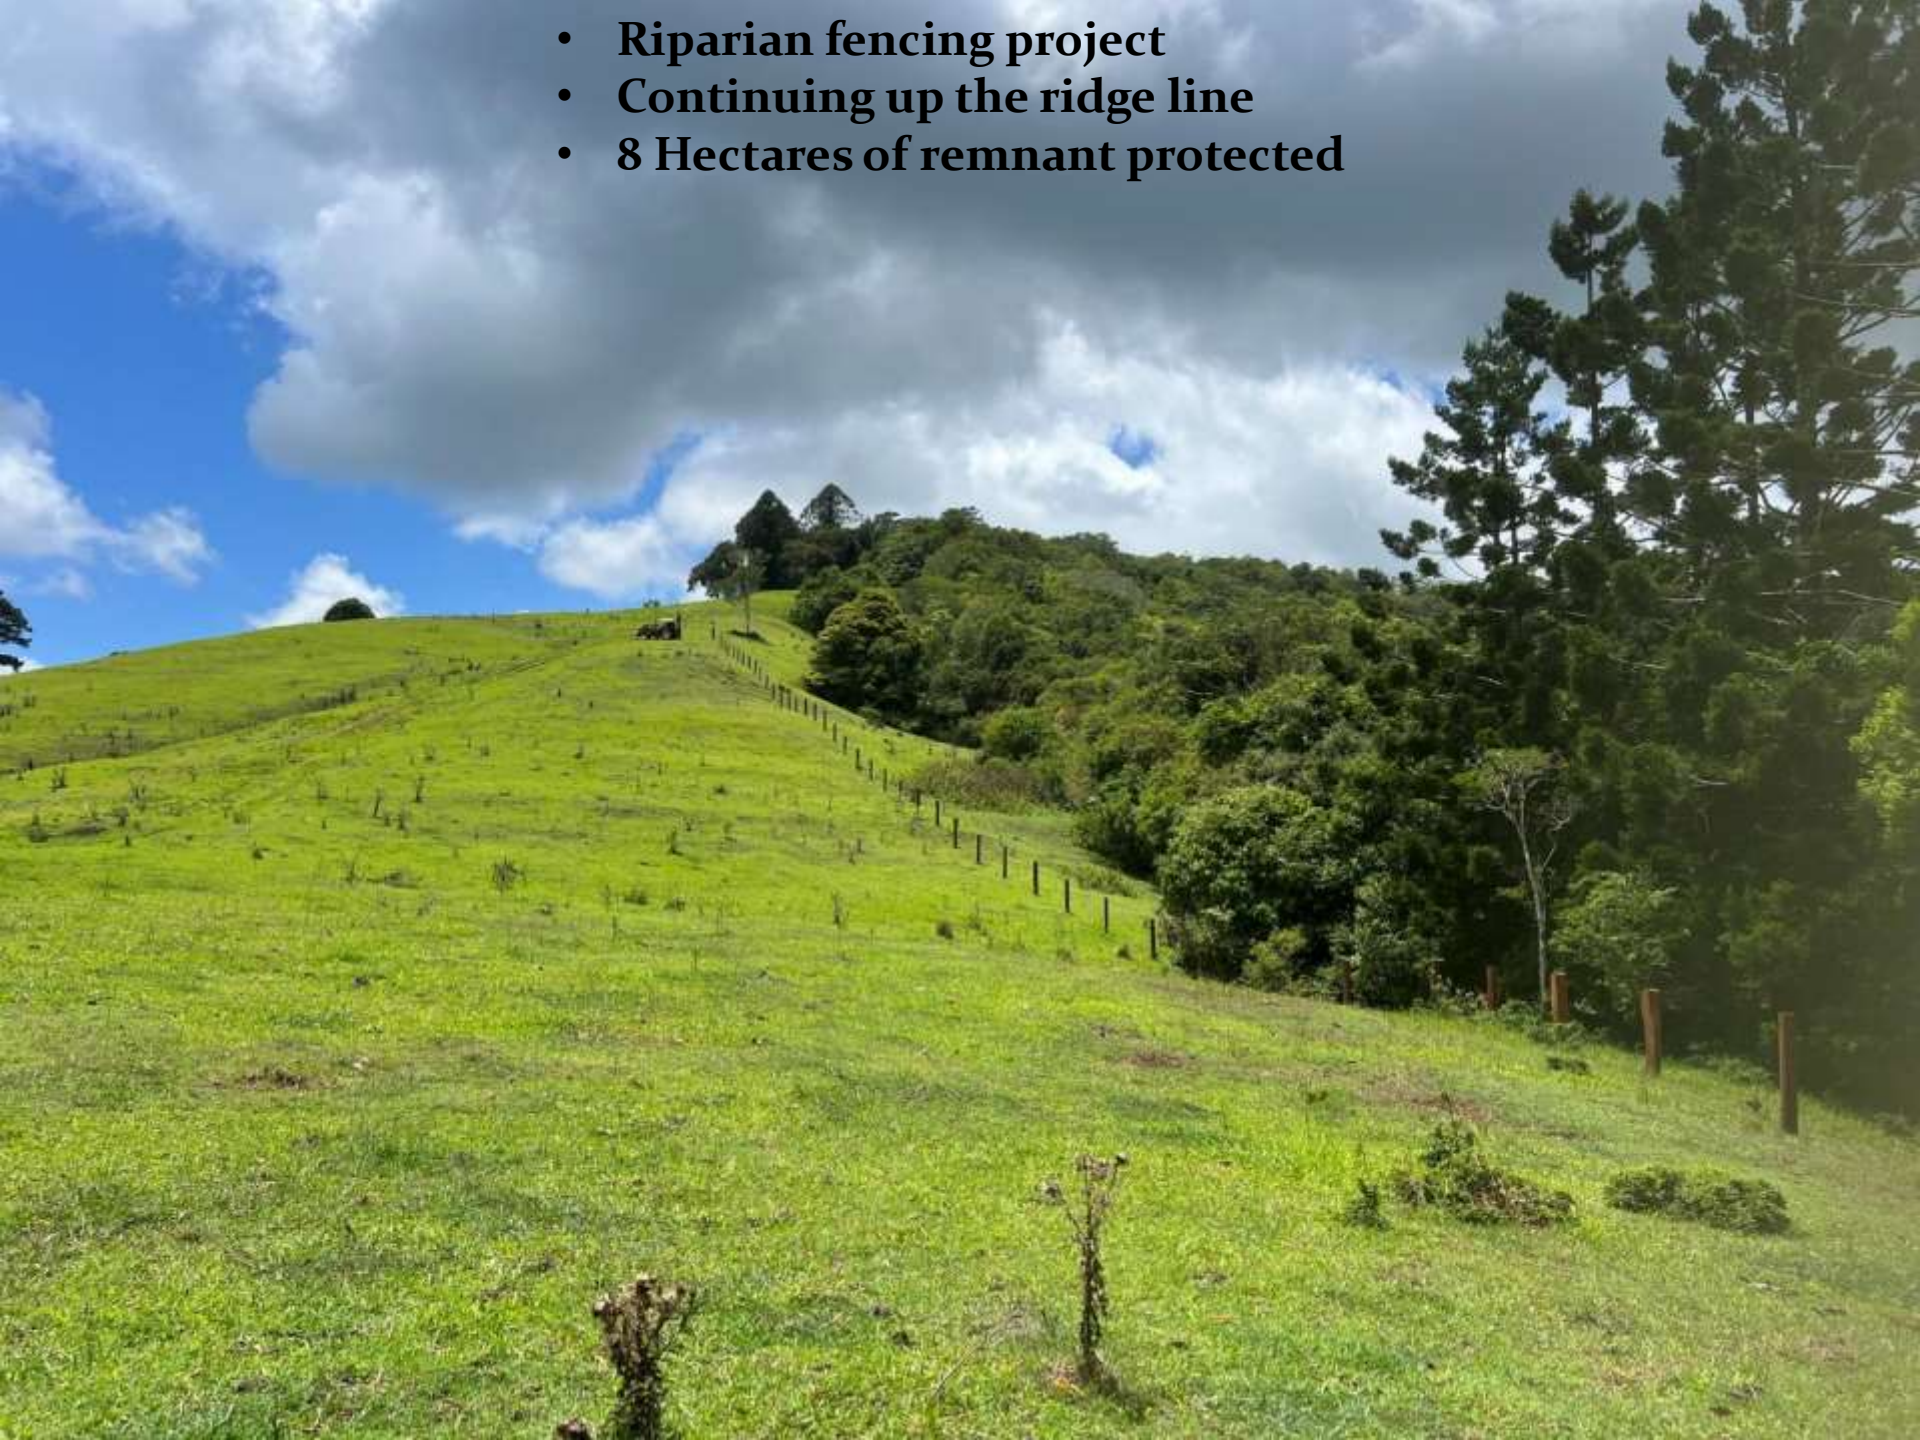
- **Fineline placement dictated by the terrain**
- **700 meters of Obi Obi frontage below**
