Riparian Condition Improvement, Agricultural Practice Improvement Report 8th February 2024

Lake
Baroon
Catchment
Care
Group

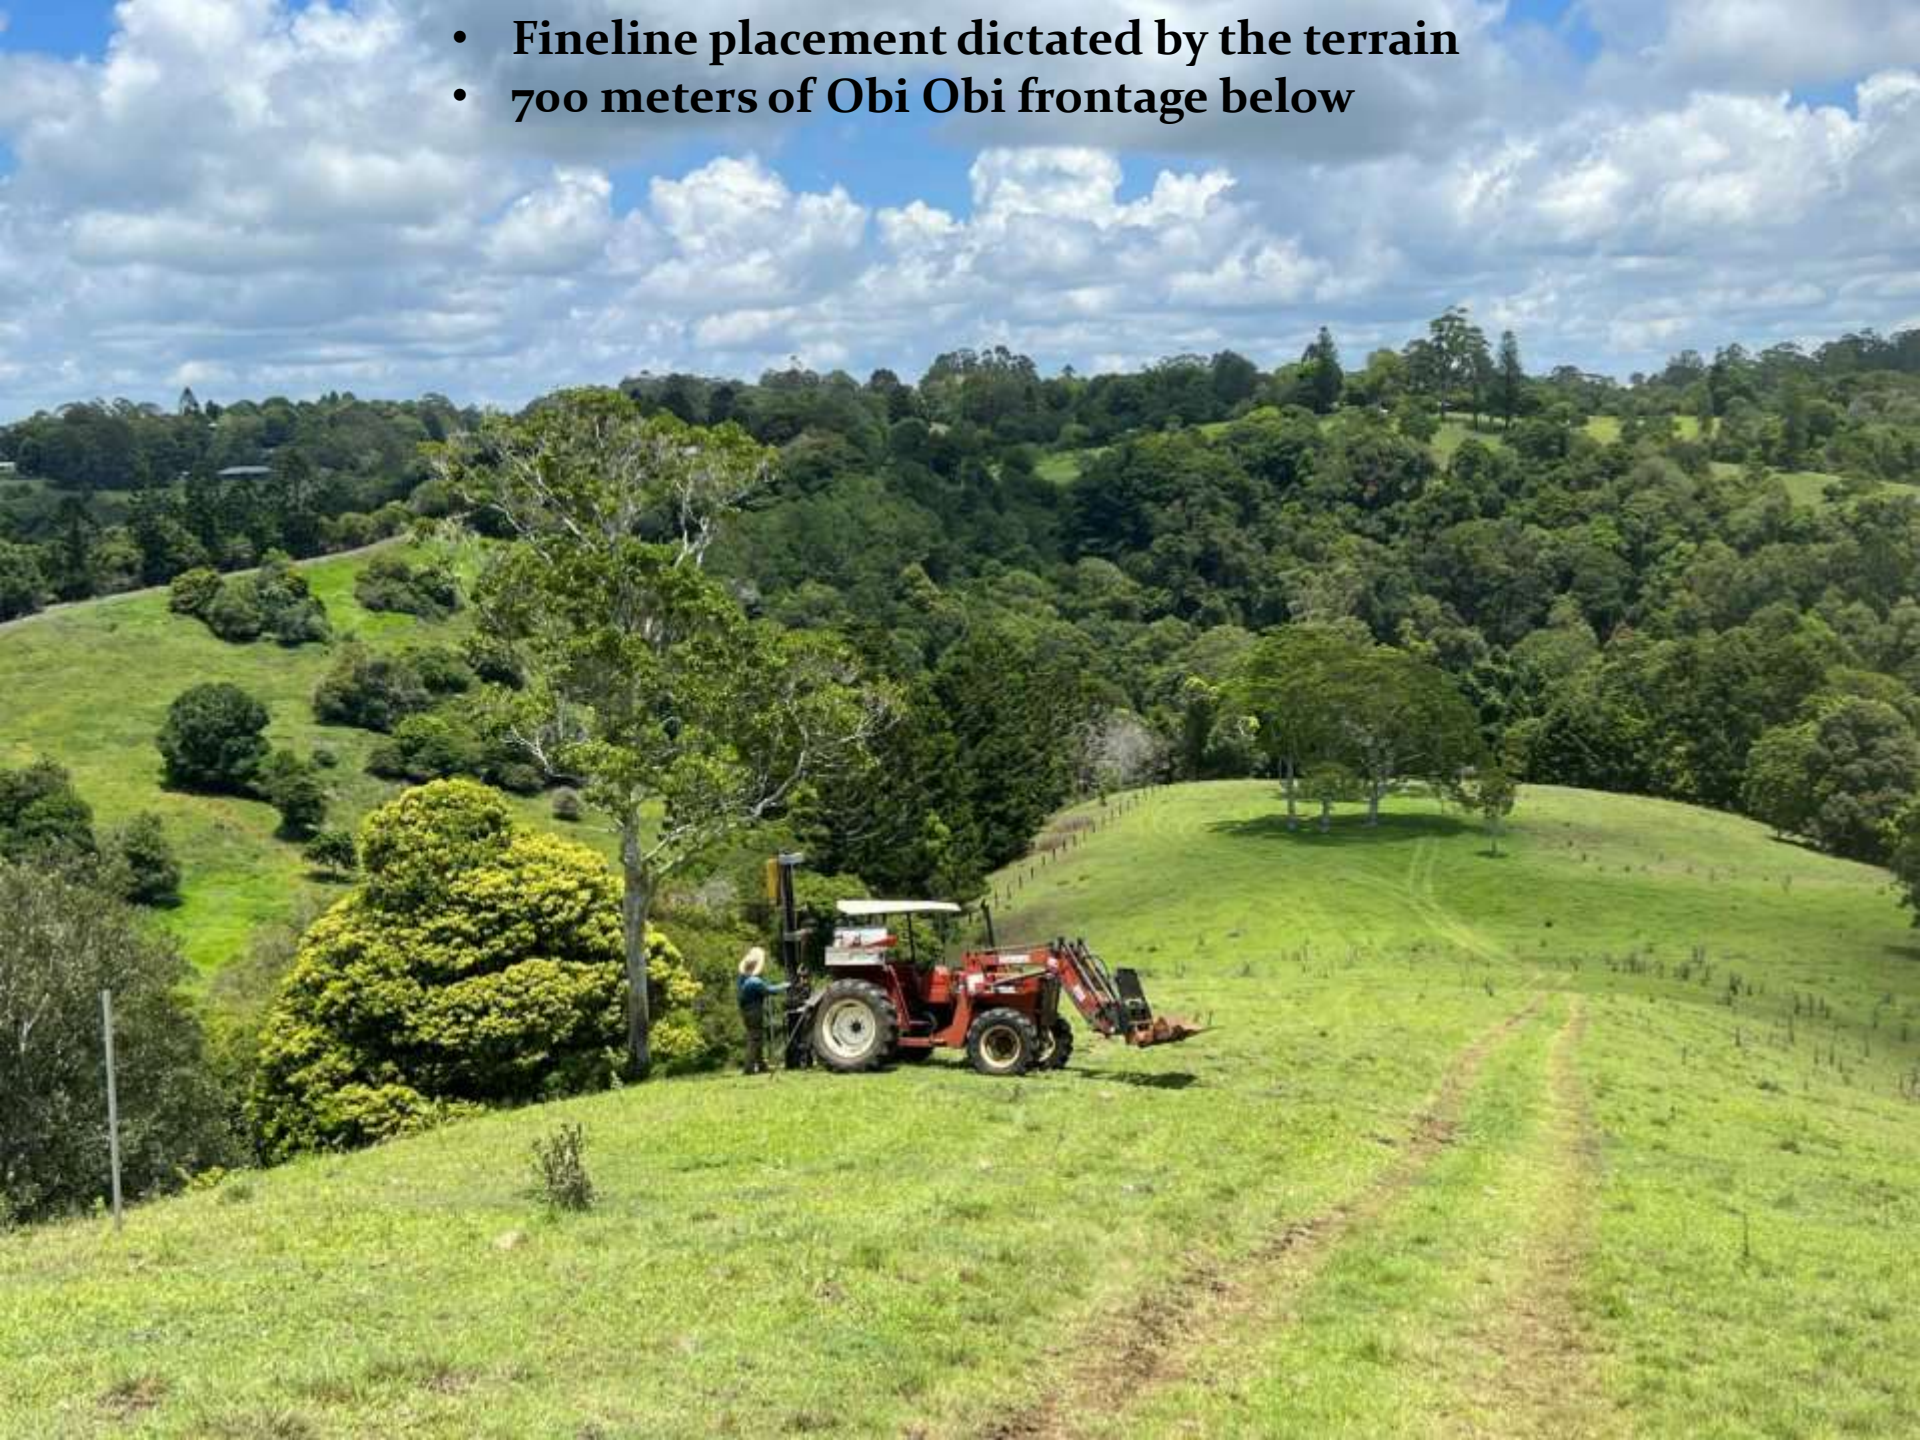
- **800 meters of fence line completed**
- **Waratah Longlife Barbwire**
