Riparian Condition Improvement, Agricultural Practice Improvement Report 14th December 2023

Lake
Baroon
Catchment
Care
Group

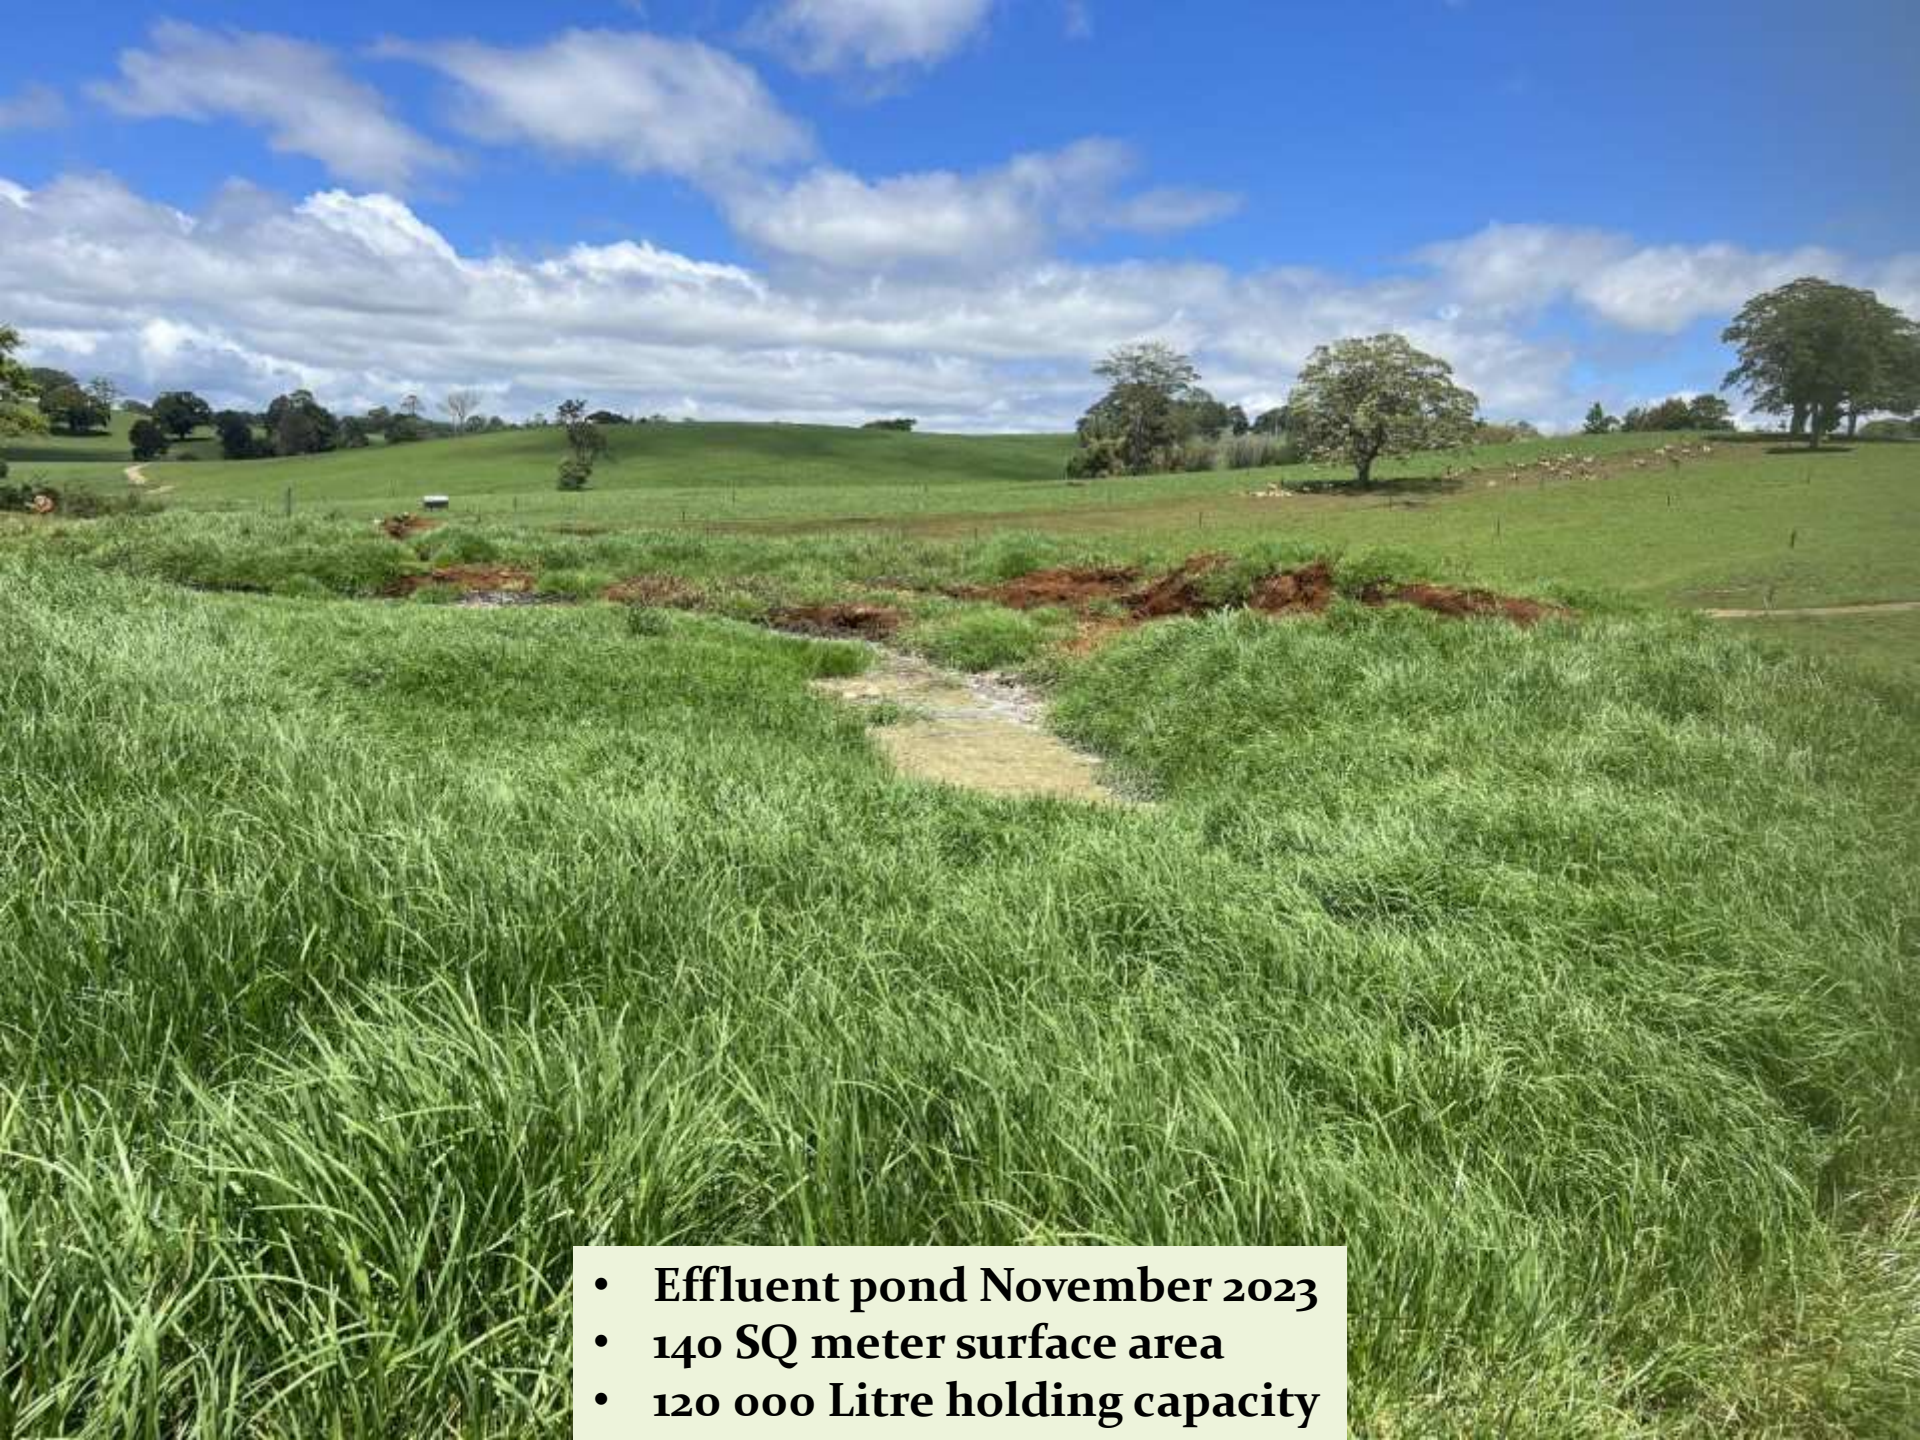
- Effluent pond November 2023
- 140 SQ meter surface area
- 120 000 Litre holding capacity

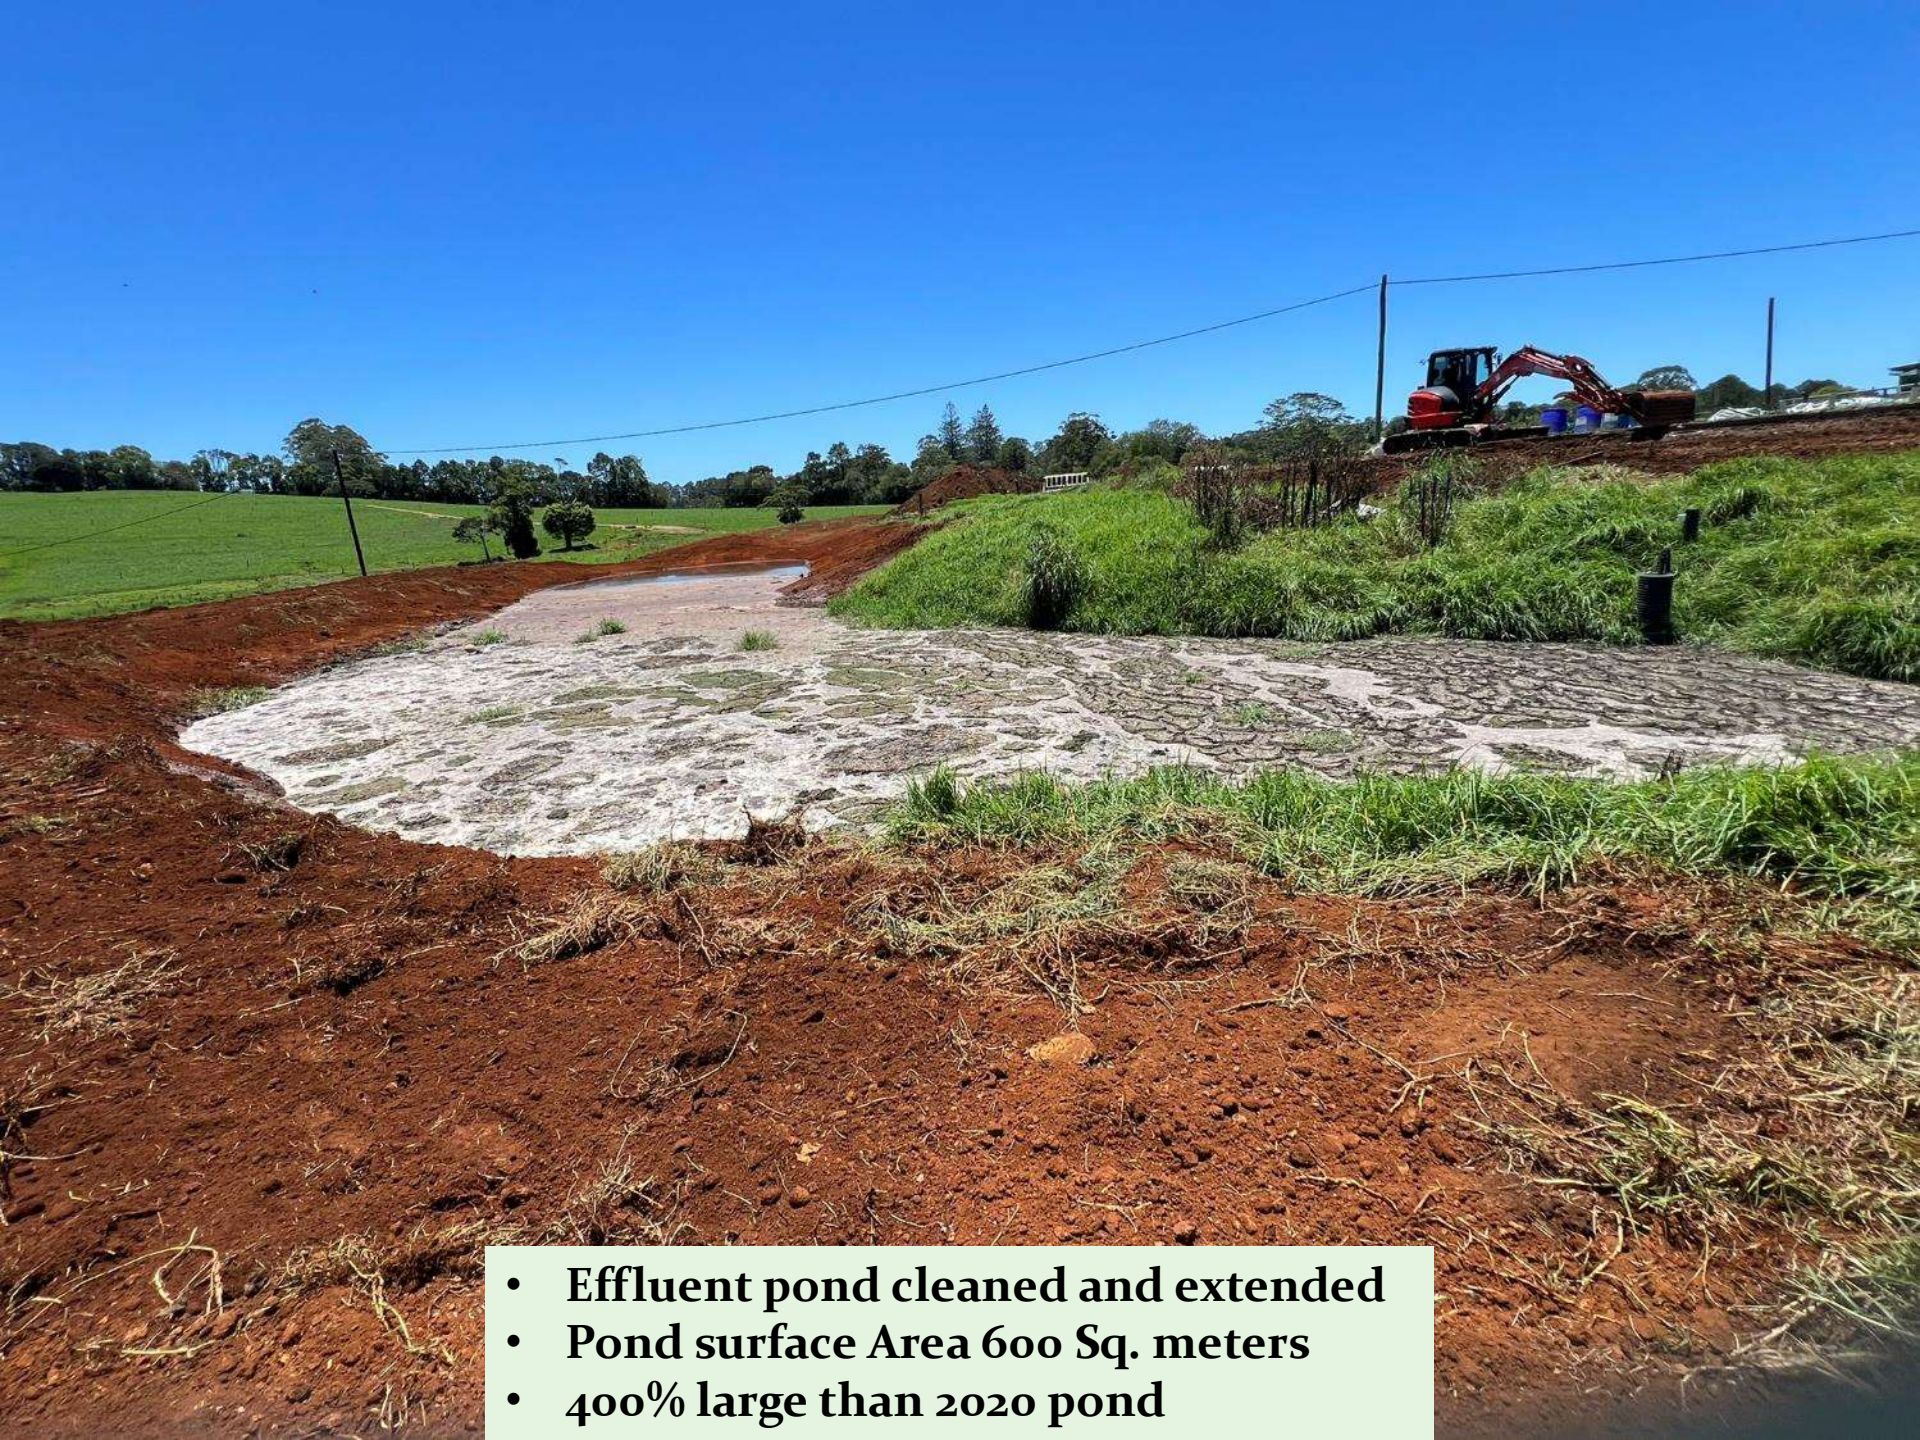
- **Effluent pond cleaned and extended**
- **Pond surface Area 600 Sq. meters**
- **400% large than 2020 pond**

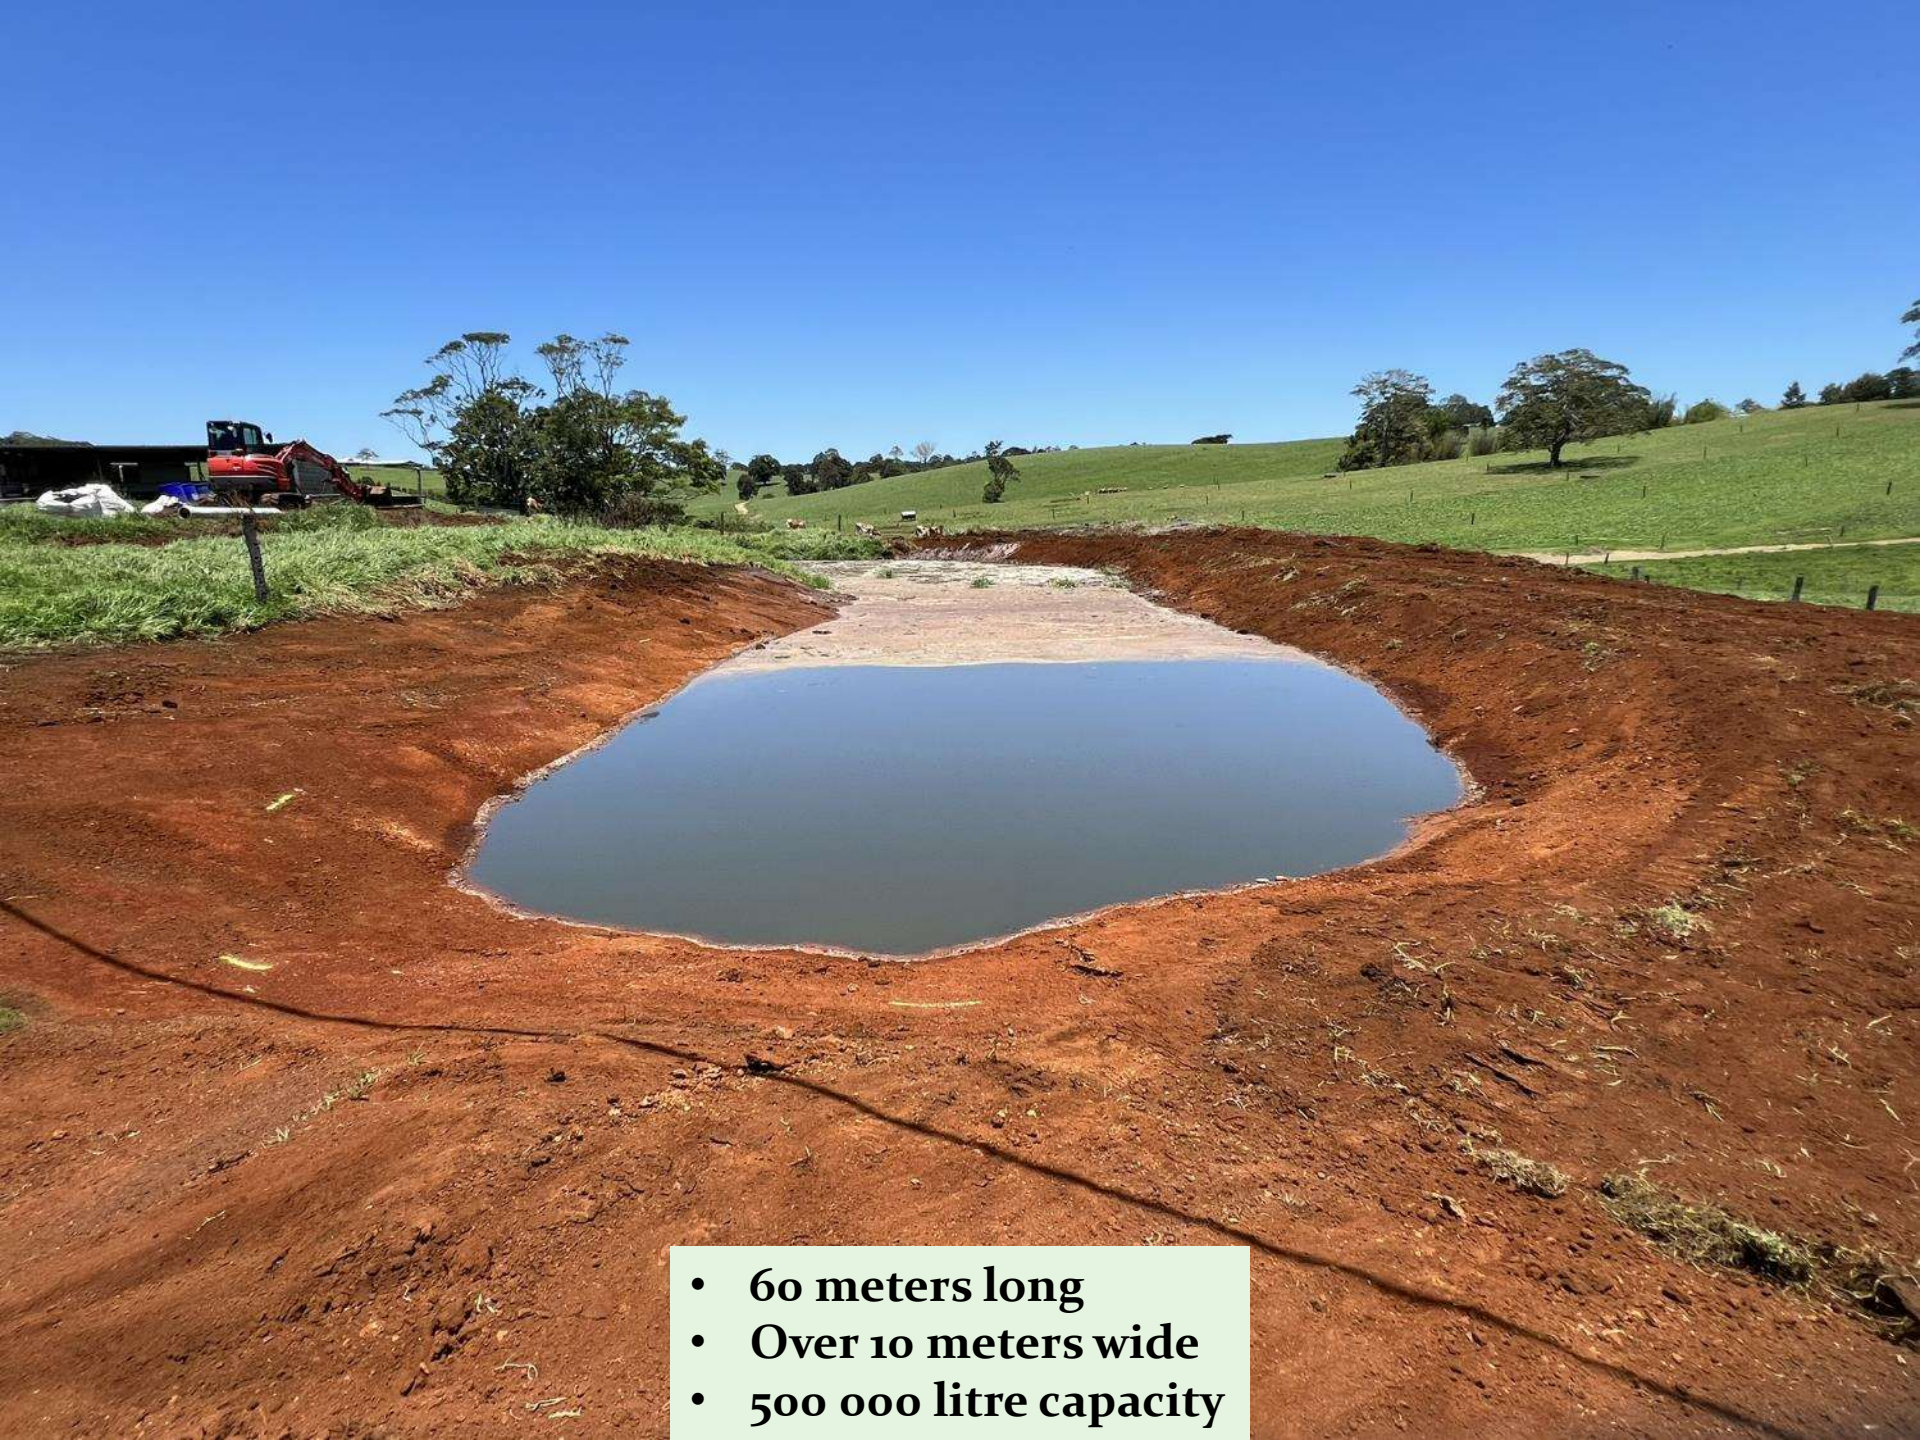
- 60 meters long
- Over 10 meters wide
- 500 000 litre capacity

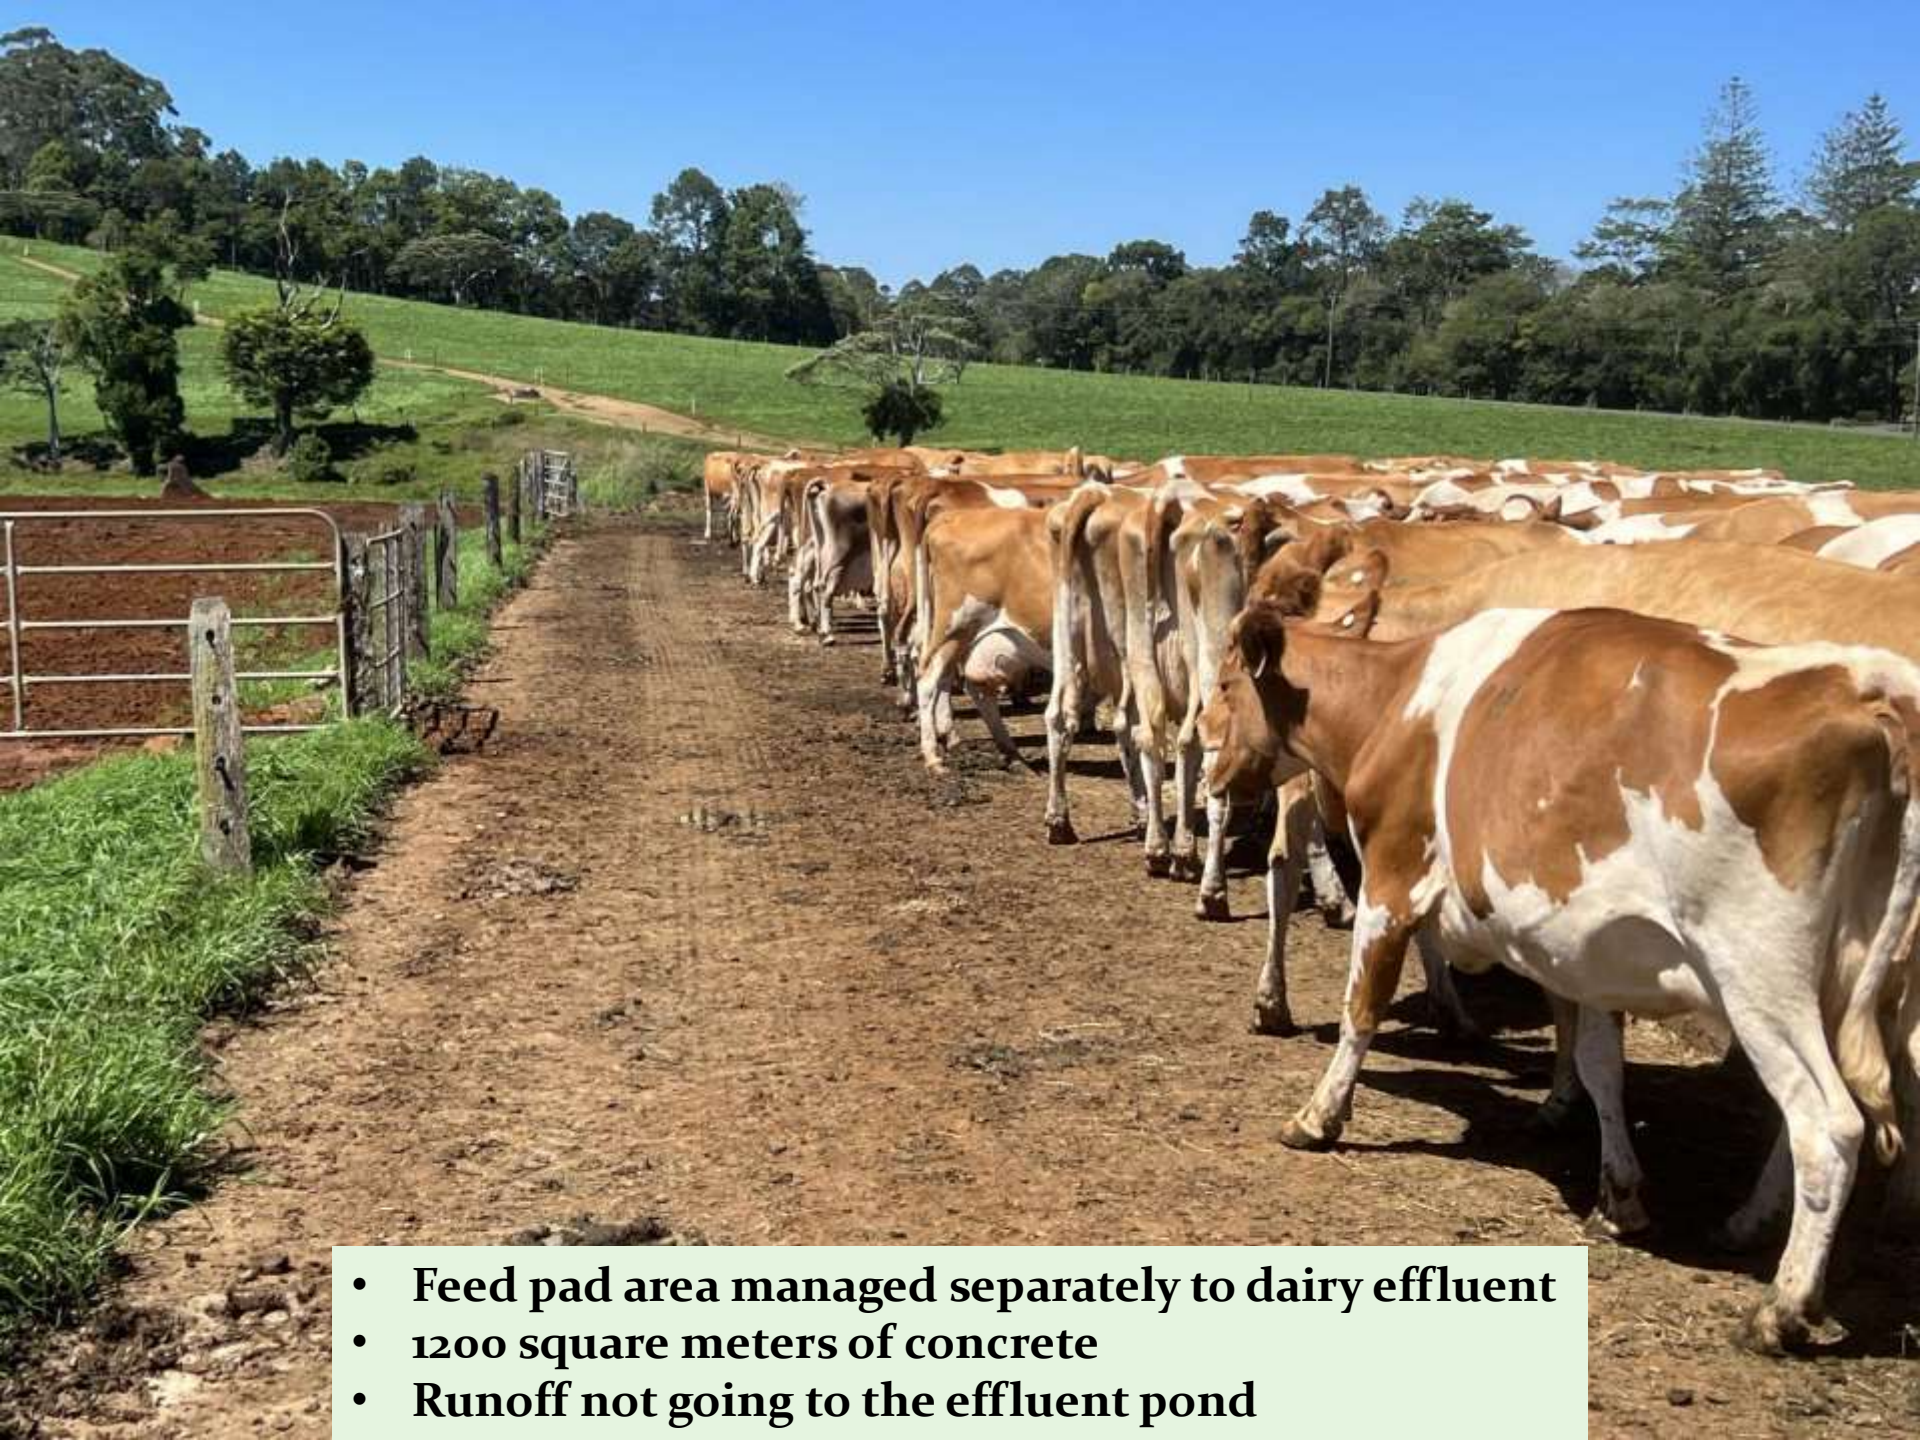
- Feed pad area managed separately to dairy effluent
- 1200 square meters of concrete
- Runoff not going to the effluent pond

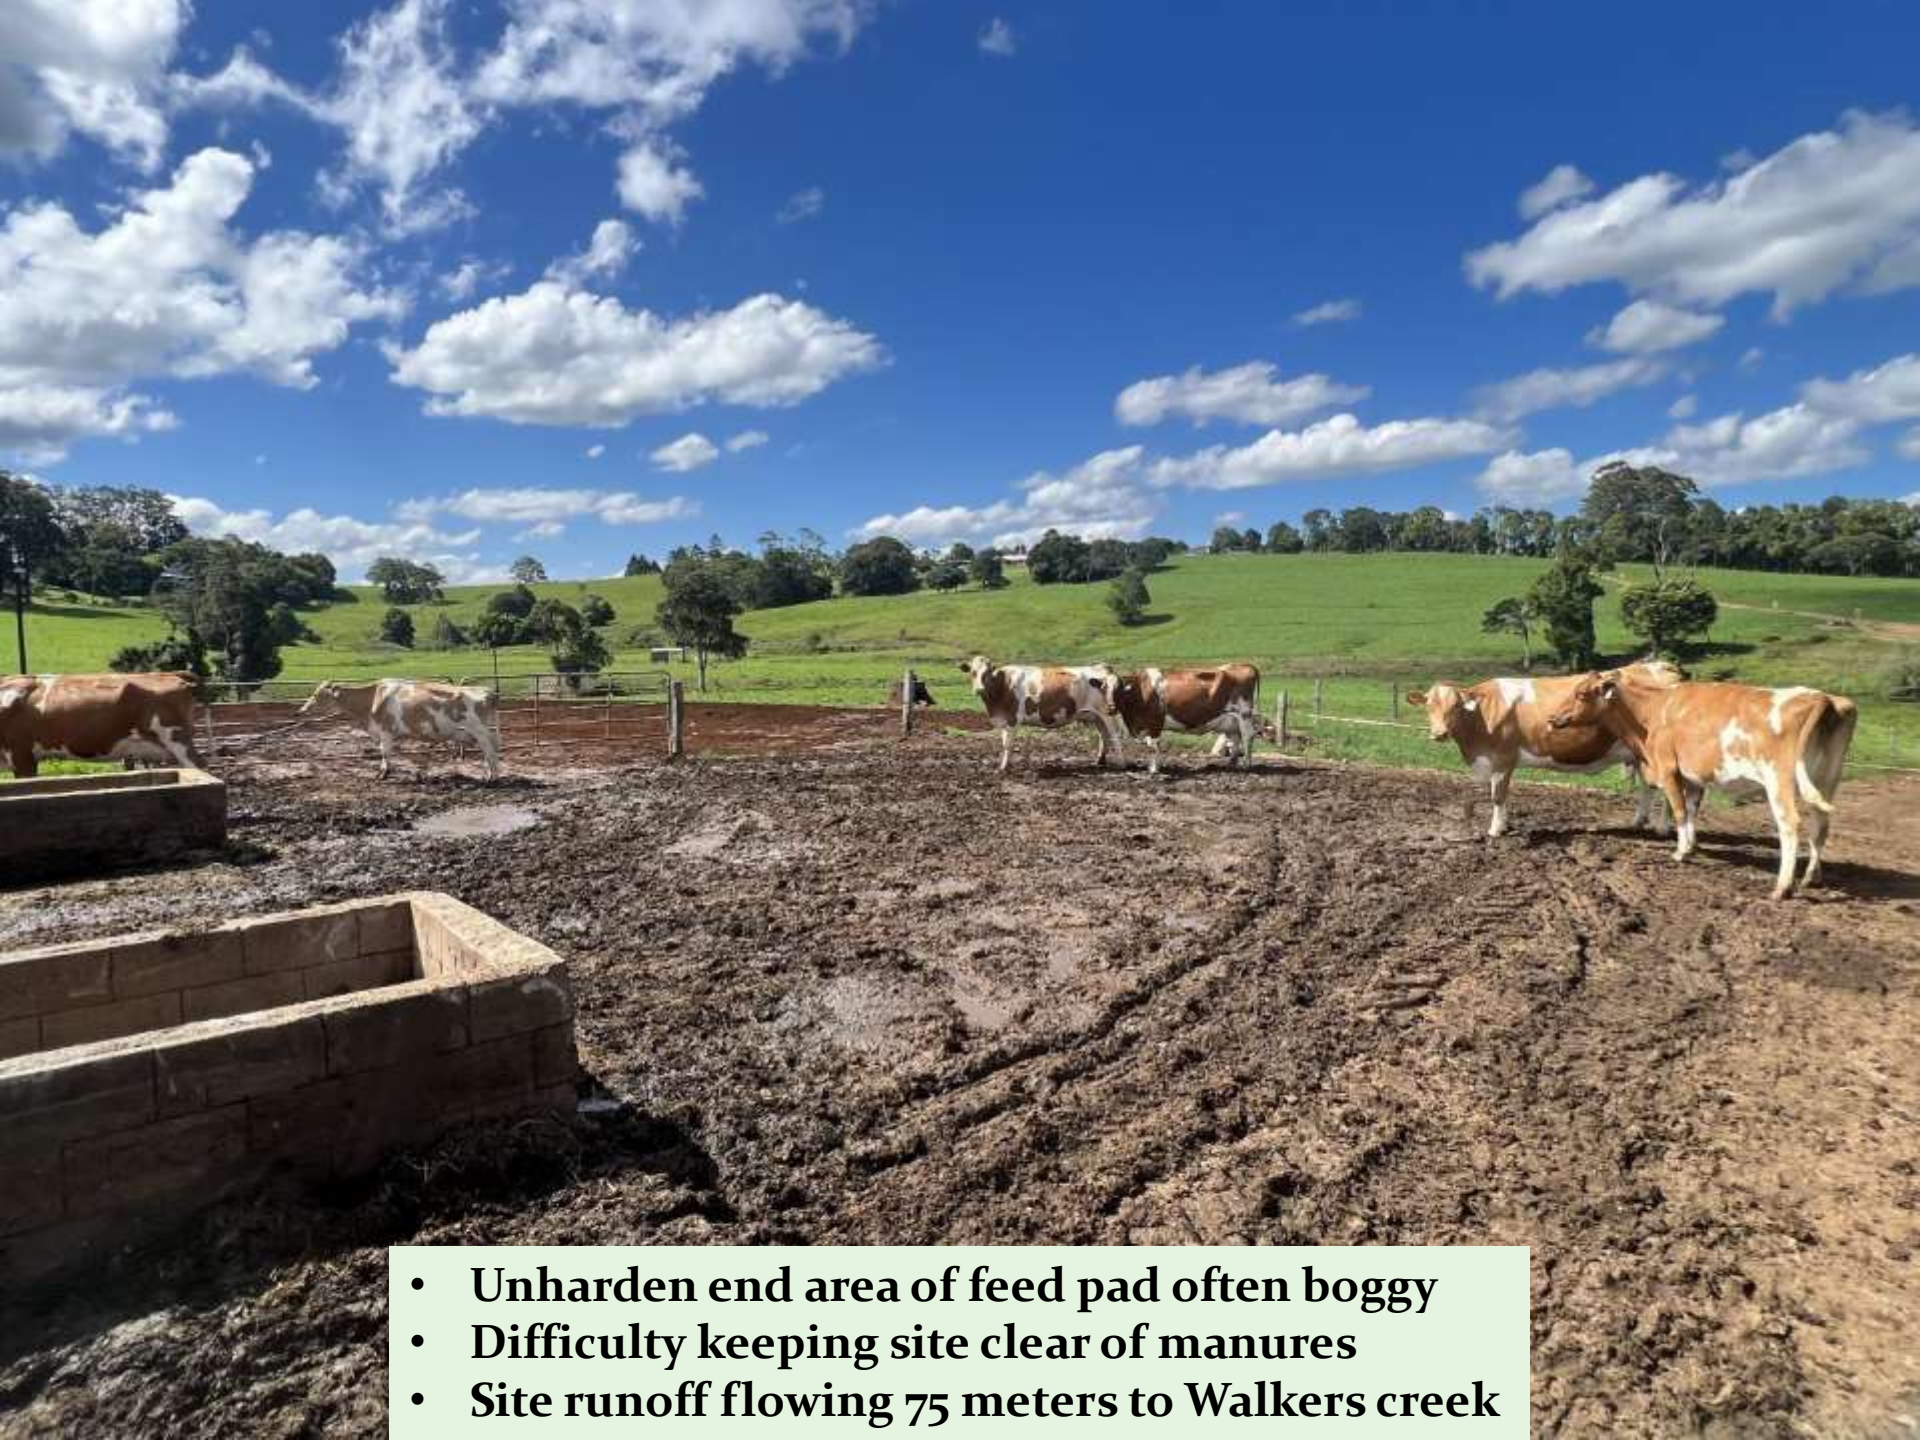
- Unharden end area of feed pad often boggy
- Difficulty keeping site clear of manures
- Site runoff flowing 75 meters to Walkers creek

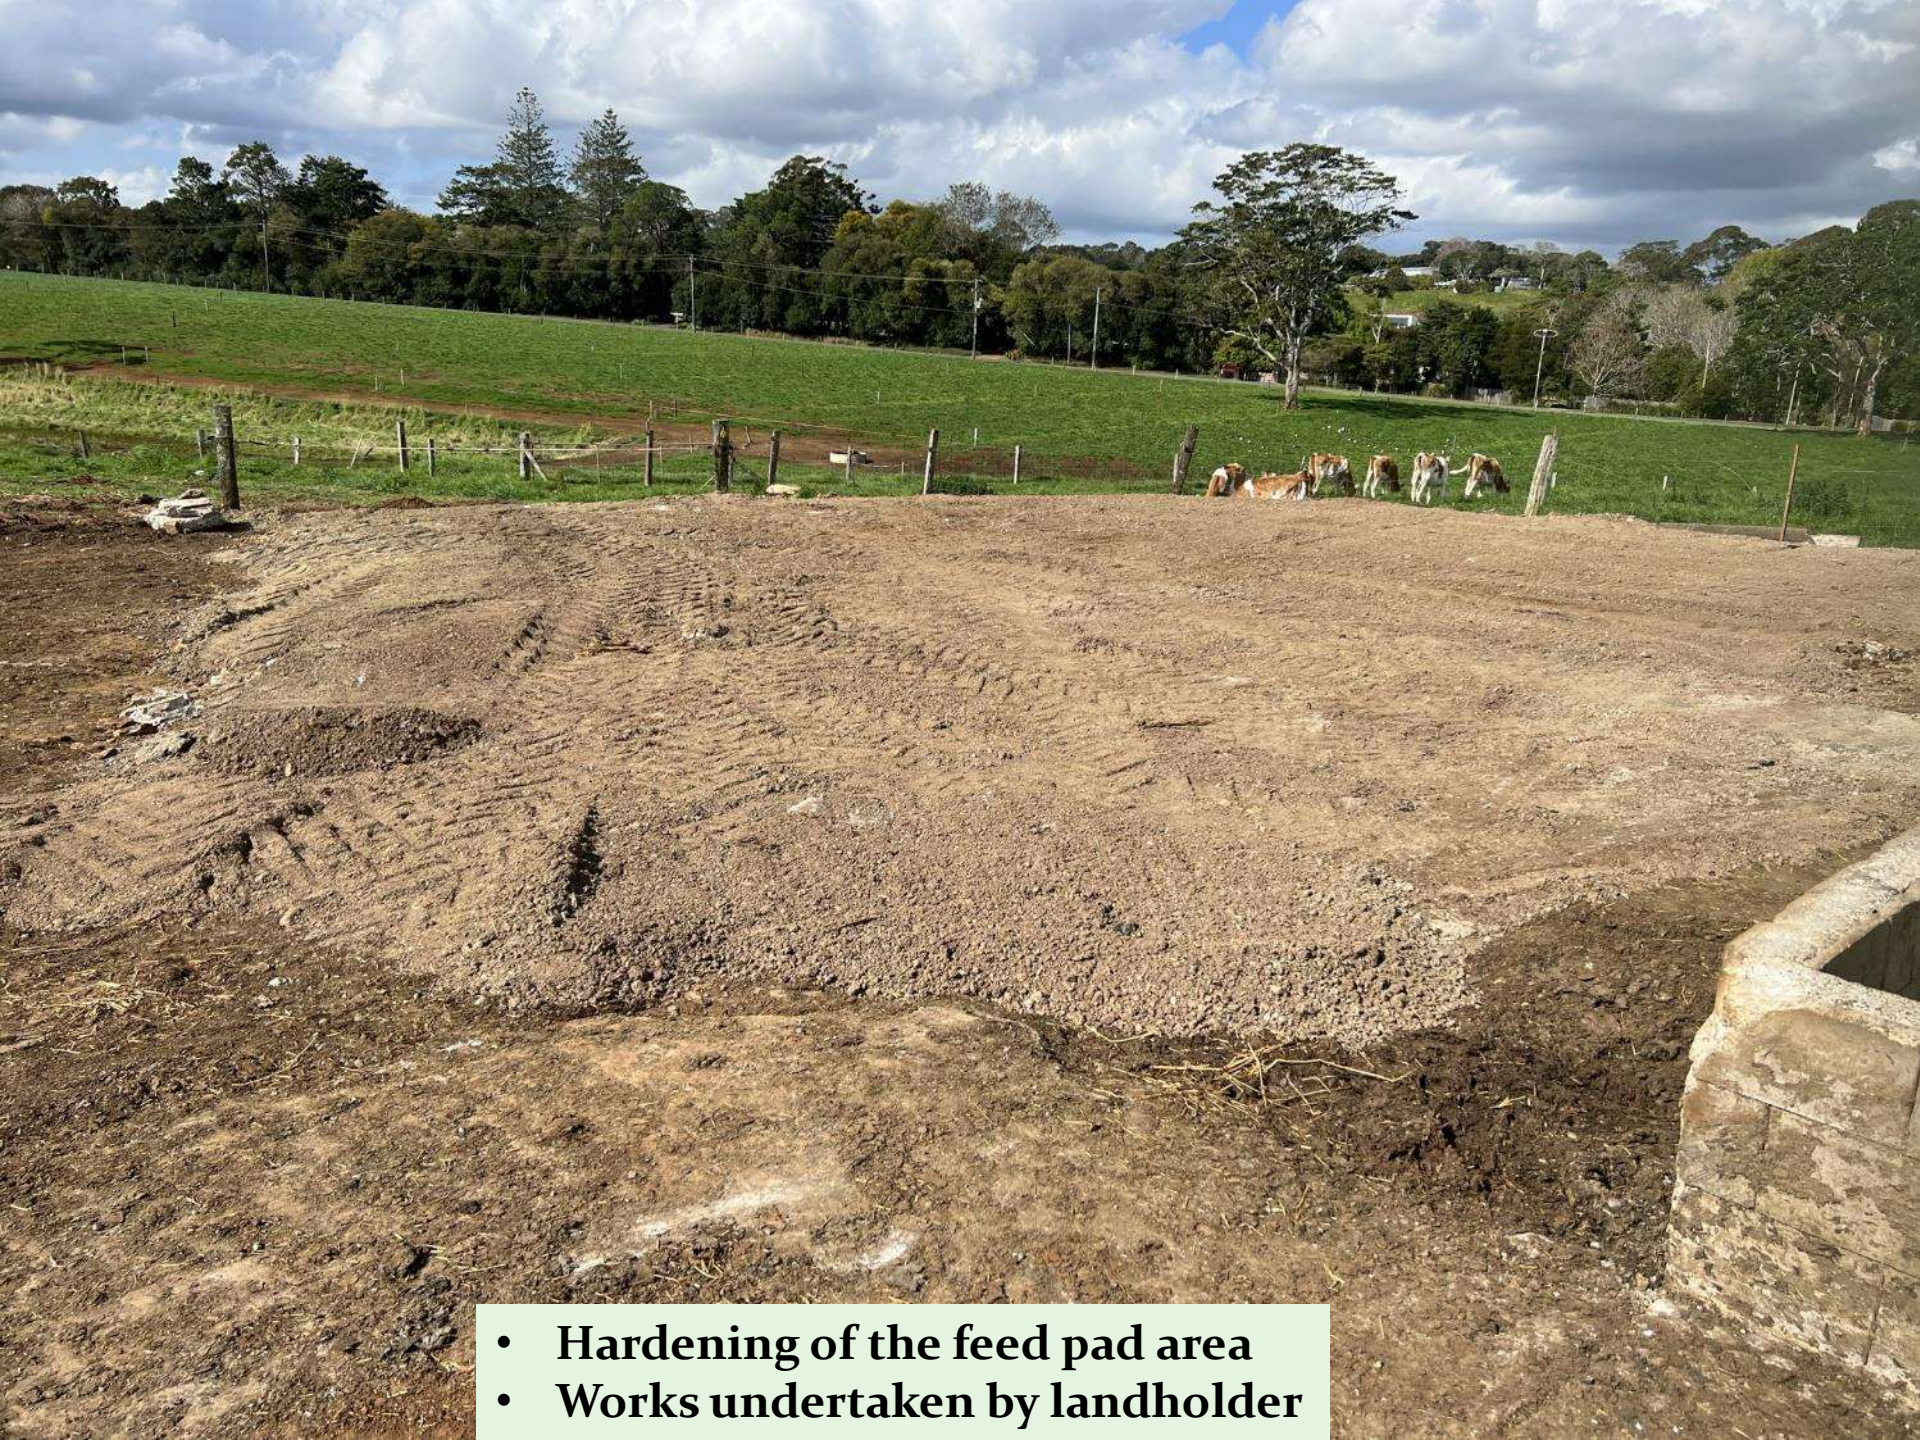
- **Hardening of the feed pad area**
- **Works undertaken by landholder**

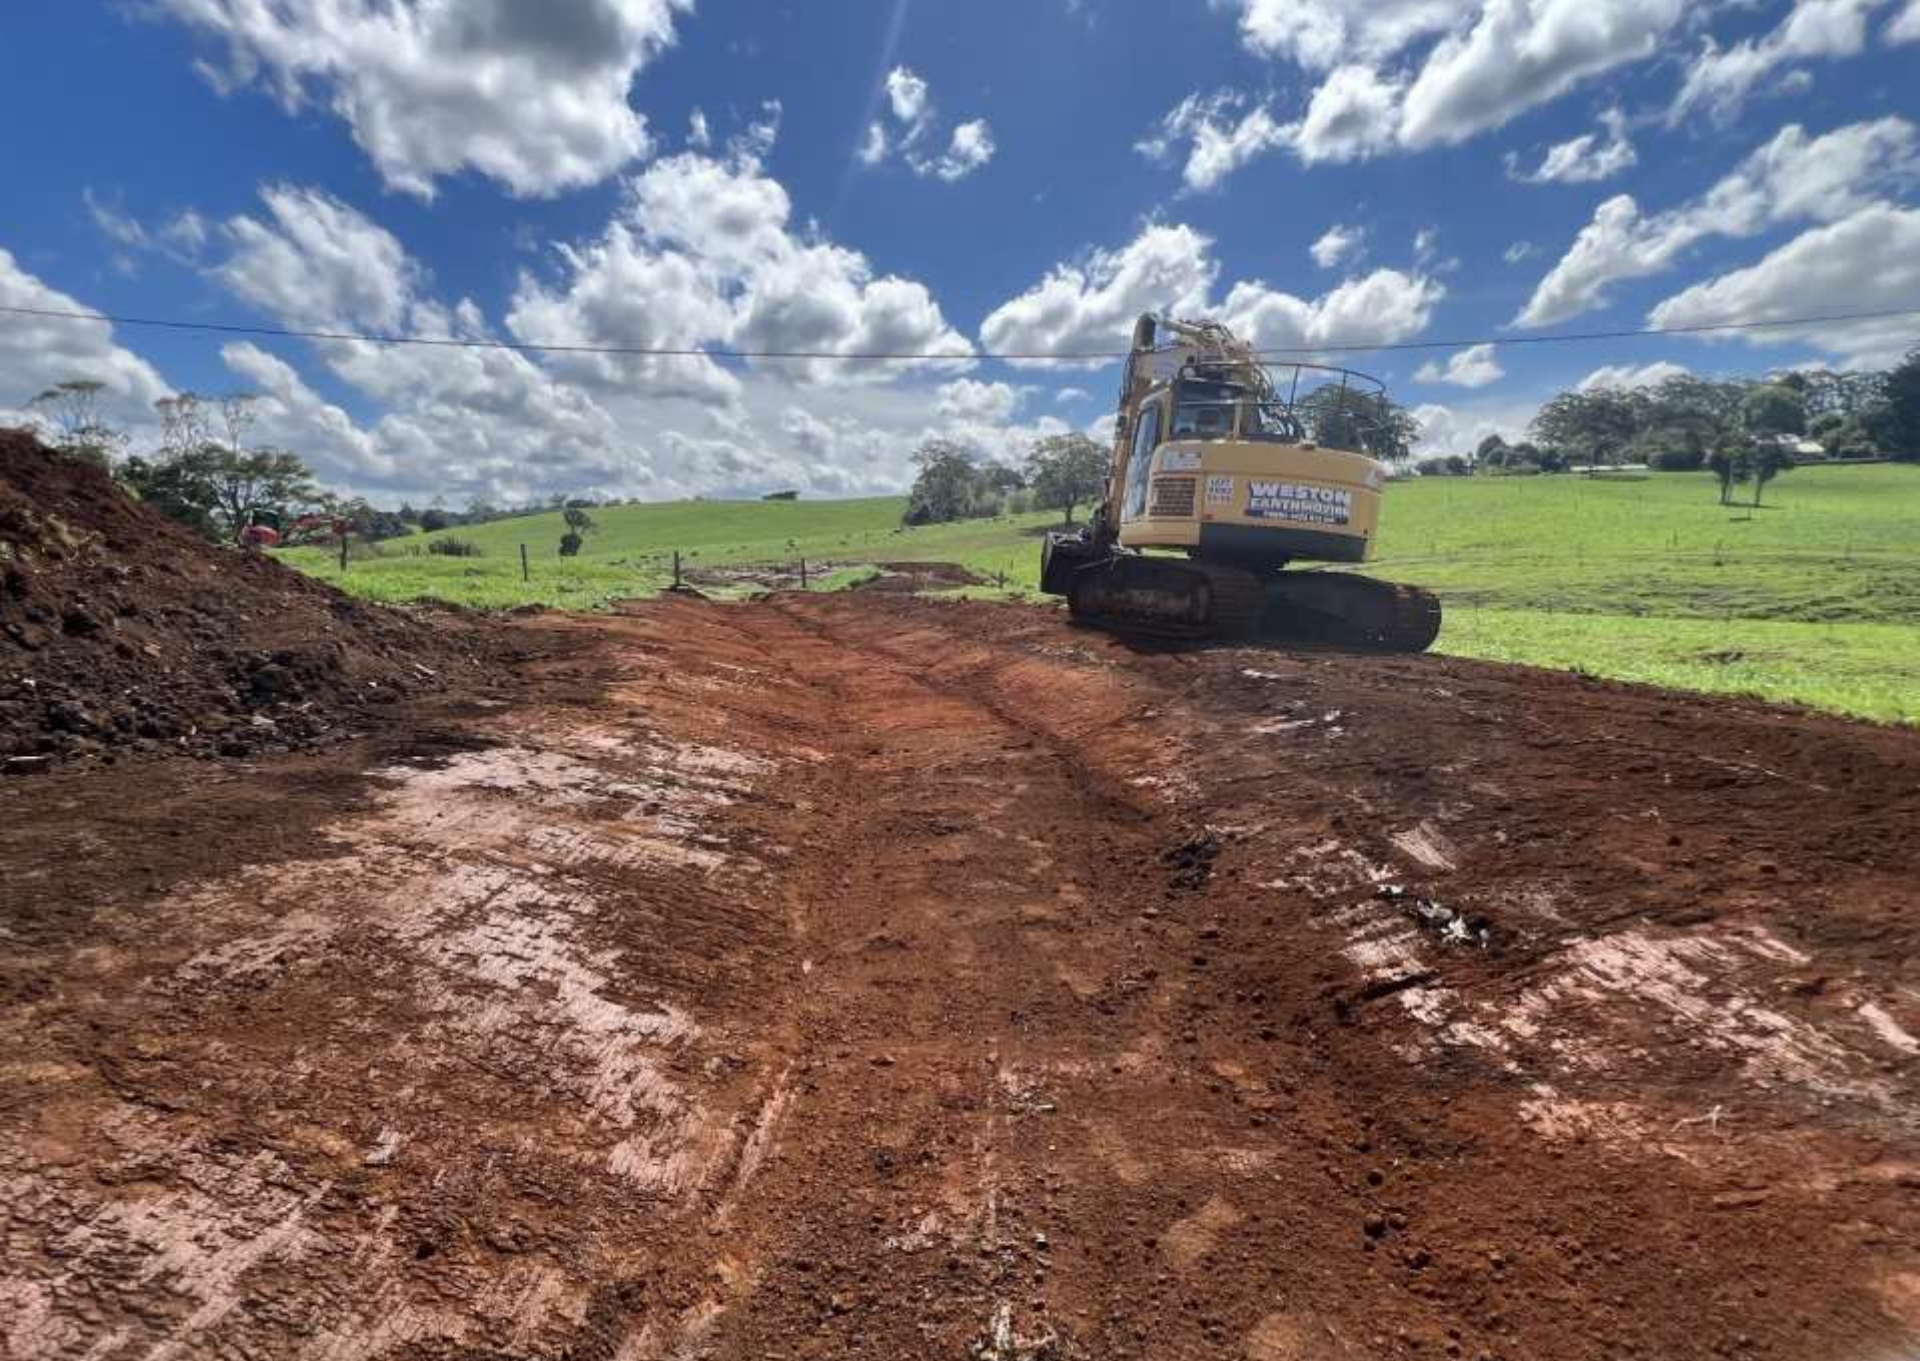
• 50 meter contour drain connecting feed pad to the effluent pond

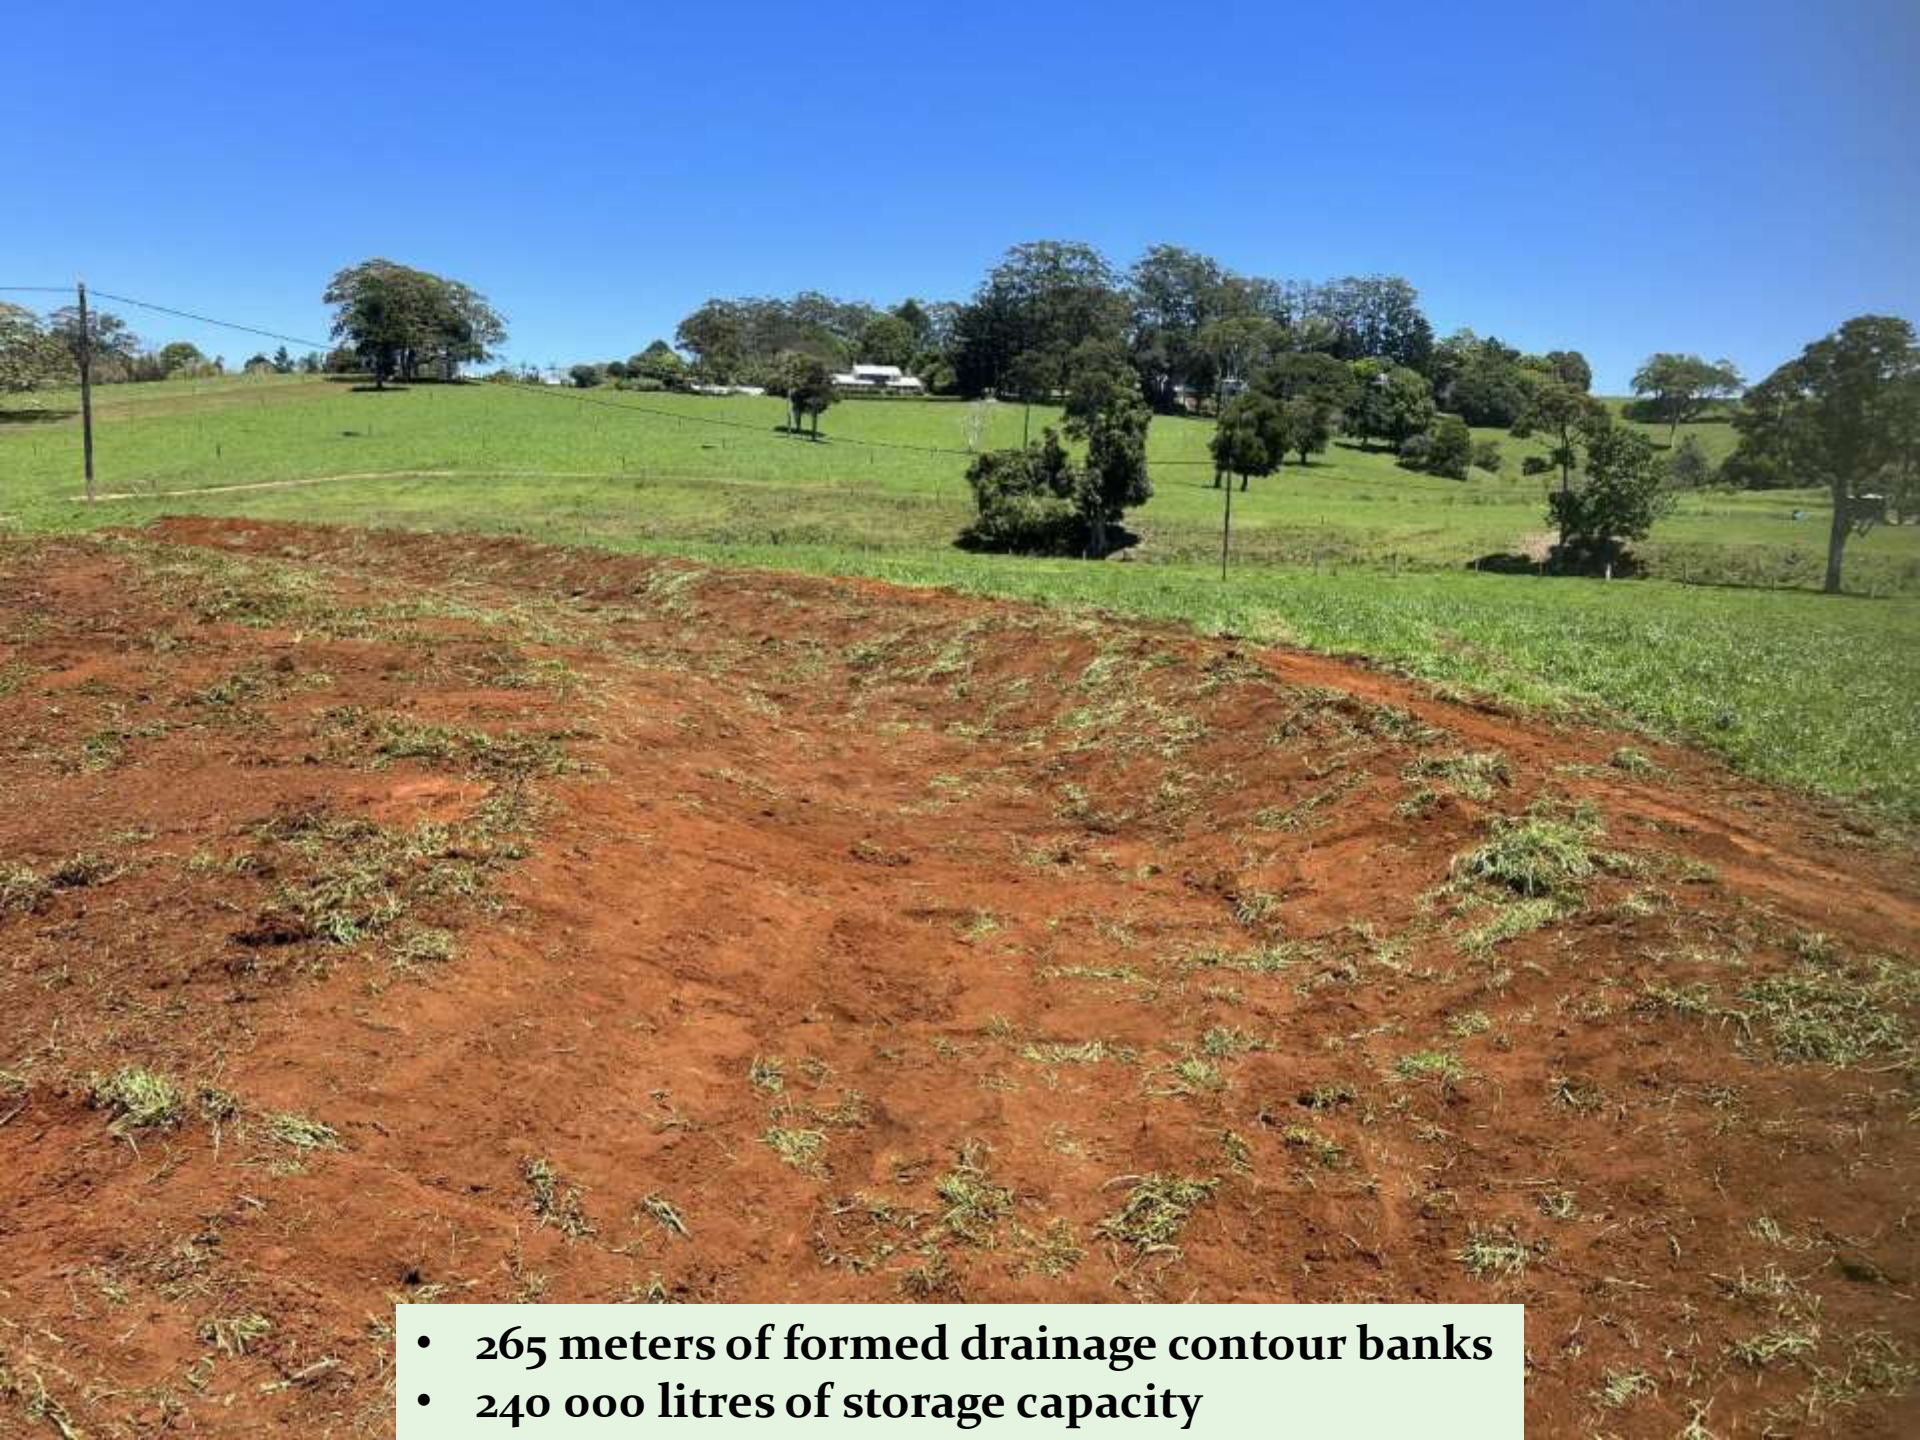
- 265 meters of formed drainage contour banks
- 240 000 litres of storage capacity
