Riparian Condition Improvement, Agricultural Practice Improvement Report 14th December 2023

Lake
Baroon
Catchment
Care
Group

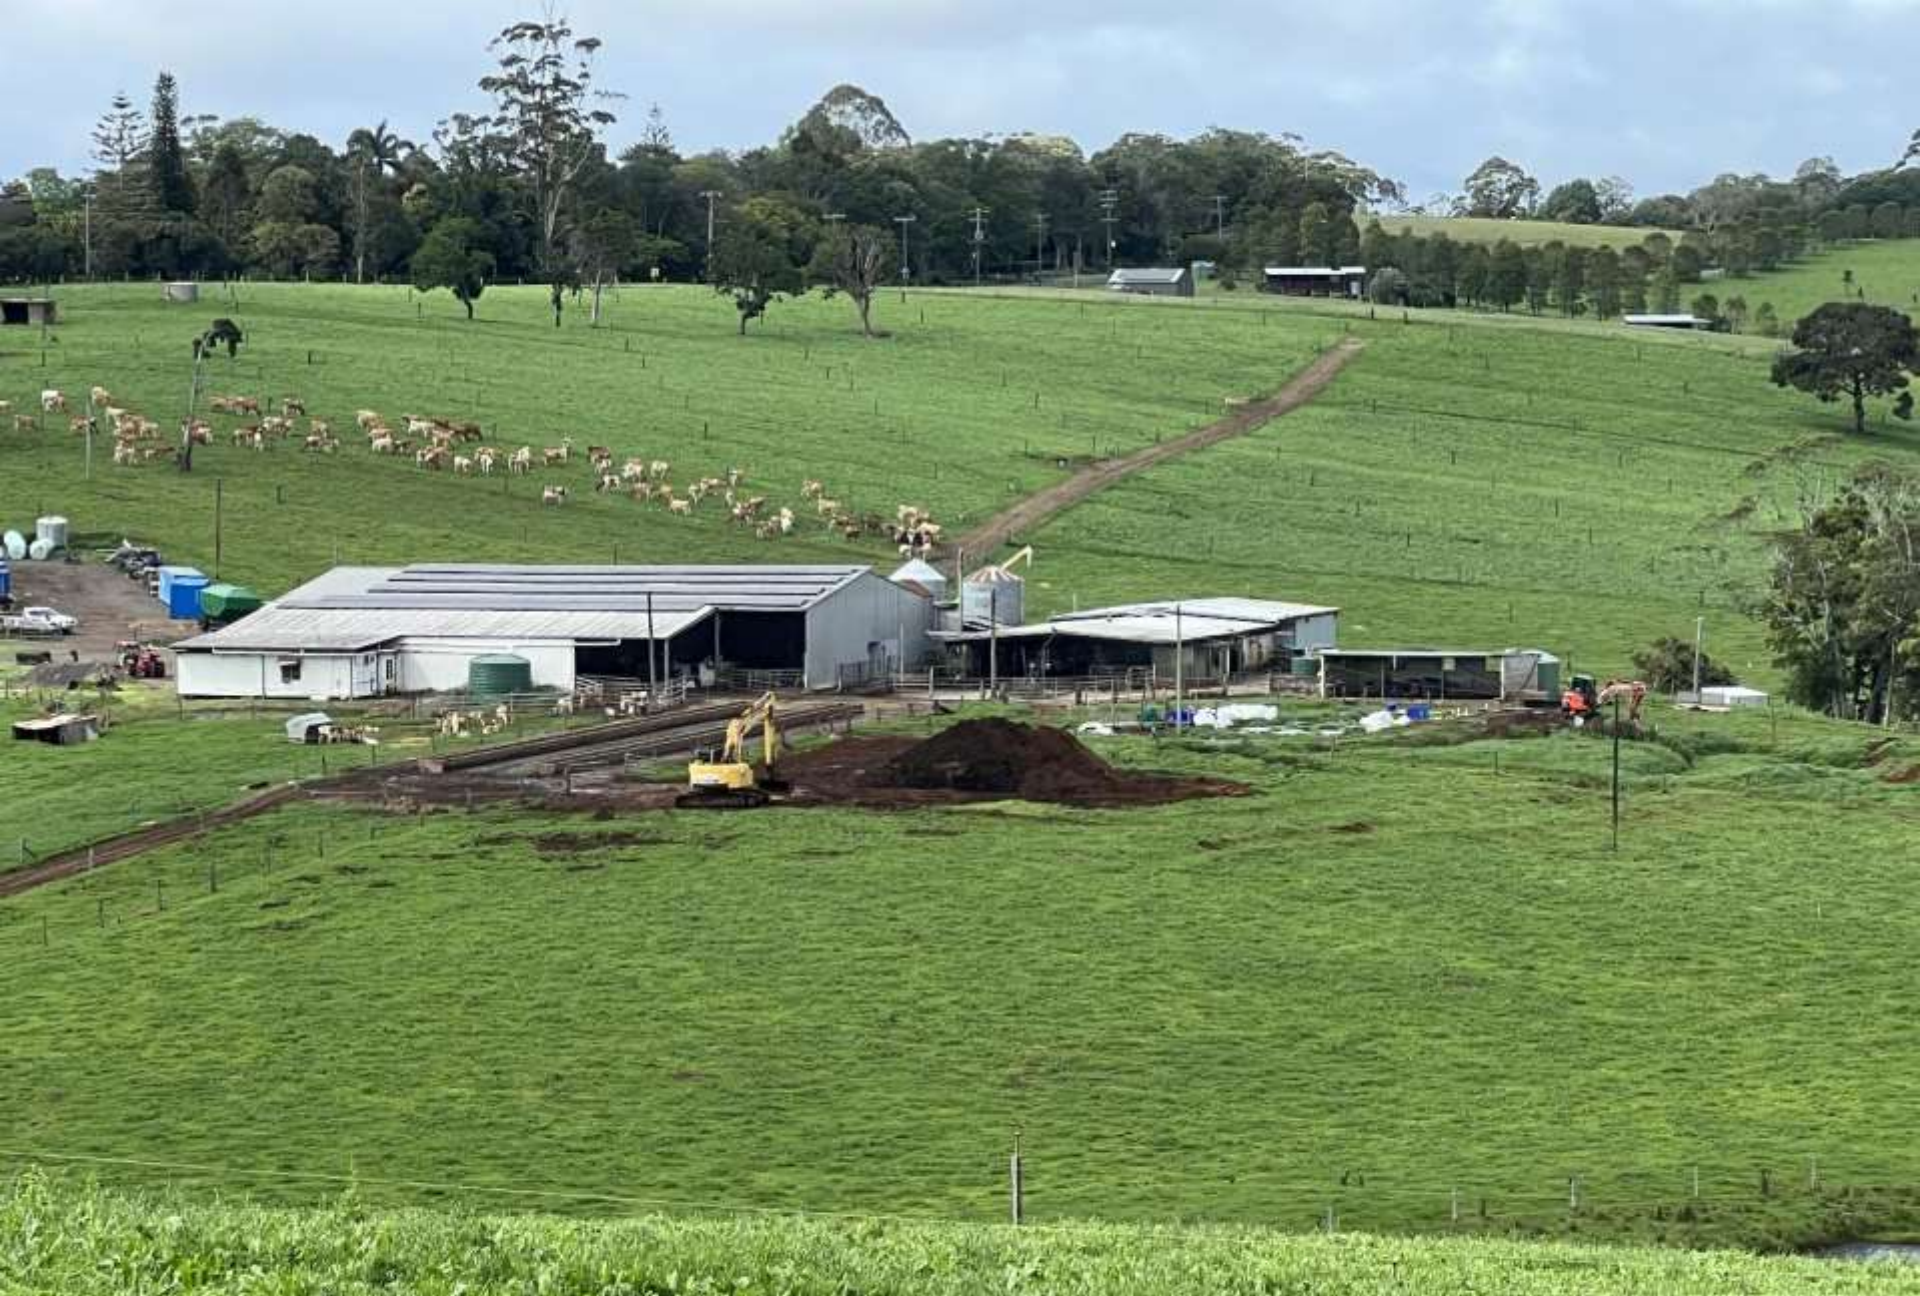
- Previous effluent system had a holding capacity of 140 000 litres
- Pond overflow travelled 170 meters to enter Walkers Creek

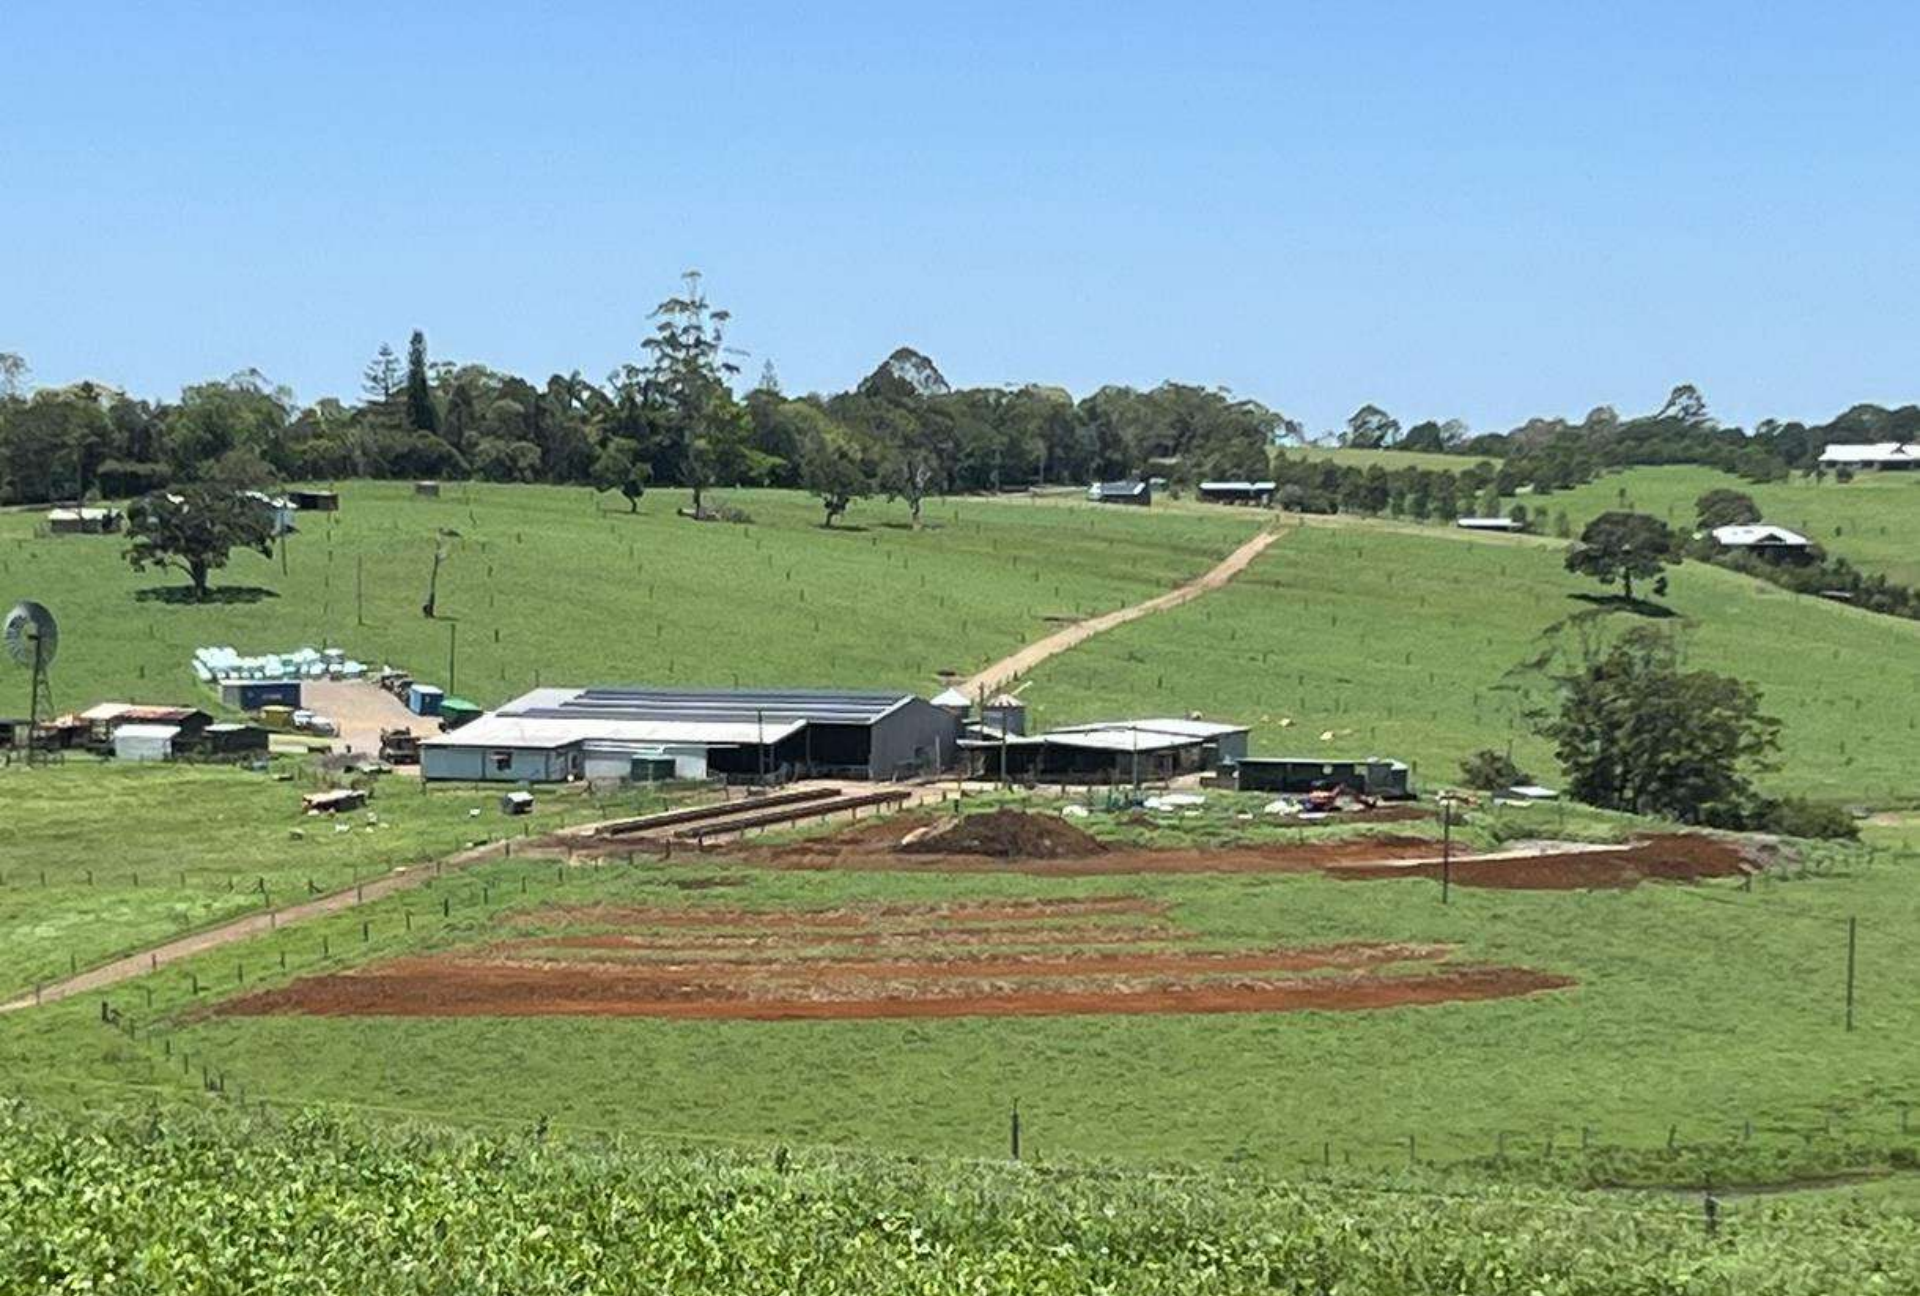
- **New effluent system now has a total holding capacity of 740 000 litres**
- **Pond overflow now travels 345 Meters to reach Walkers Creek**

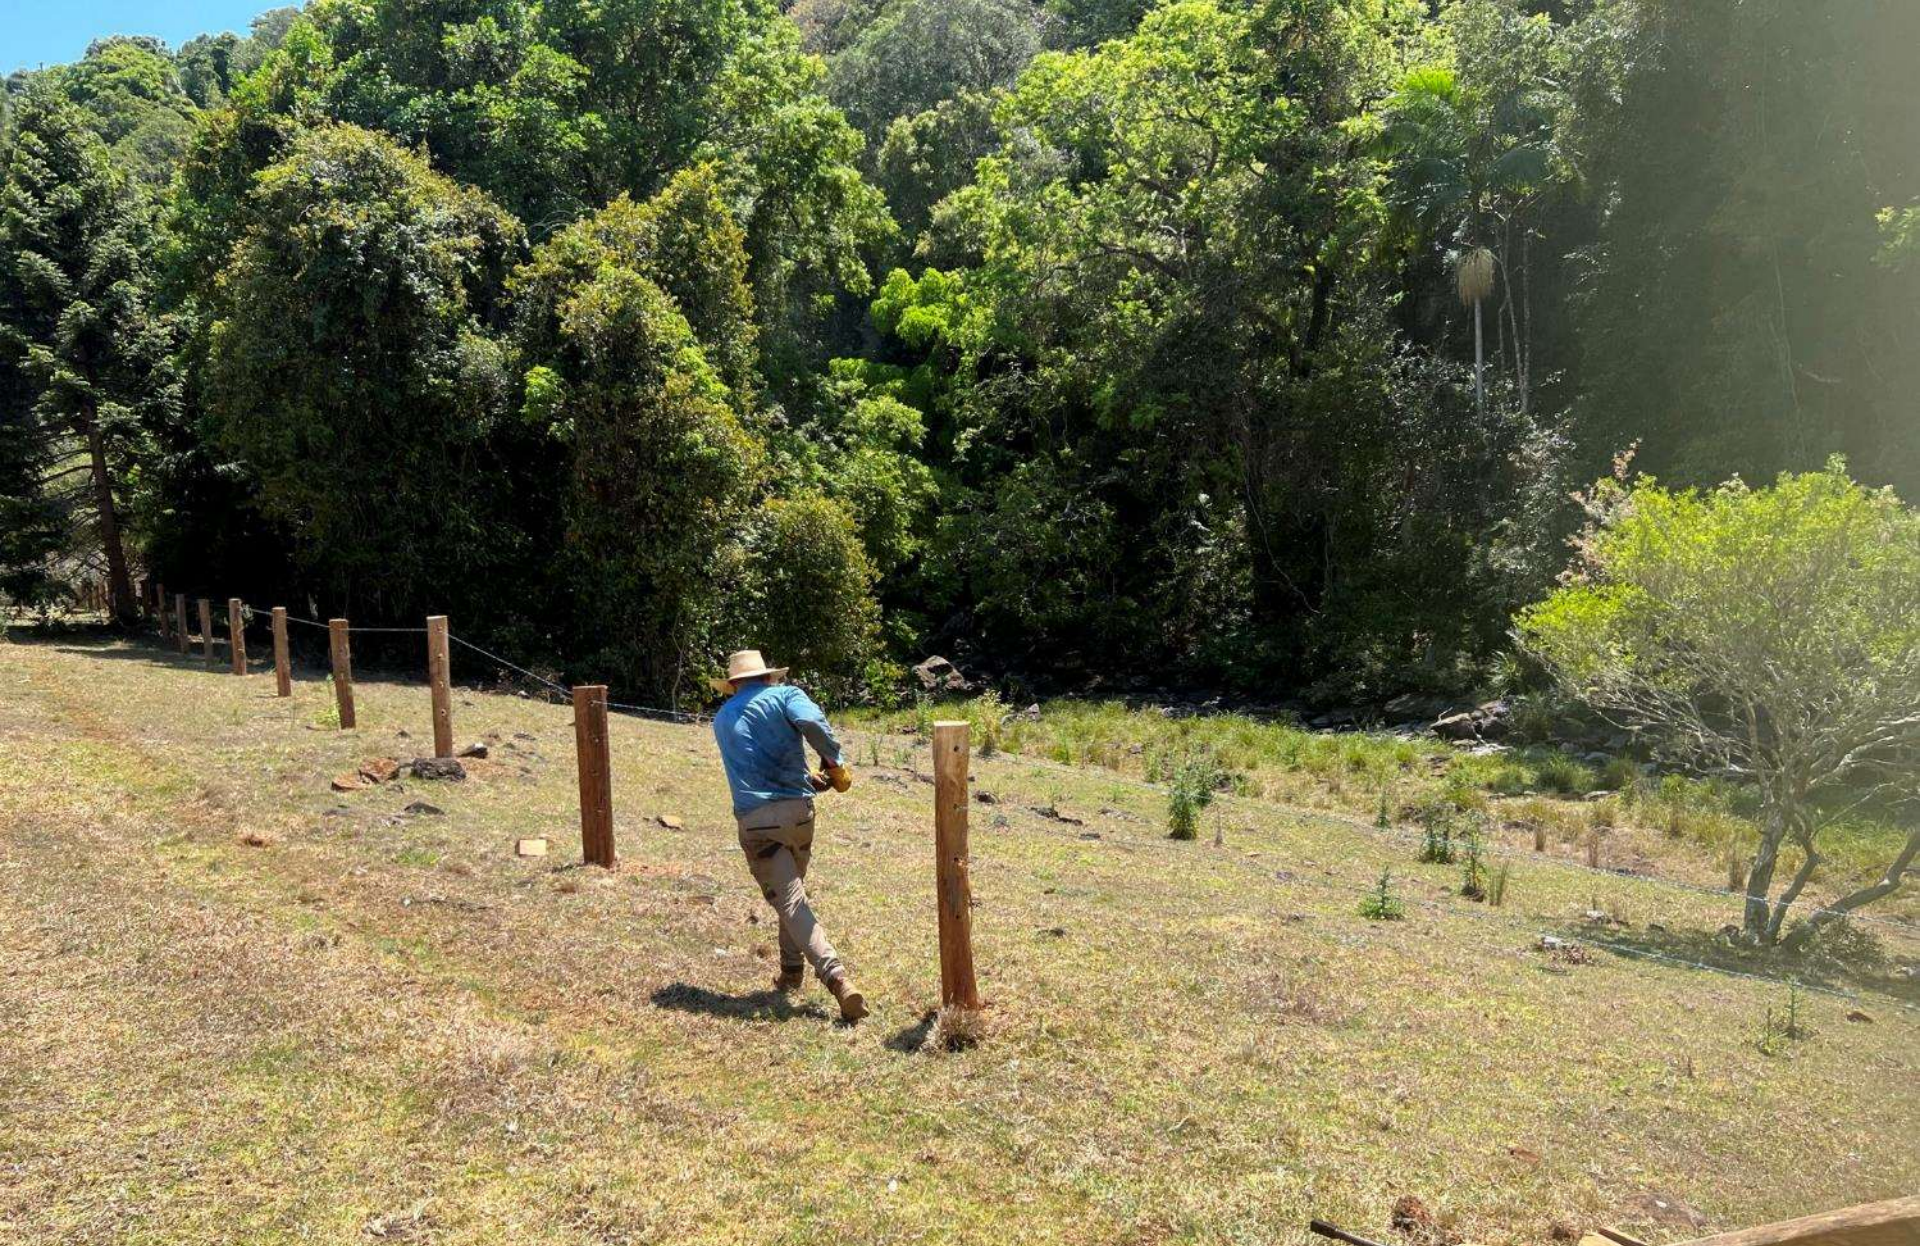
- Riparian fencing commenced along Obi Obi Creek
- Stage two of the Obi Obi Project
- Tim Davies TAG Rural Fencing

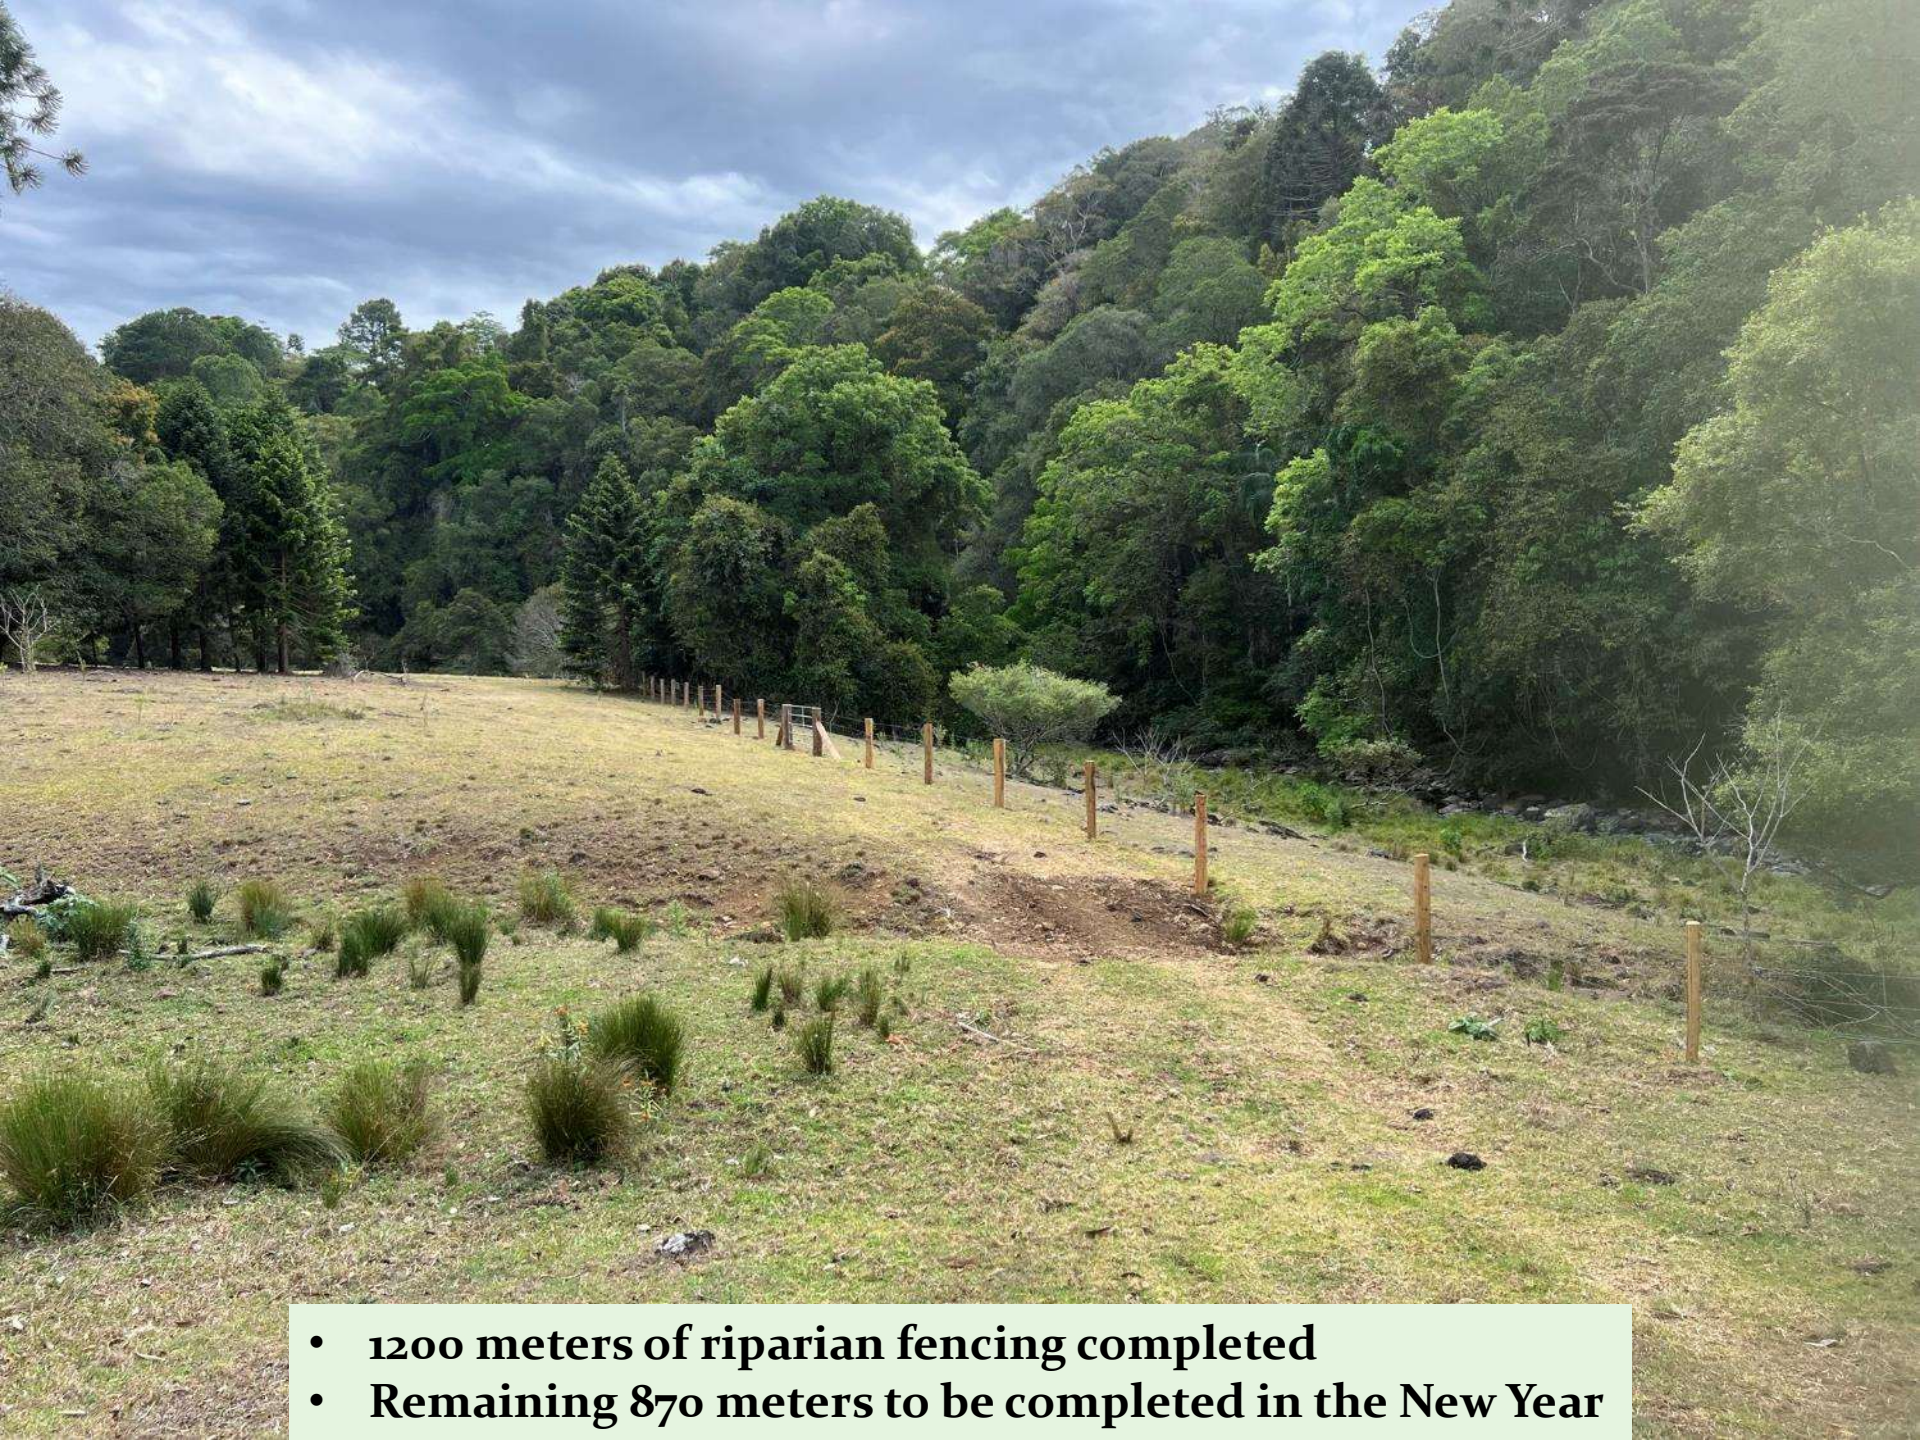
- 1200 meters of riparian fencing completed
- Remaining 870 meters to be completed in the New Year

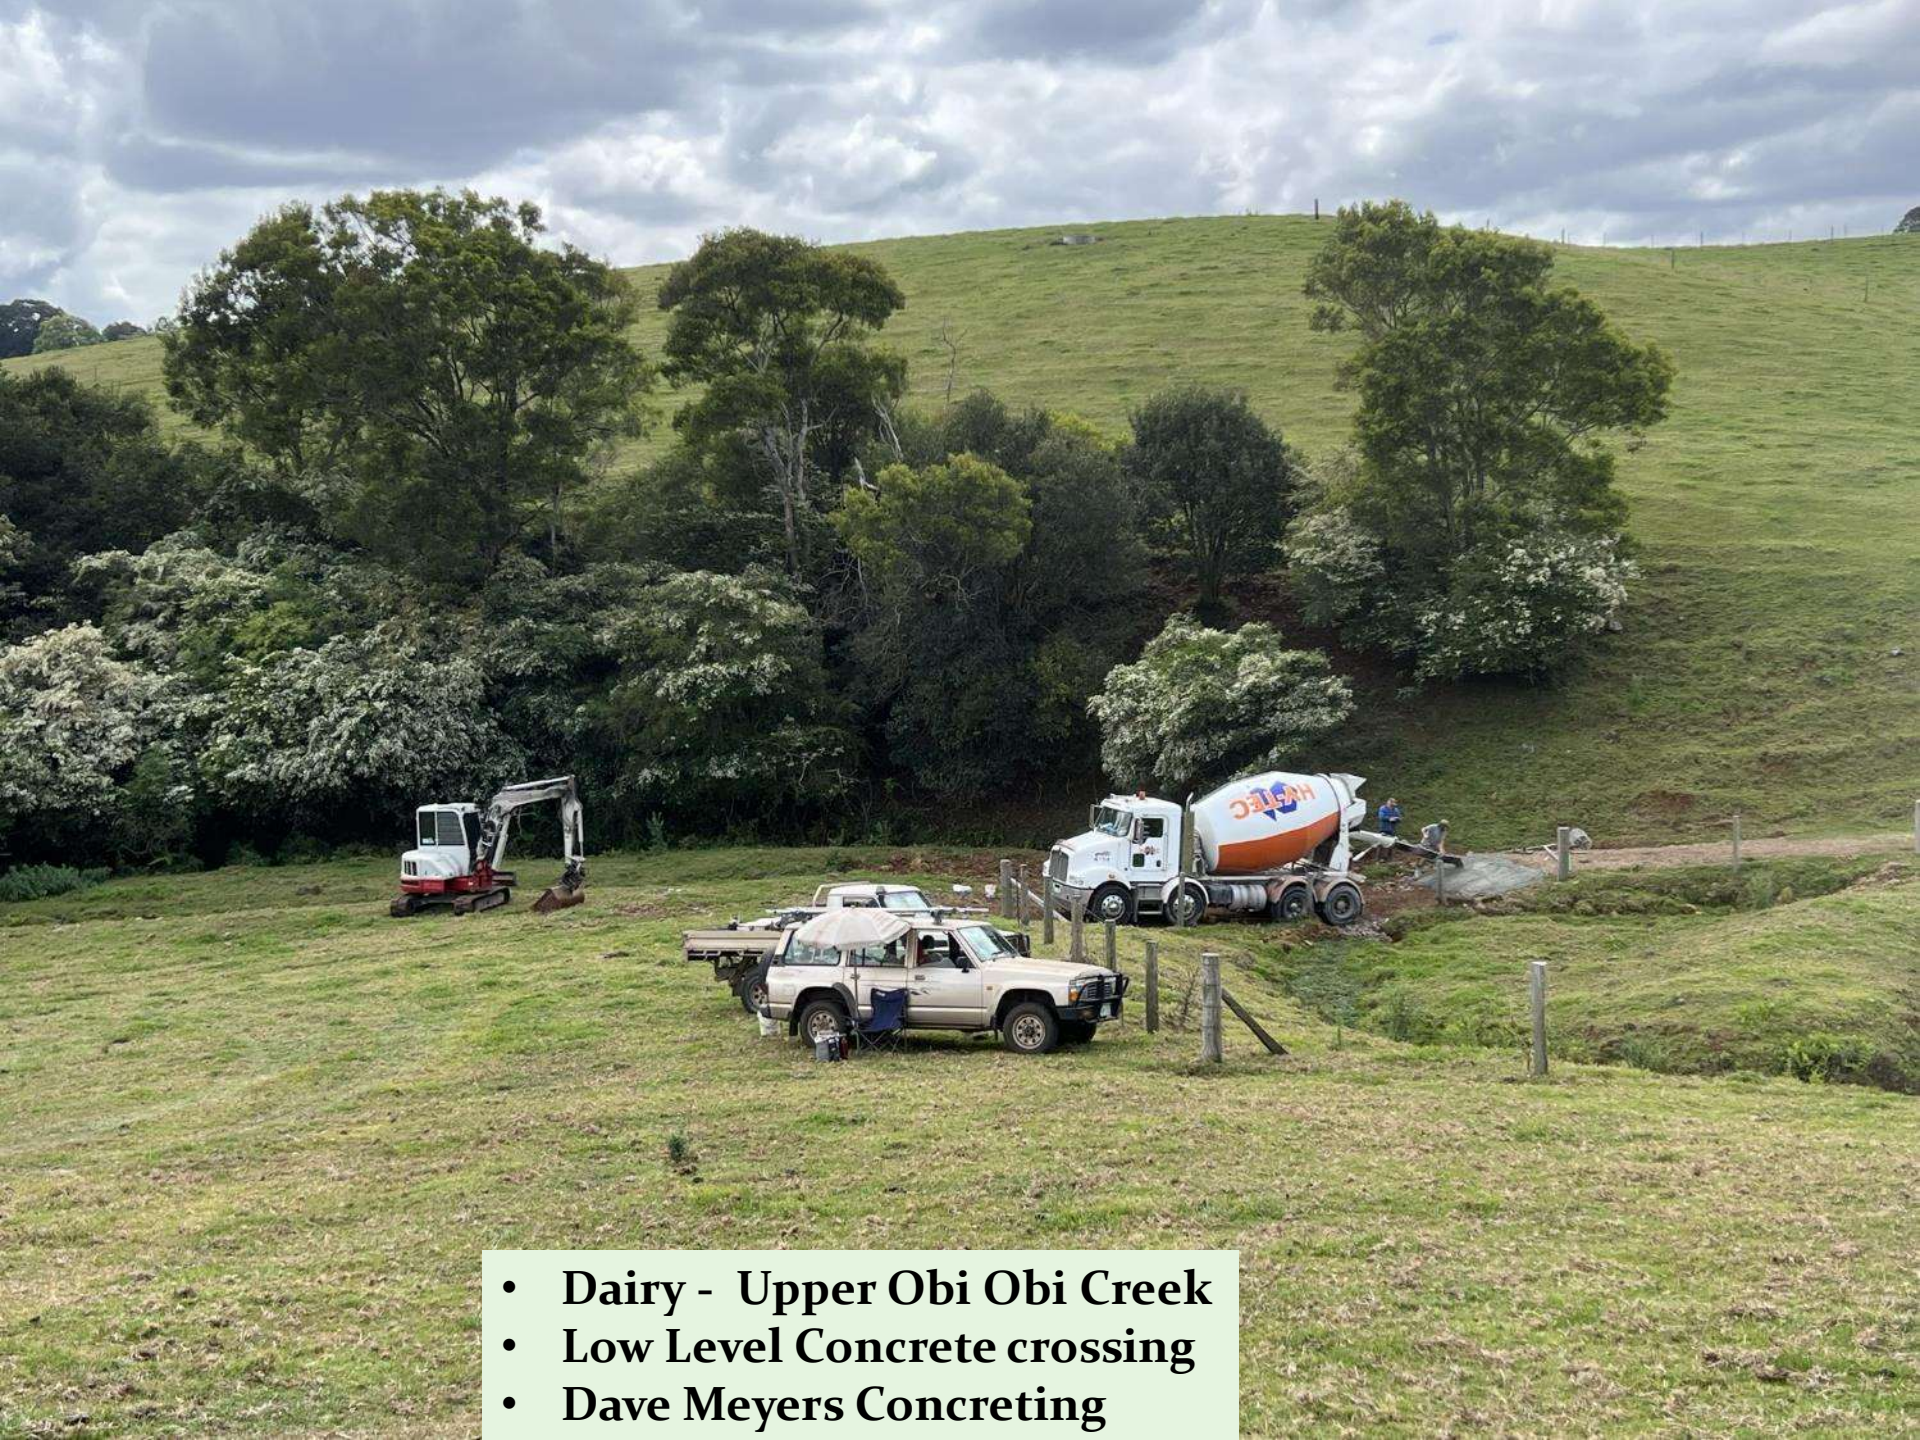
- Dairy - Upper Obi Obi Creek
- Low Level Concrete crossing
- Dave Meyers Concreting

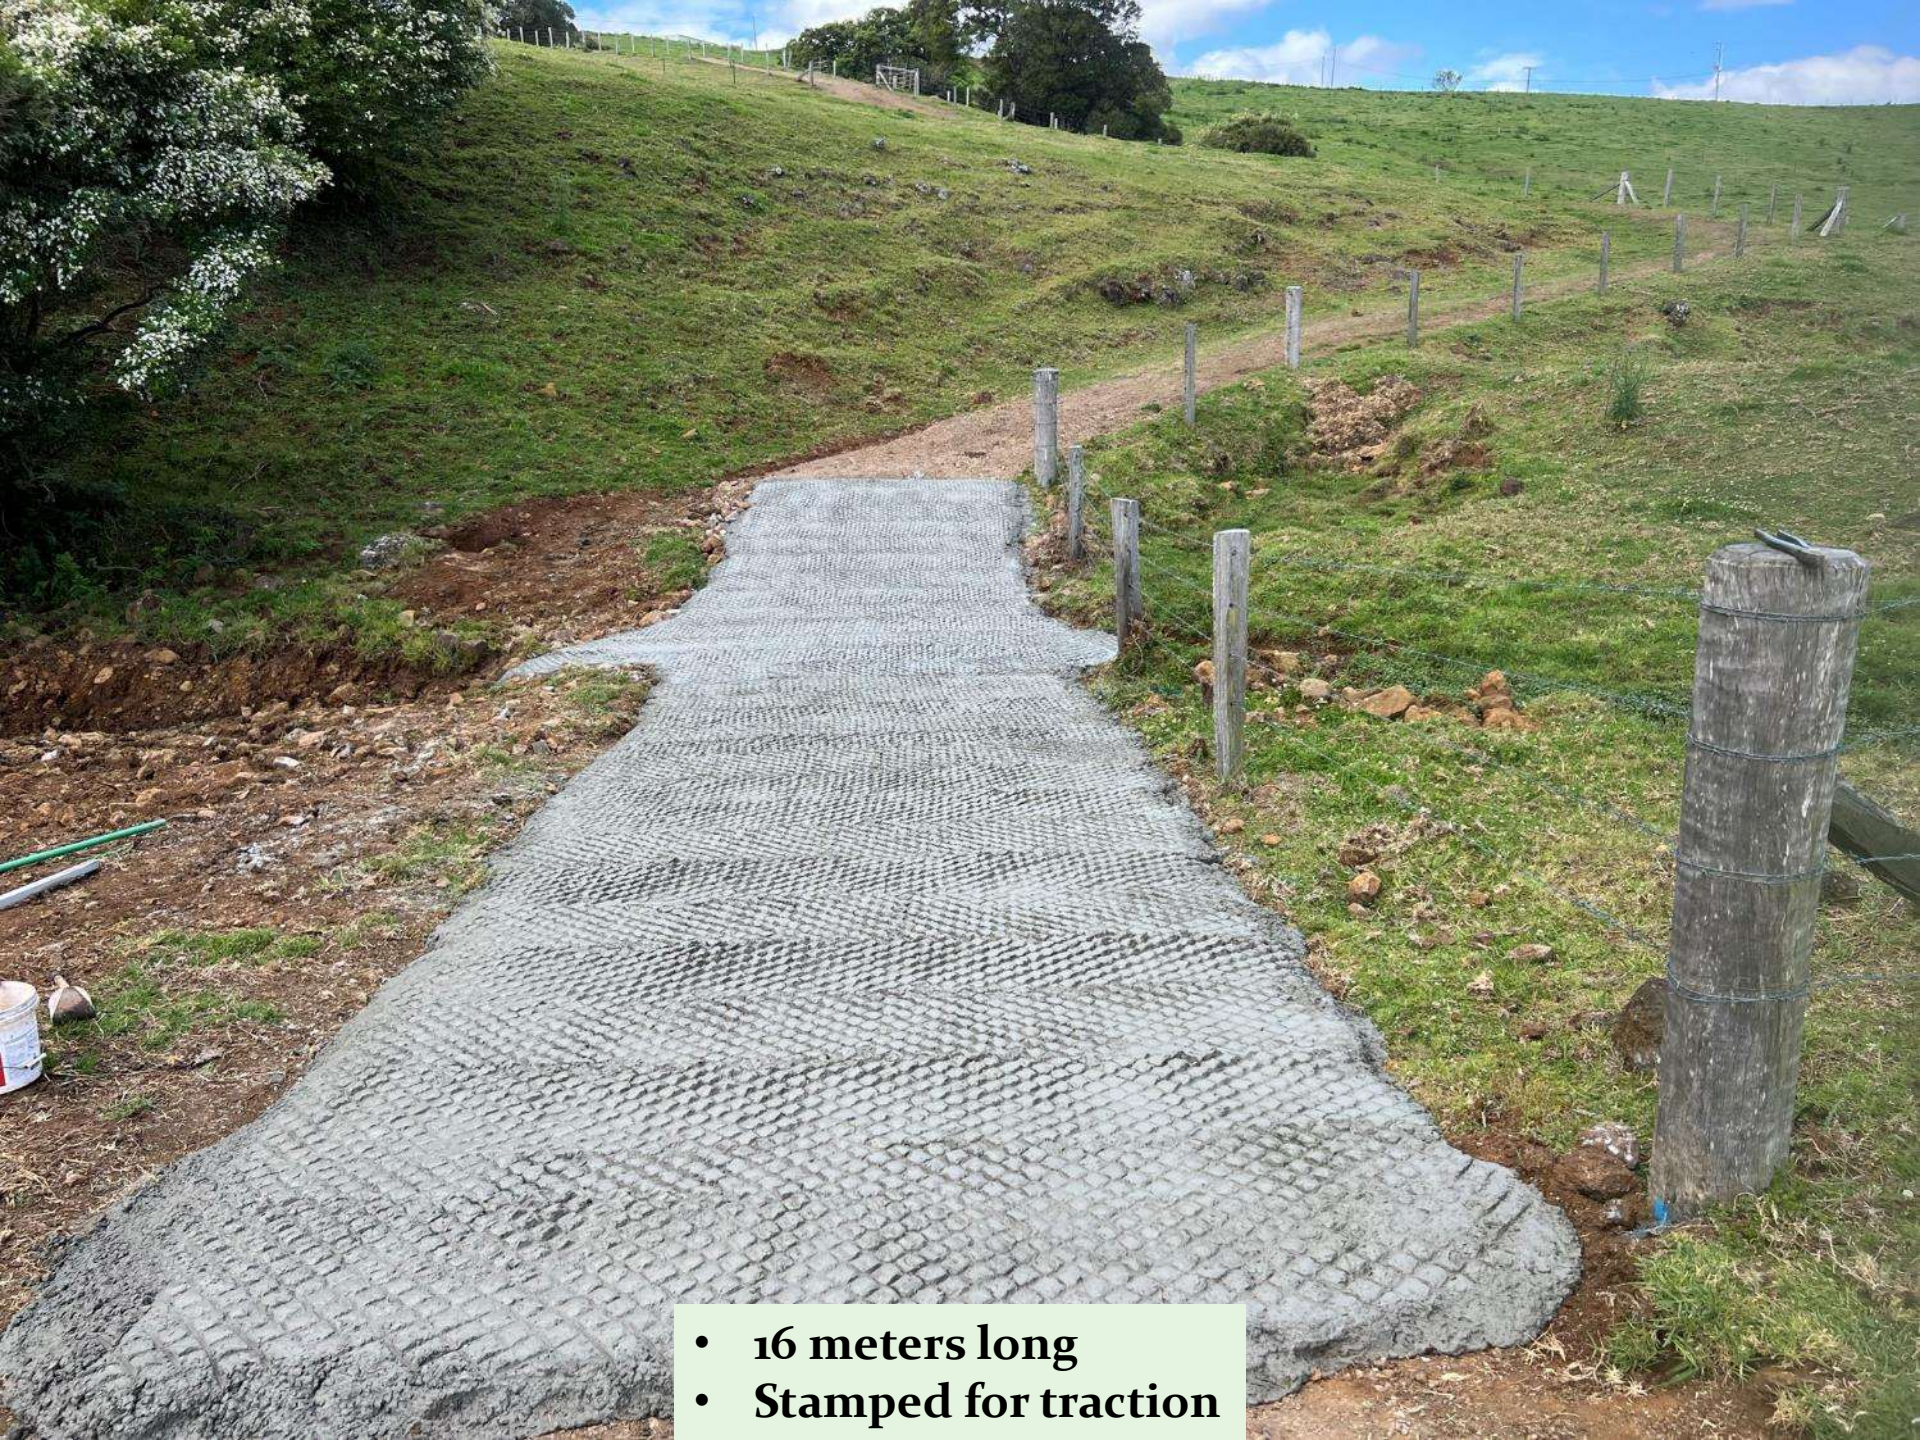
- 16 meters long
- Stamped for traction

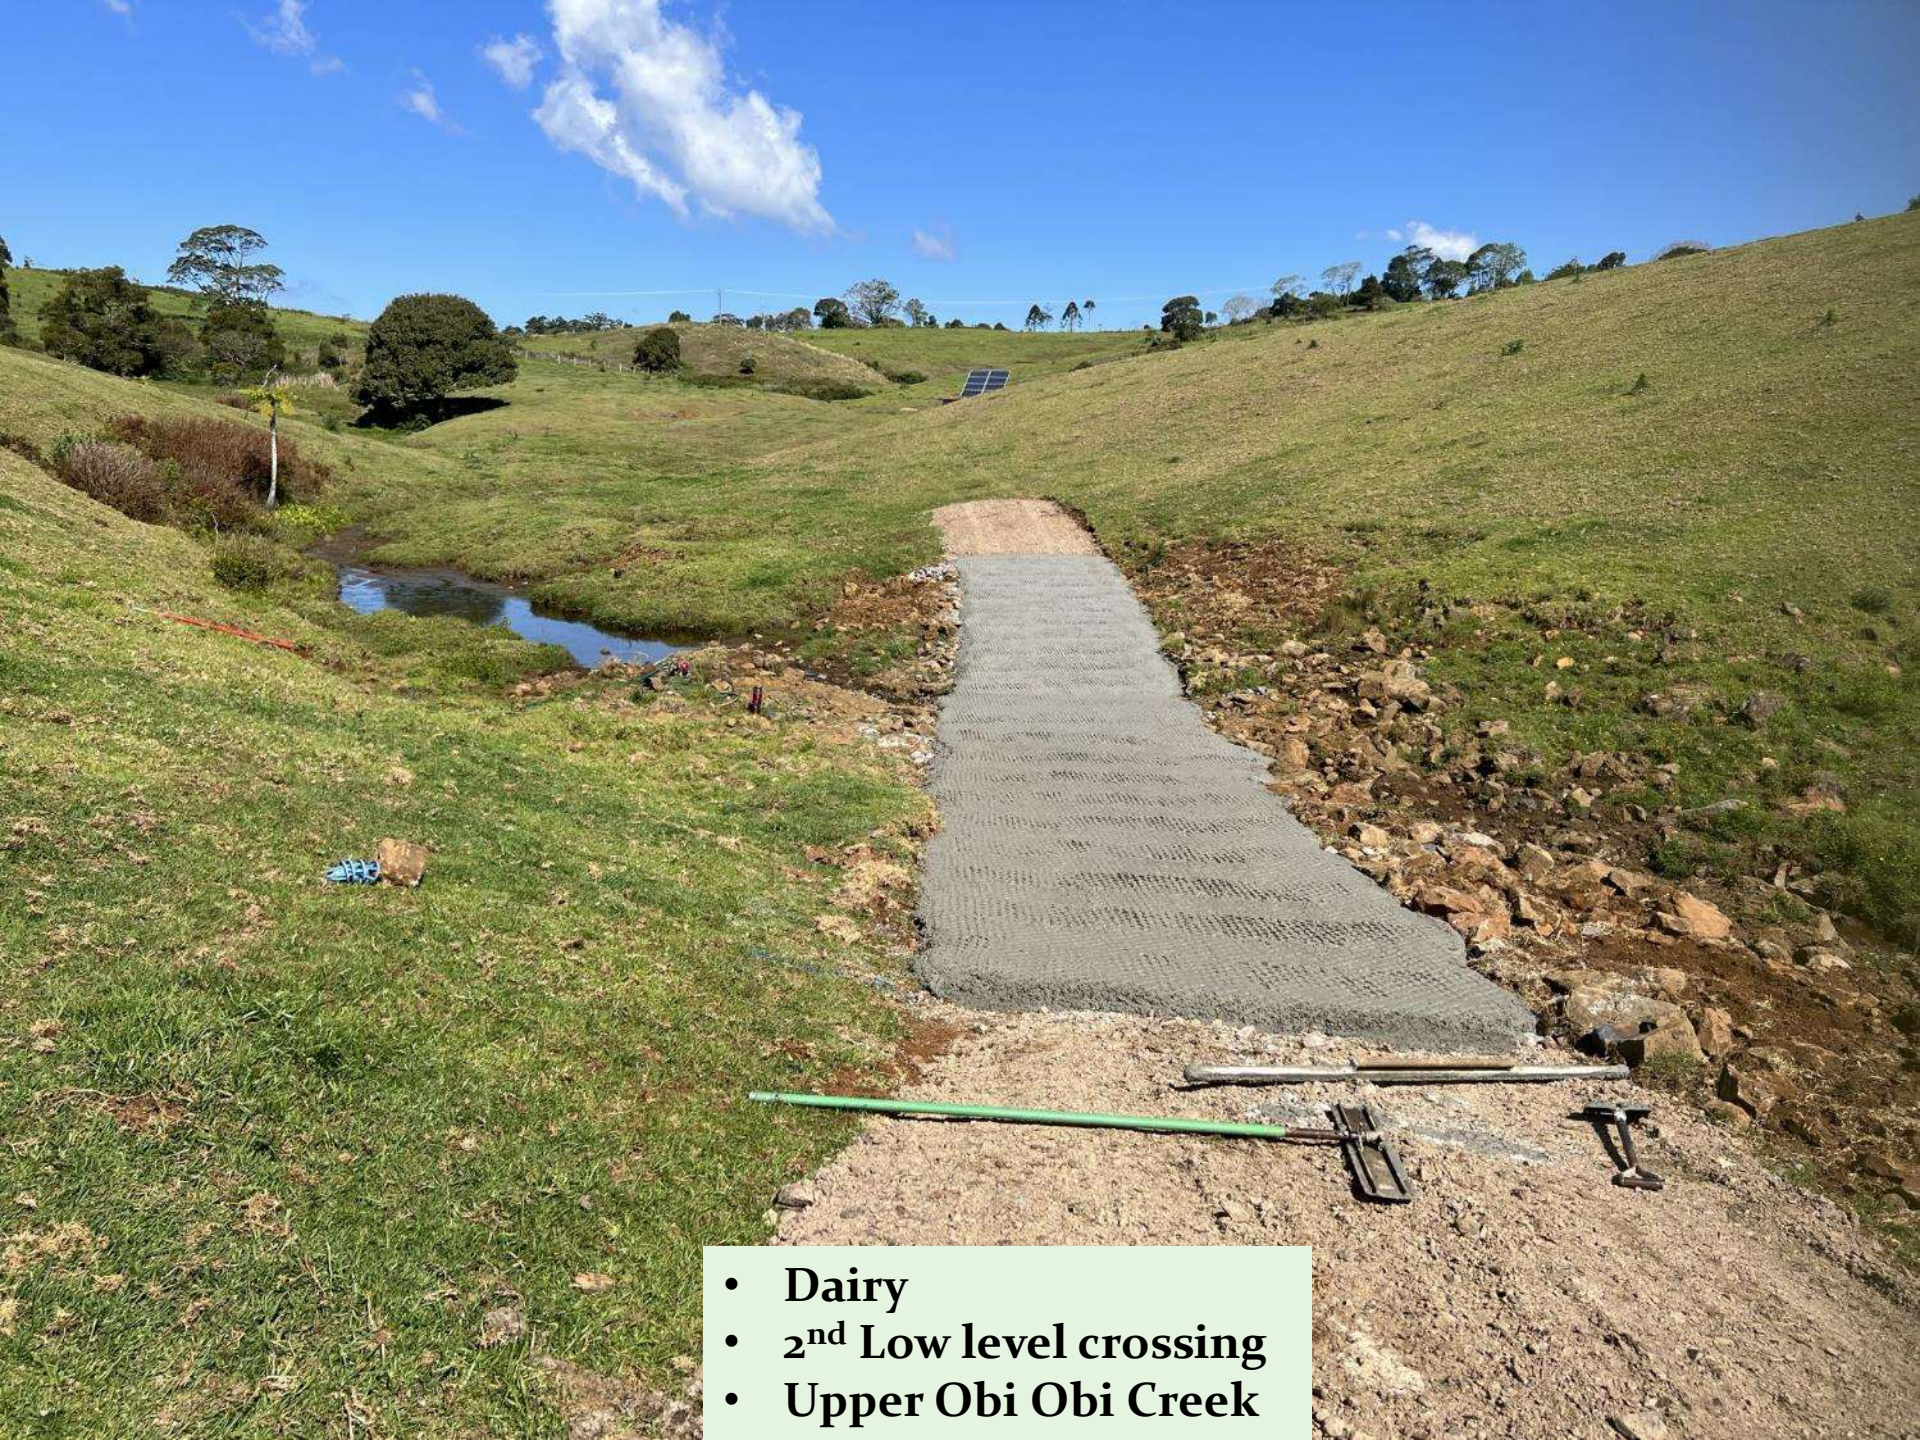
- Dairy
- 2nd Low level crossing
- Upper Obi Obi Creek

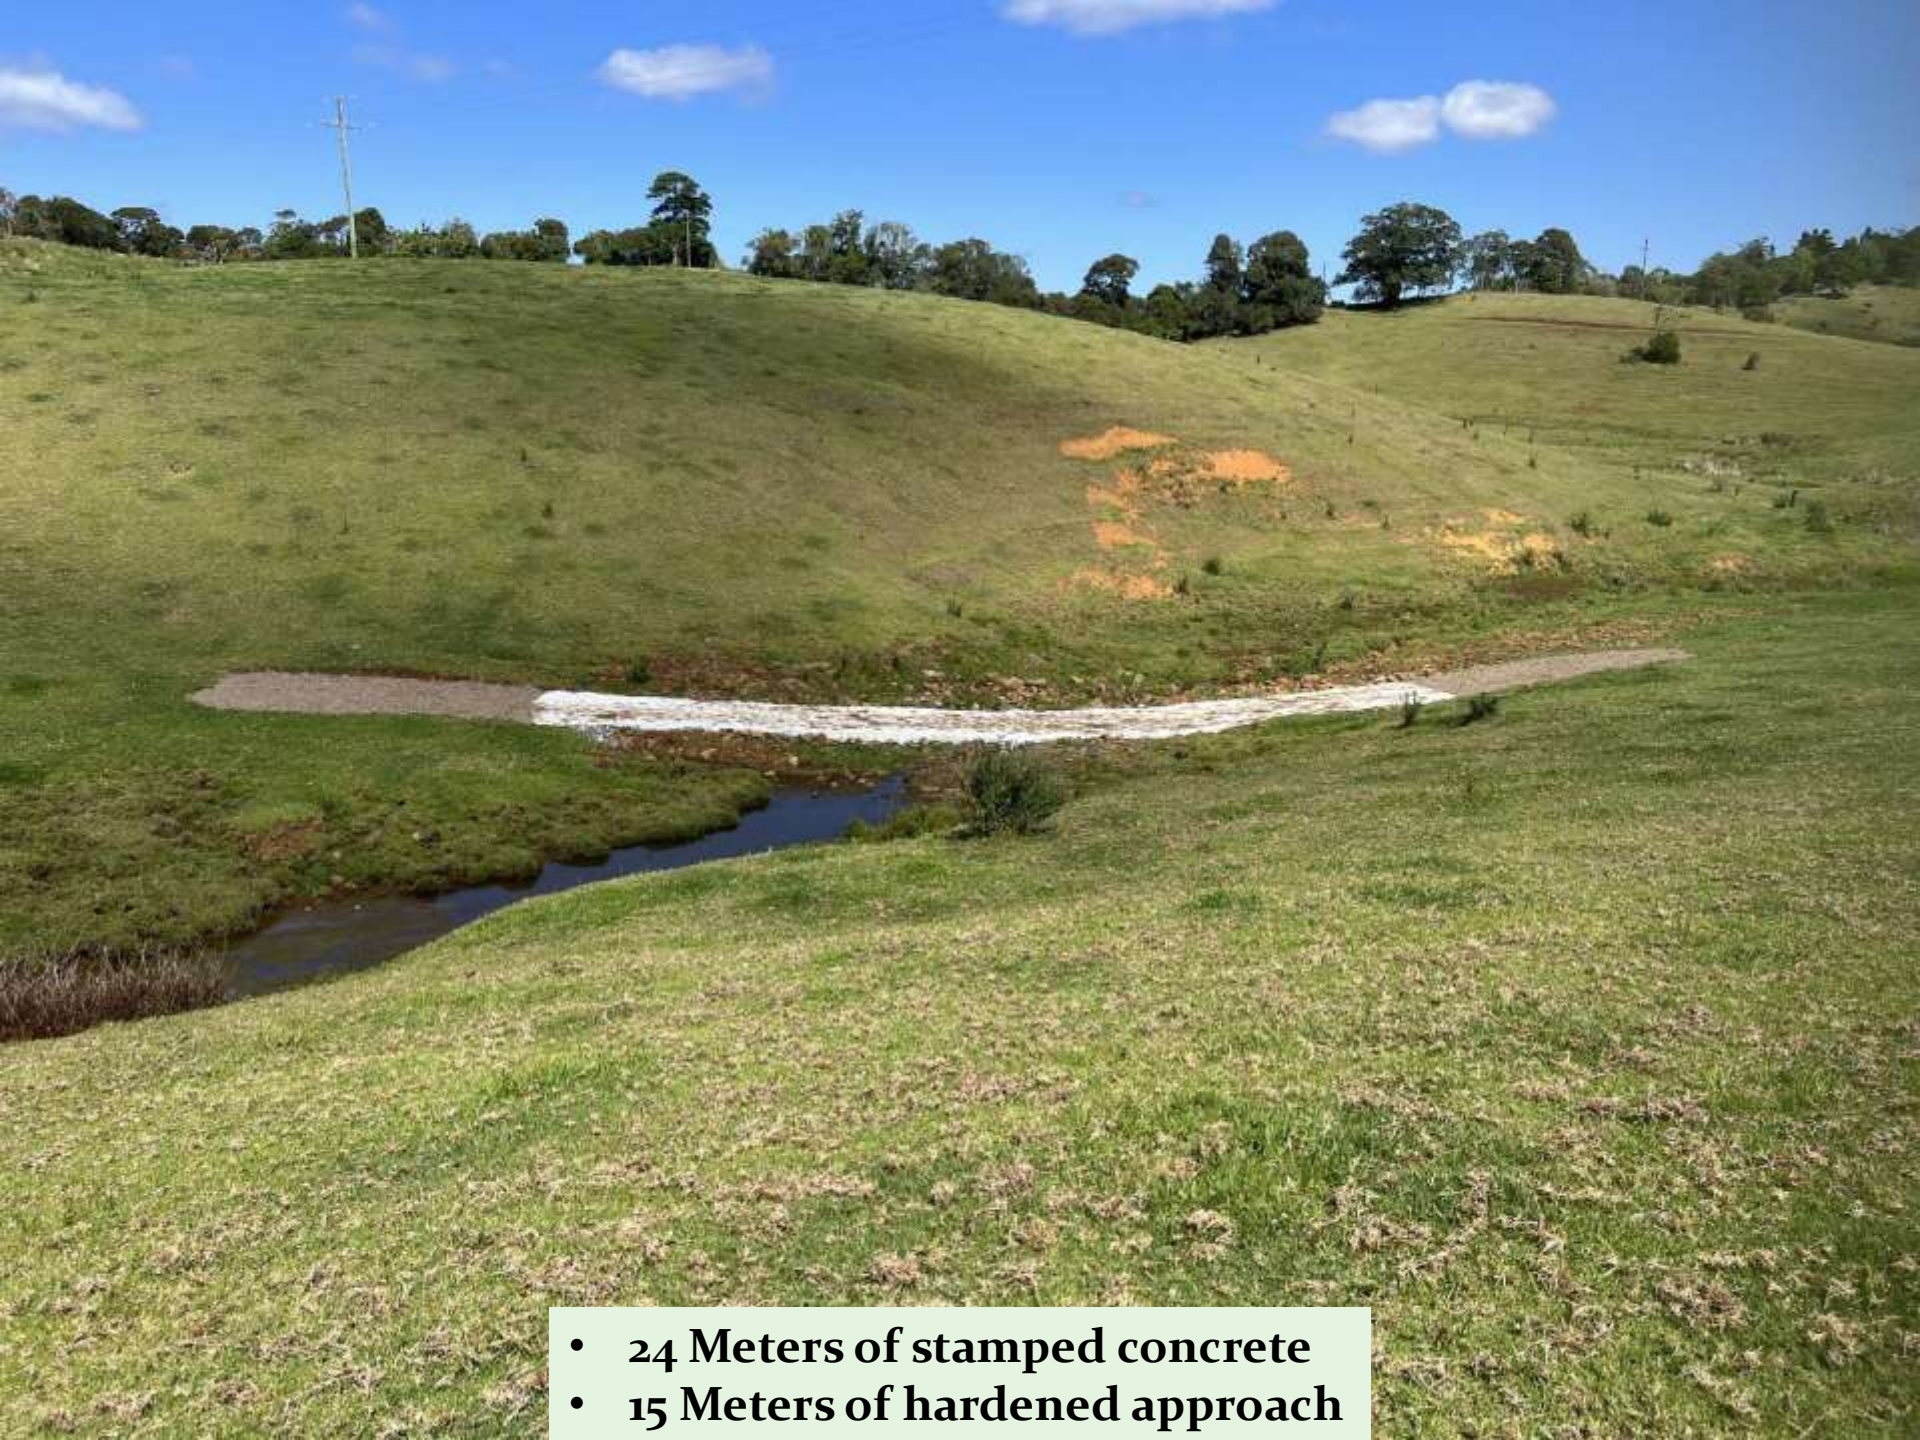
- 24 Meters of stamped concrete
- 15 Meters of hardened approach
