## Falls Creek *(Riparian revegetation)*

## PROJECT PLAN

Riparian Condition Improvement  
& Agricultural Practice  
Improvement Program

CBP2324-002

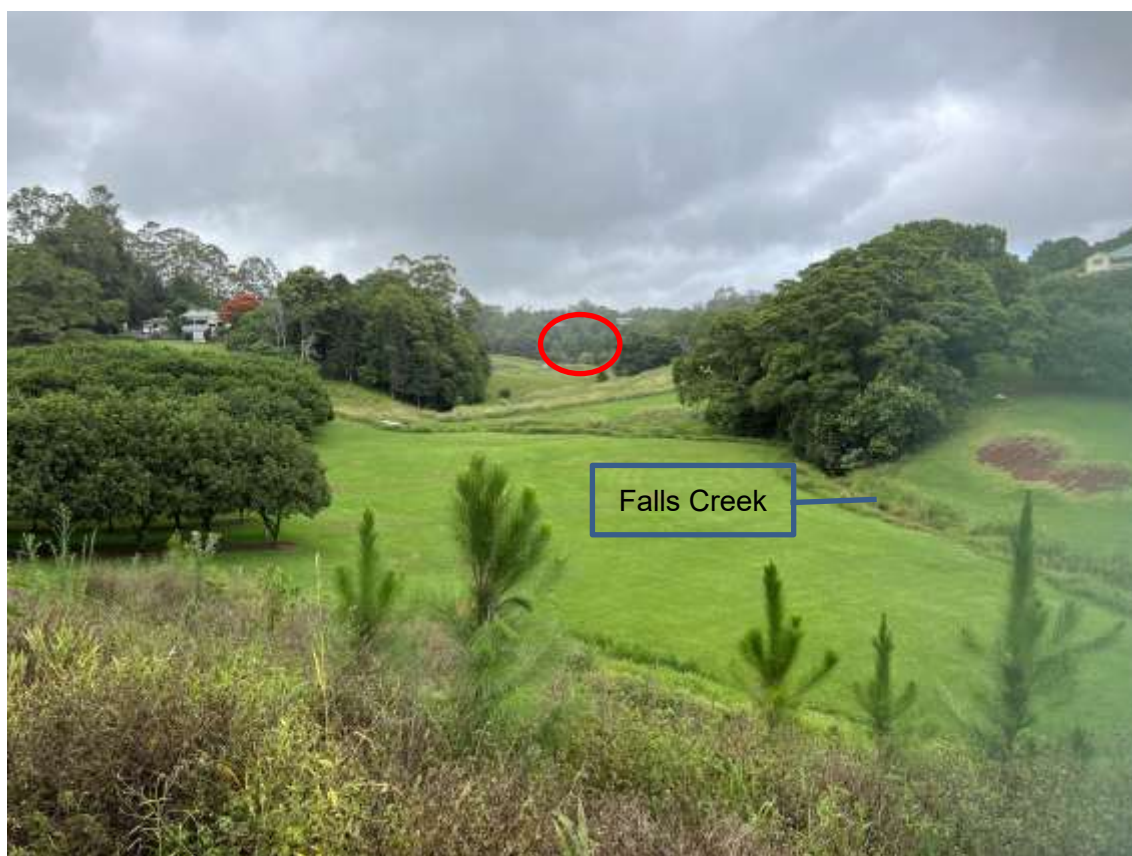
*Left: Falls Creek running through the Macadamia orchid. A patch of native vegetation will be linked to the revegetation, once complete.*

*Also in the background, is the site of a revegetation planting from 2022/3*

The revegetation of Falls Creek on the property will create a vegetative buffer and wildlife corridor of over 350 m. The plantings will connect existing remnant and regrowth vegetation along the creek. The revegetation will use a diverse variety of local rainforest species, with an emphasis on planting species that will result in flowering throughout the year. 1640 trees will be planted in 2 x 2m spacings, and will be planted to give, roughly a 10 m buffer along the creek.

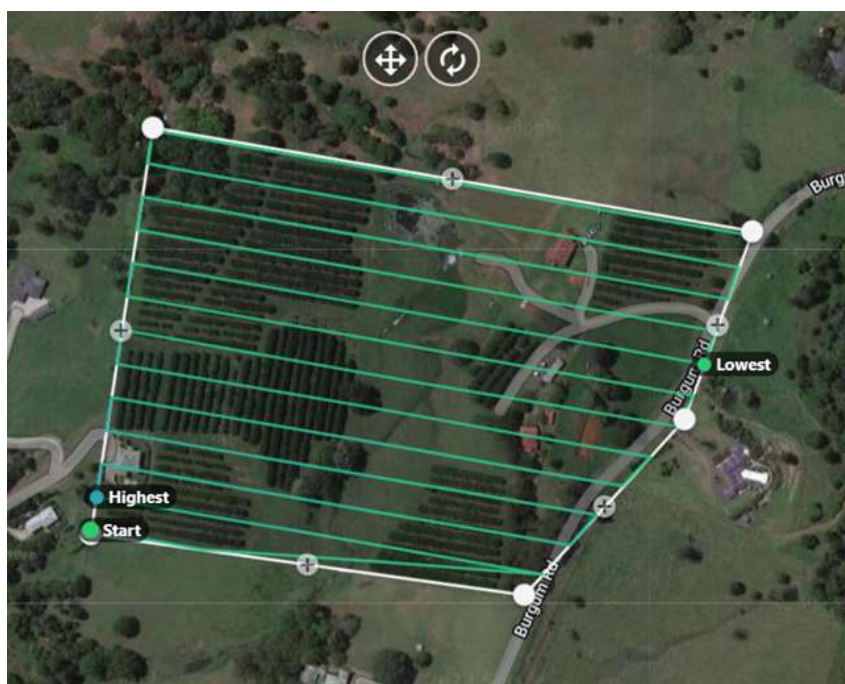
*Left: An example of the mapping of Falls Creek using the drone which will be used for monitoring the project*

Drone footage will be captured for the project site. A detailed map and photo monitoring points will be created for the site. The maps and photo monitoring points will be produced annually and will provide valuable evidence of works completion, a record of changes over time, and provide an important assessment tool to evaluate the project.

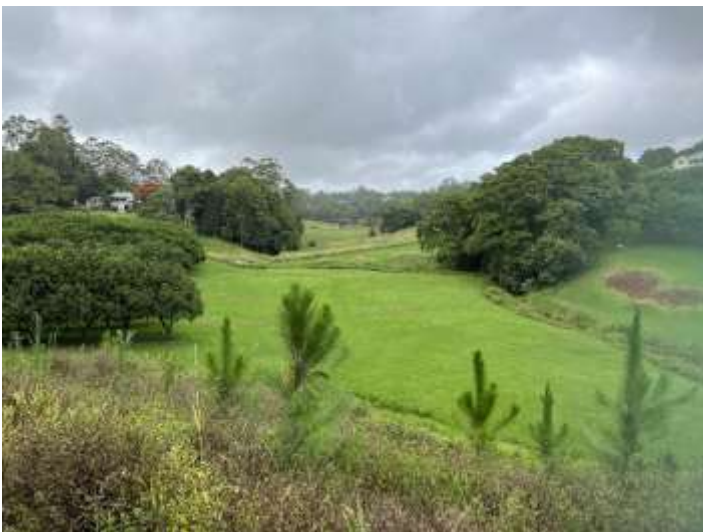
*Left: A section of the proposed planting site along Falls Creek. The tree planting will strengthen the health of the riparian buffer and will link in with existing remnant and regrowth vegetation present along the creek.*

Revegetation will occur along Falls Creek on Bob Grices' property, resulting in the revegetation of approximately 350 m of the creek. This planting will be a diverse selection of rainforest species found in the area. The trees will provide a buffer between the macadamia orchard and Falls Creek. 1640 trees will be planted along the riparian edge, giving a buffer of 10 m on either side of the creek, this will not only have a positive impact by improving water quality, provide a significant wildlife habitat corridor, but will also provide a food source for native bees all year round.

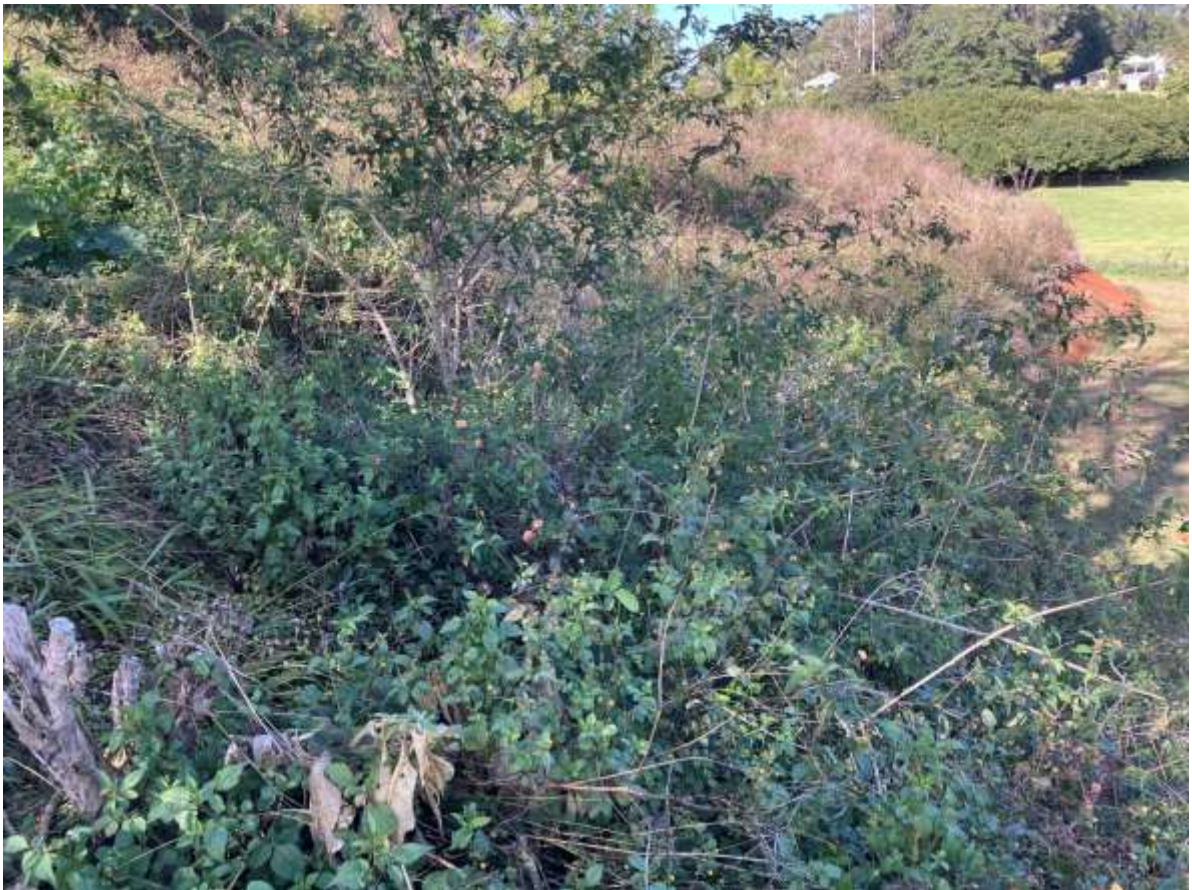
*Sections of lantana, devils fig and wild tobacco need to be brushcut and mulched, then the regrowth treated with herbicide. This is the most cost-effective way to control the weeds on the site.*

- Initial knock down with excavator or tractor mounted mulcher;
- Follow up spot spraying of re-shooting weeds;
- Cut and paste of larger weeds that cannot be mulched or sprayed (particularly important within and adjacent to remnant or good quality regrowth vegetation);
- Regular follow up over several years (as part of revegetation maintenance).
