## RCI & ESI Report – August 2023

Riparian Condition Improvement  
&  
Agricultural Practice Improvement

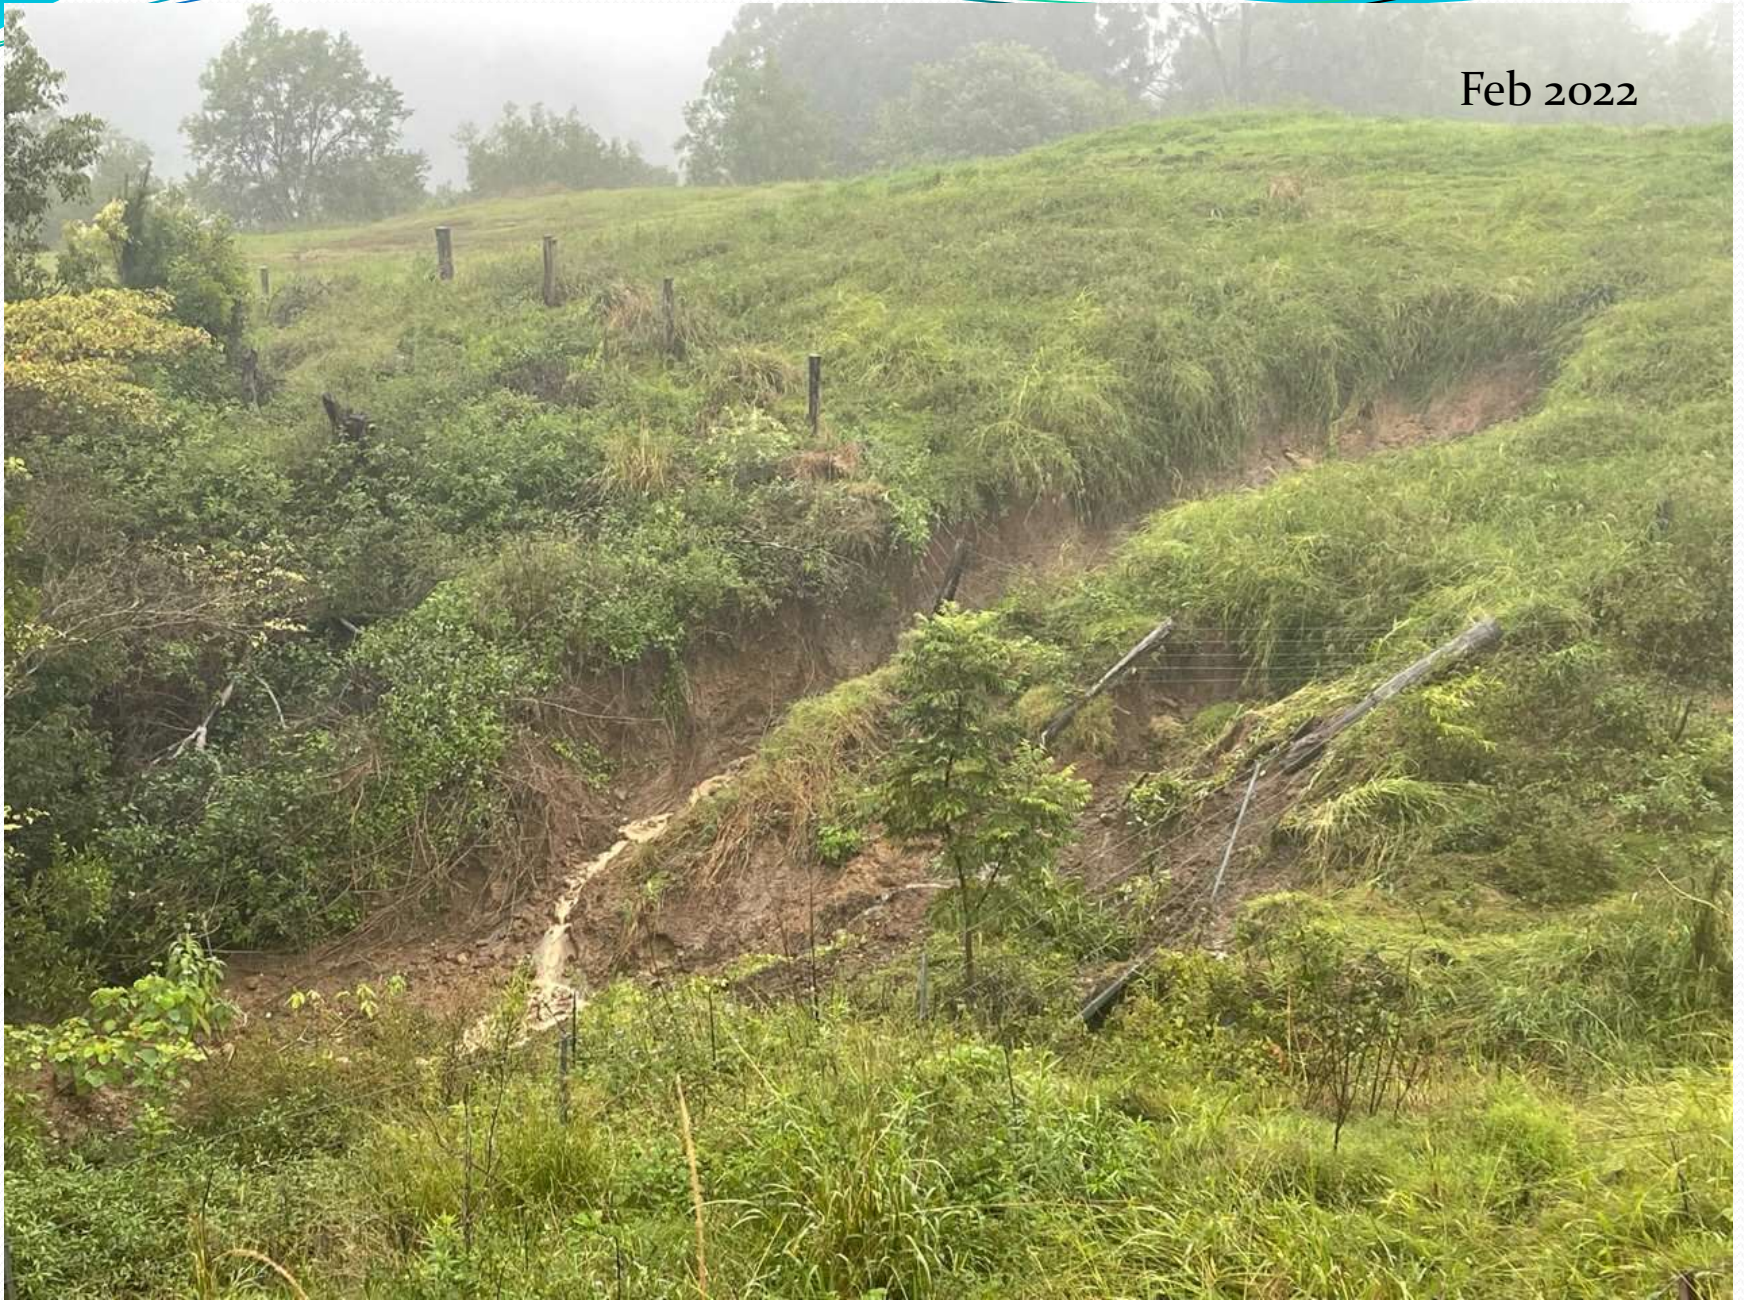
Feb 2022

March 2023 – before project commencement

- Landslip and gully erosion causing sedimentation and turbidity in Obi Obi Creek.

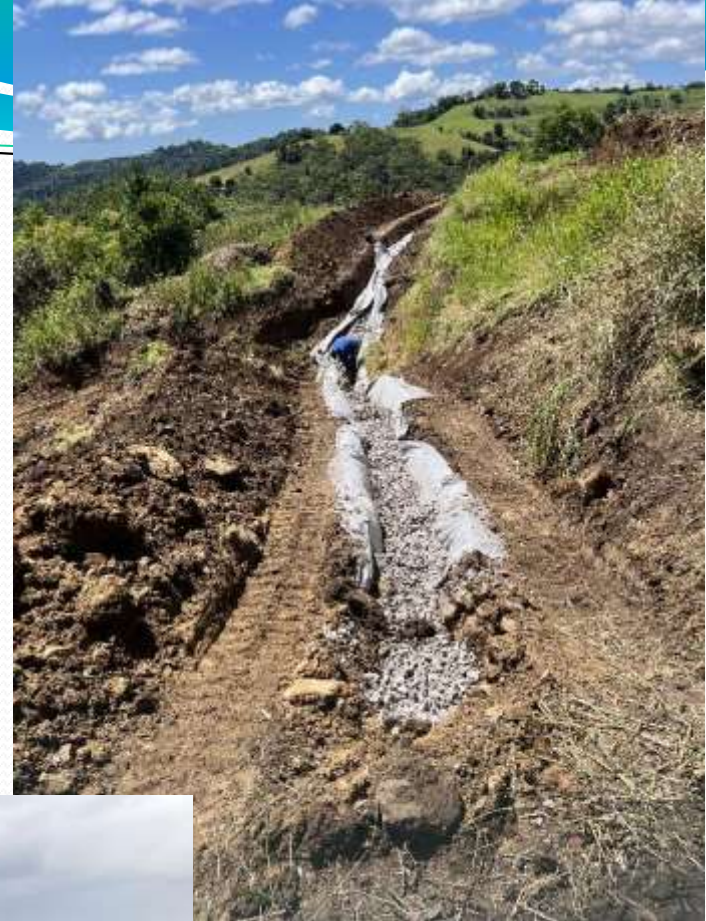
Concrete matting  
used to prevent  
any gully erosion  
occurring.

- Geofabric
- Ag pipe
- 40 mm screenings

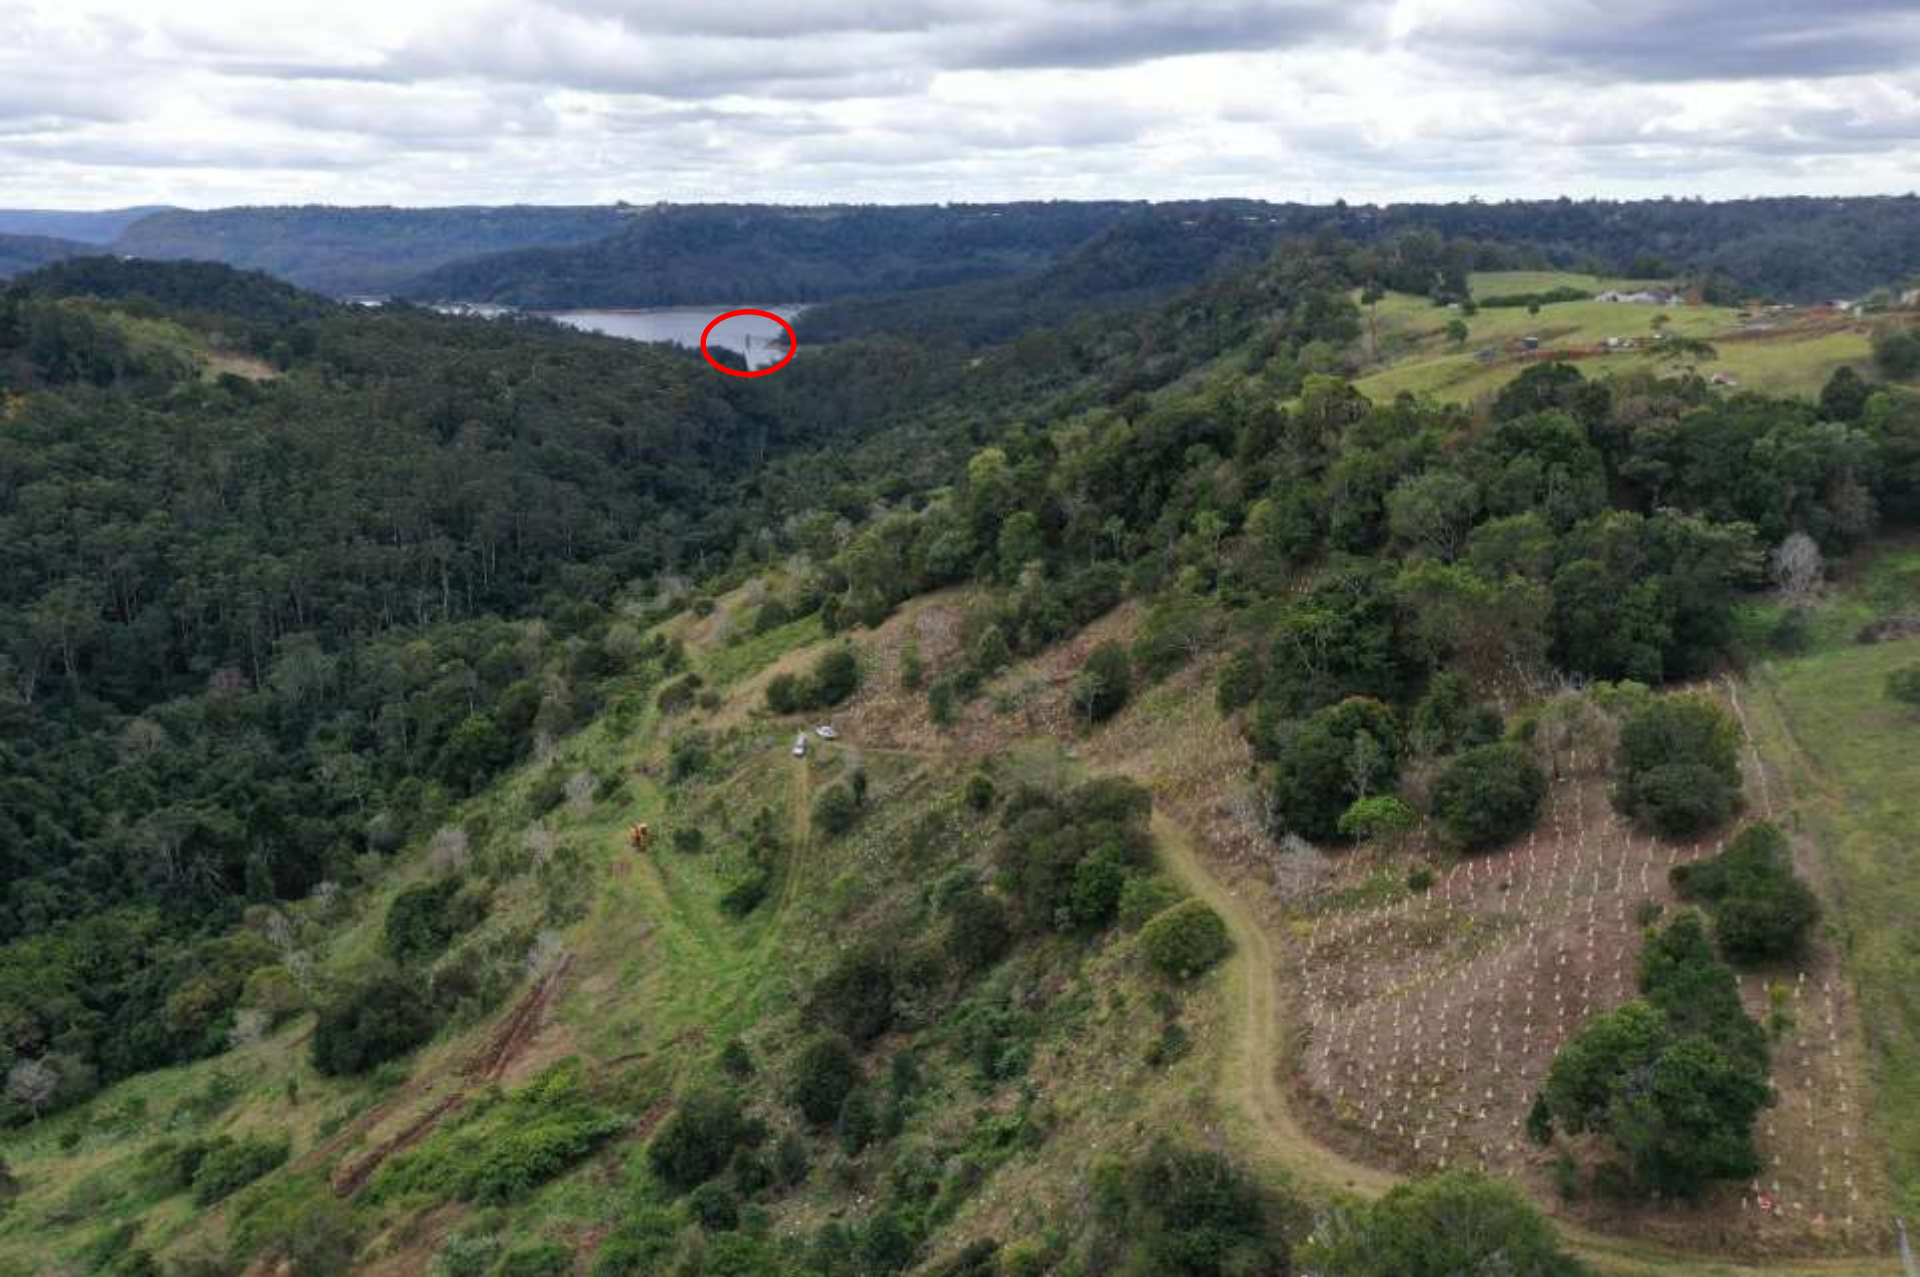
- Landholder's property is very important, due to its location to Seqwater offtake.

- Numerous areas of instability are present in the planting area
- 10% of the trees planted were Bunyas (250), to assist with the stabilisation over time

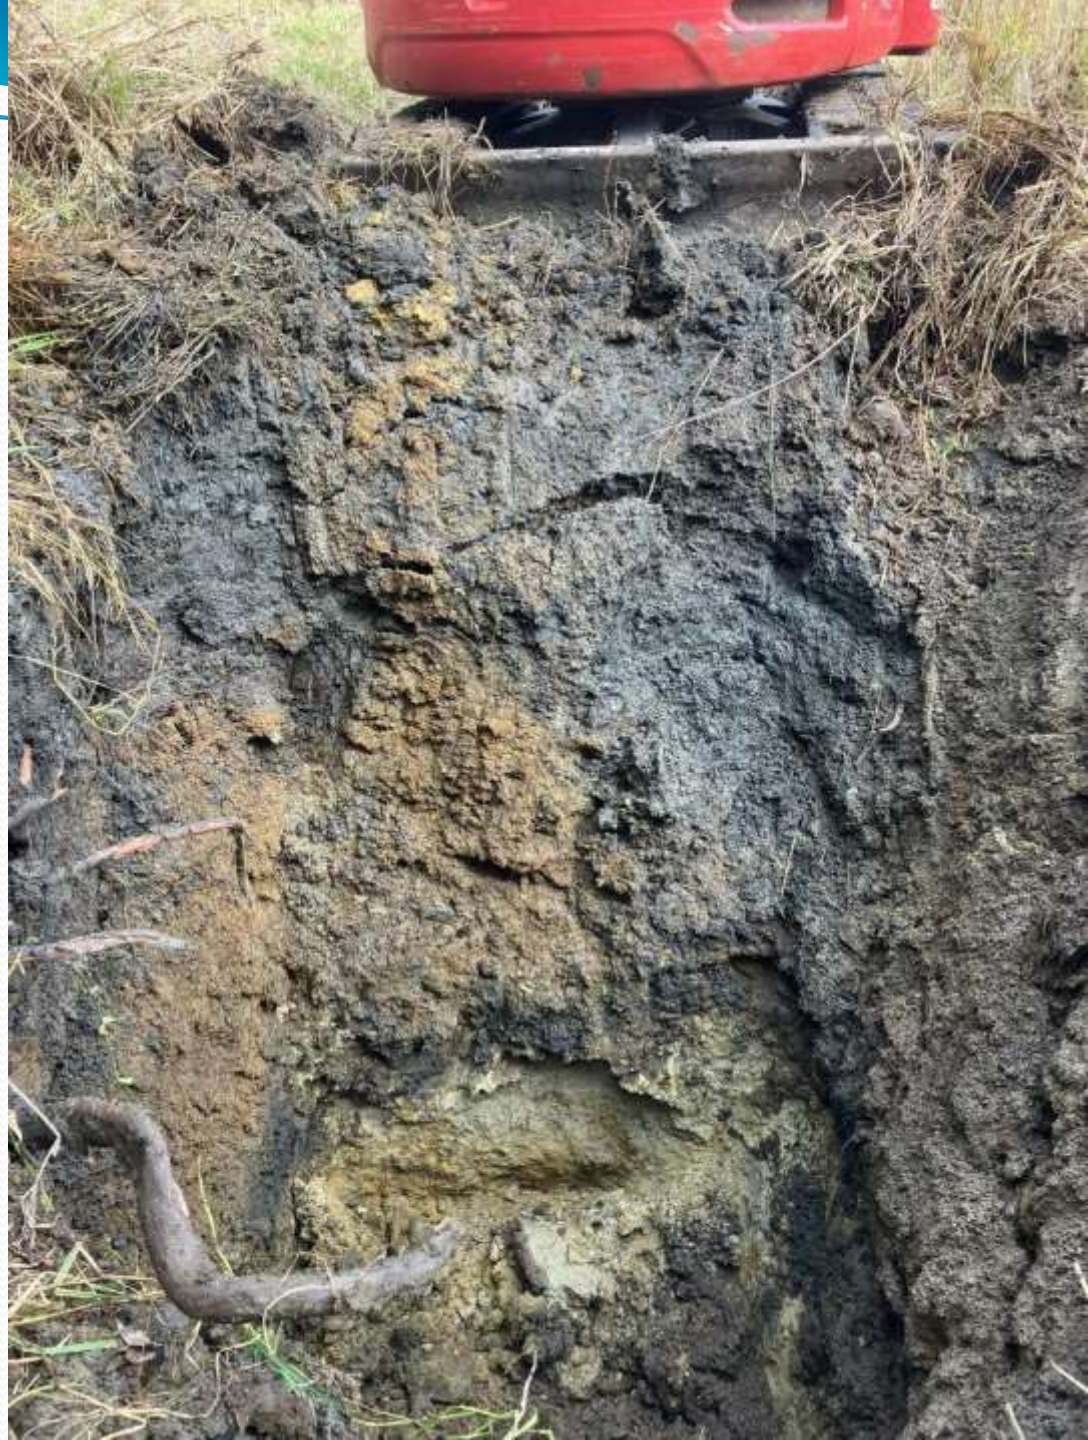
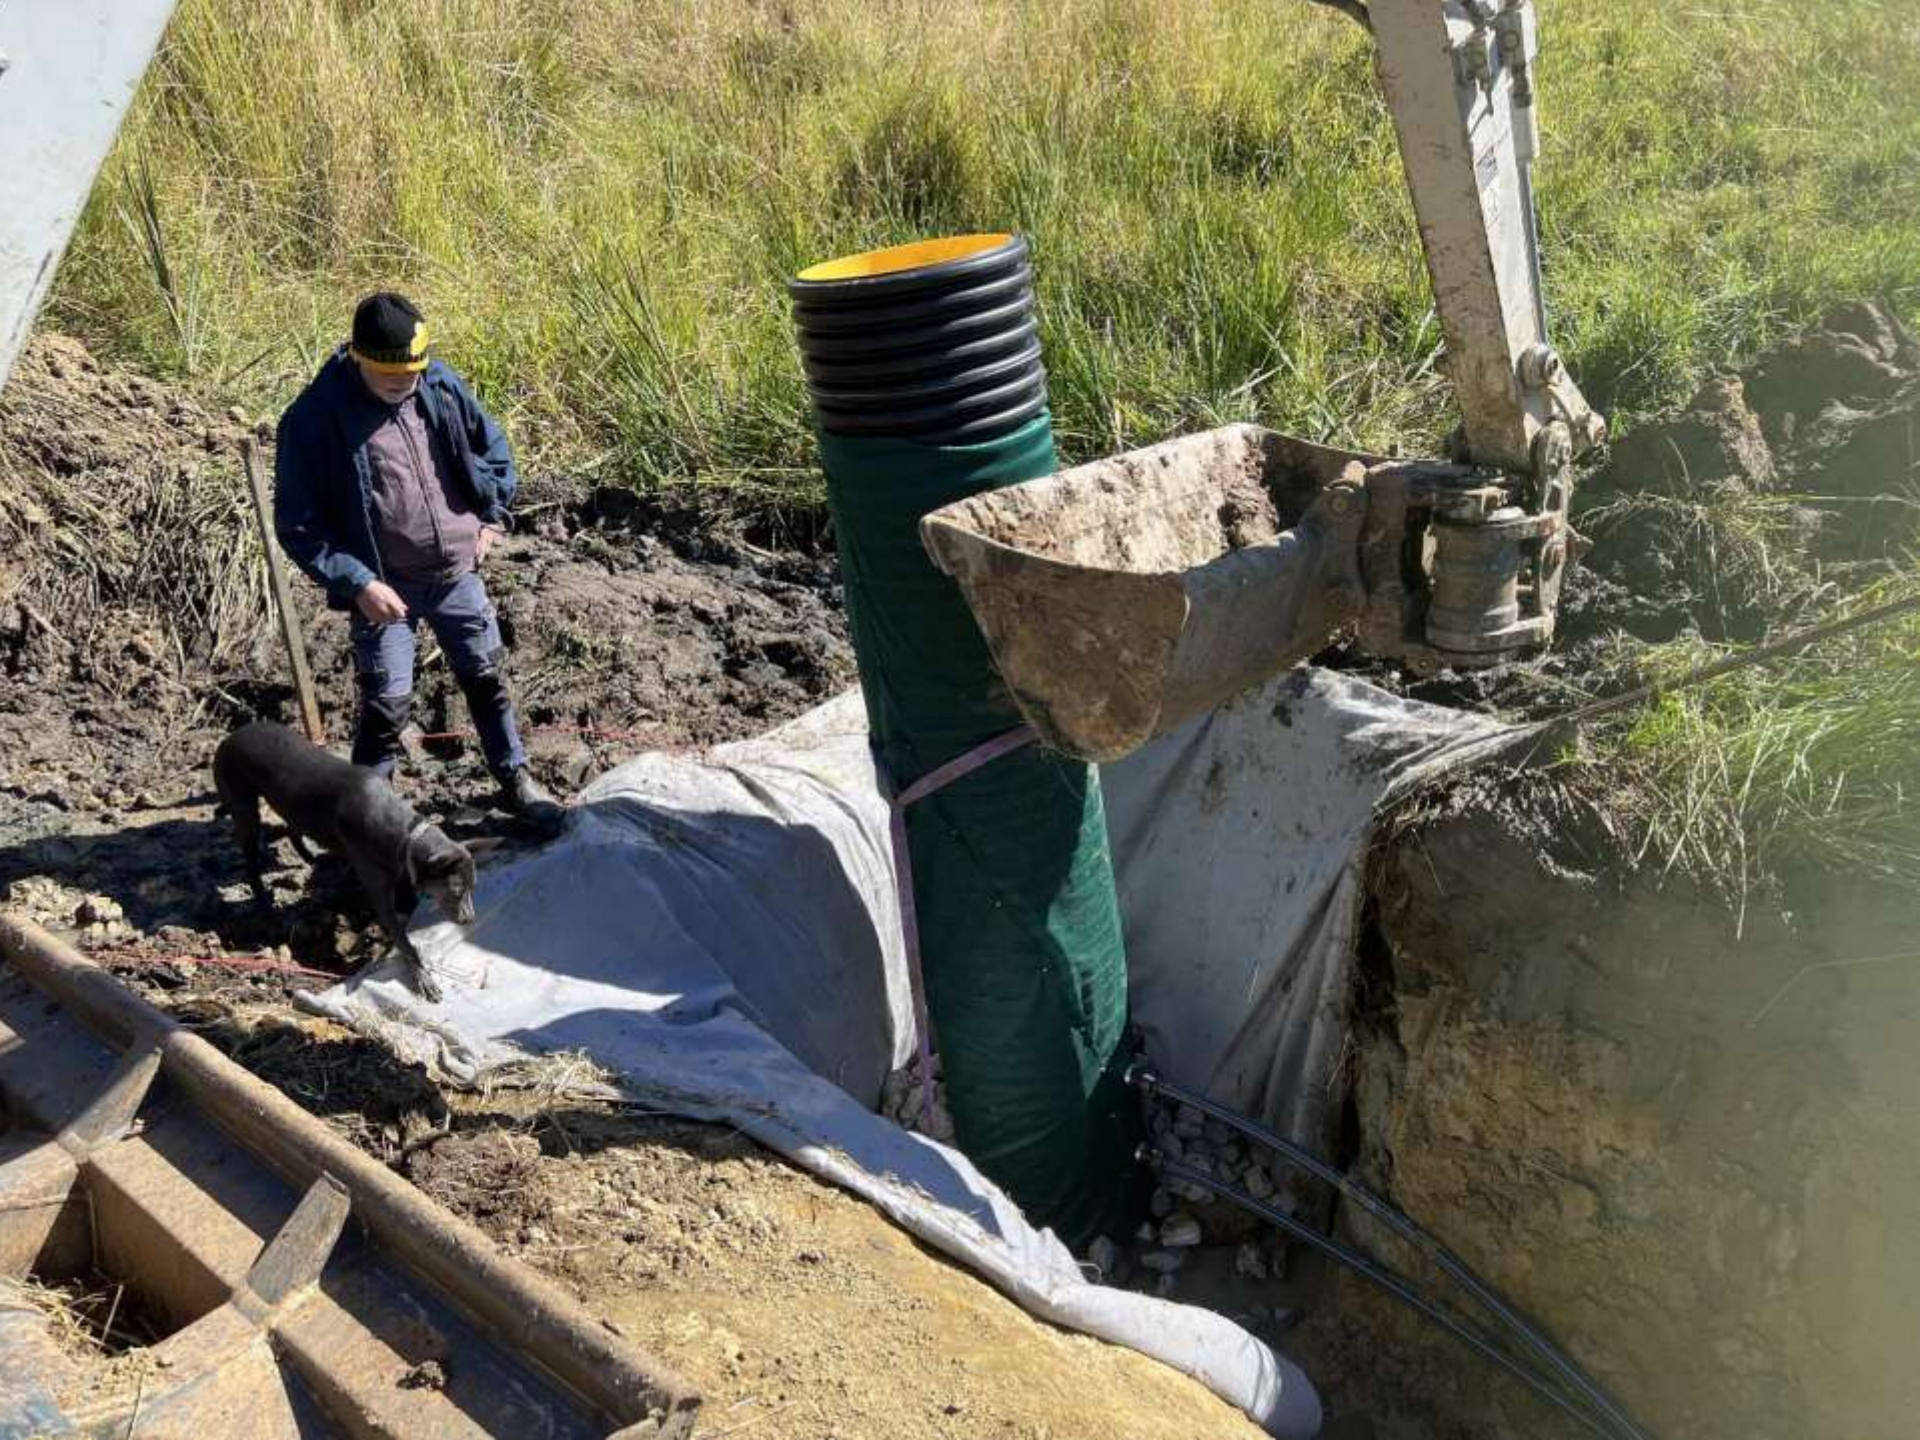
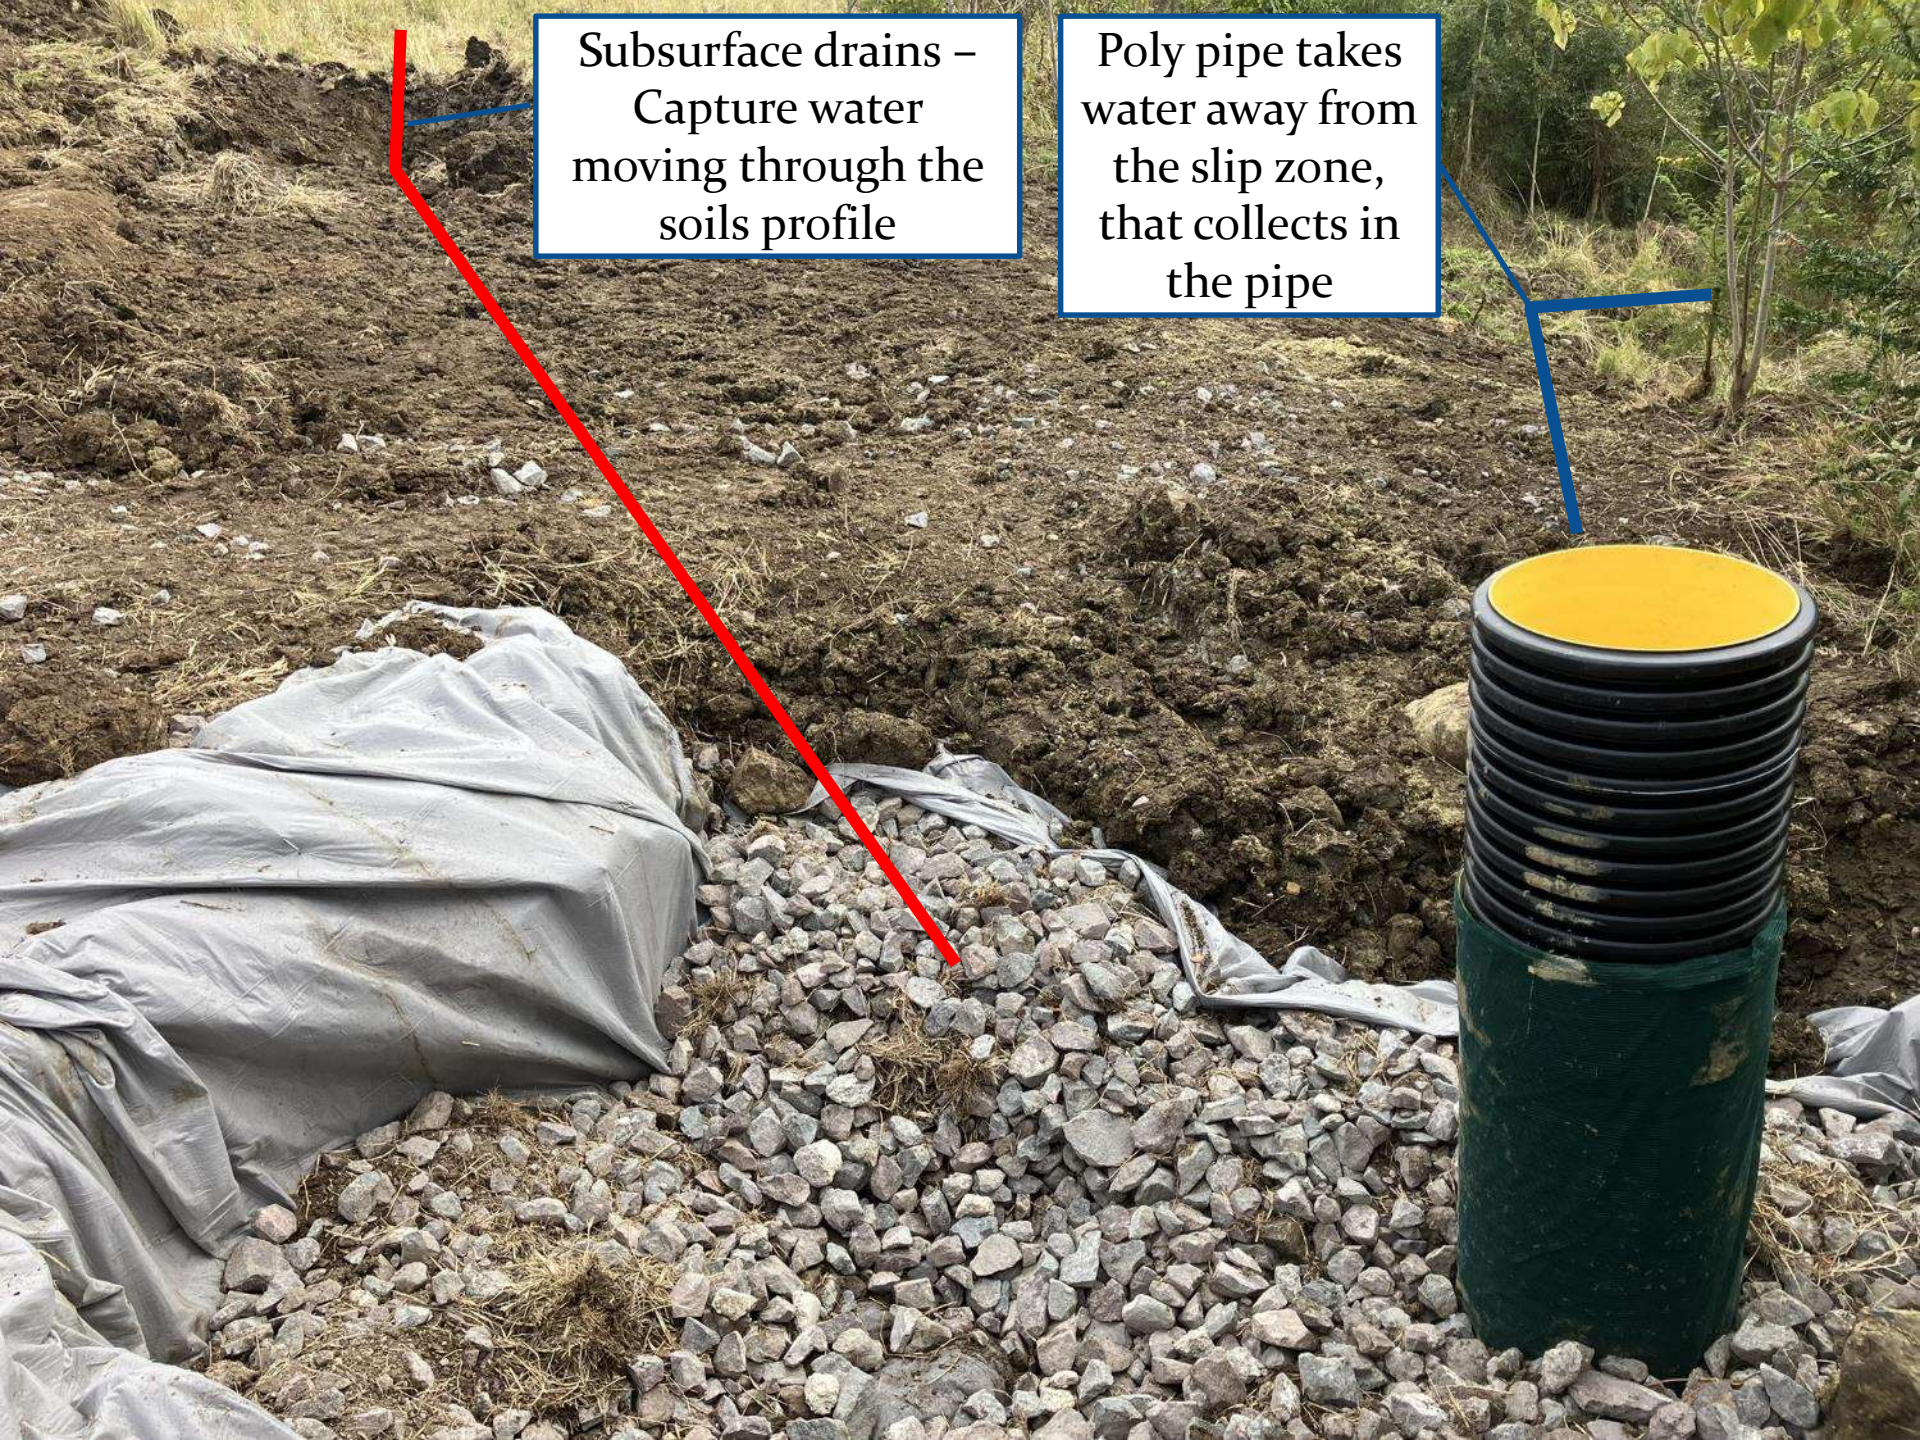
Subsurface drains –  
Capture water  
moving through the  
soils profile

Poly pipe takes  
water away from  
the slip zone,  
that collects in  
the pipe

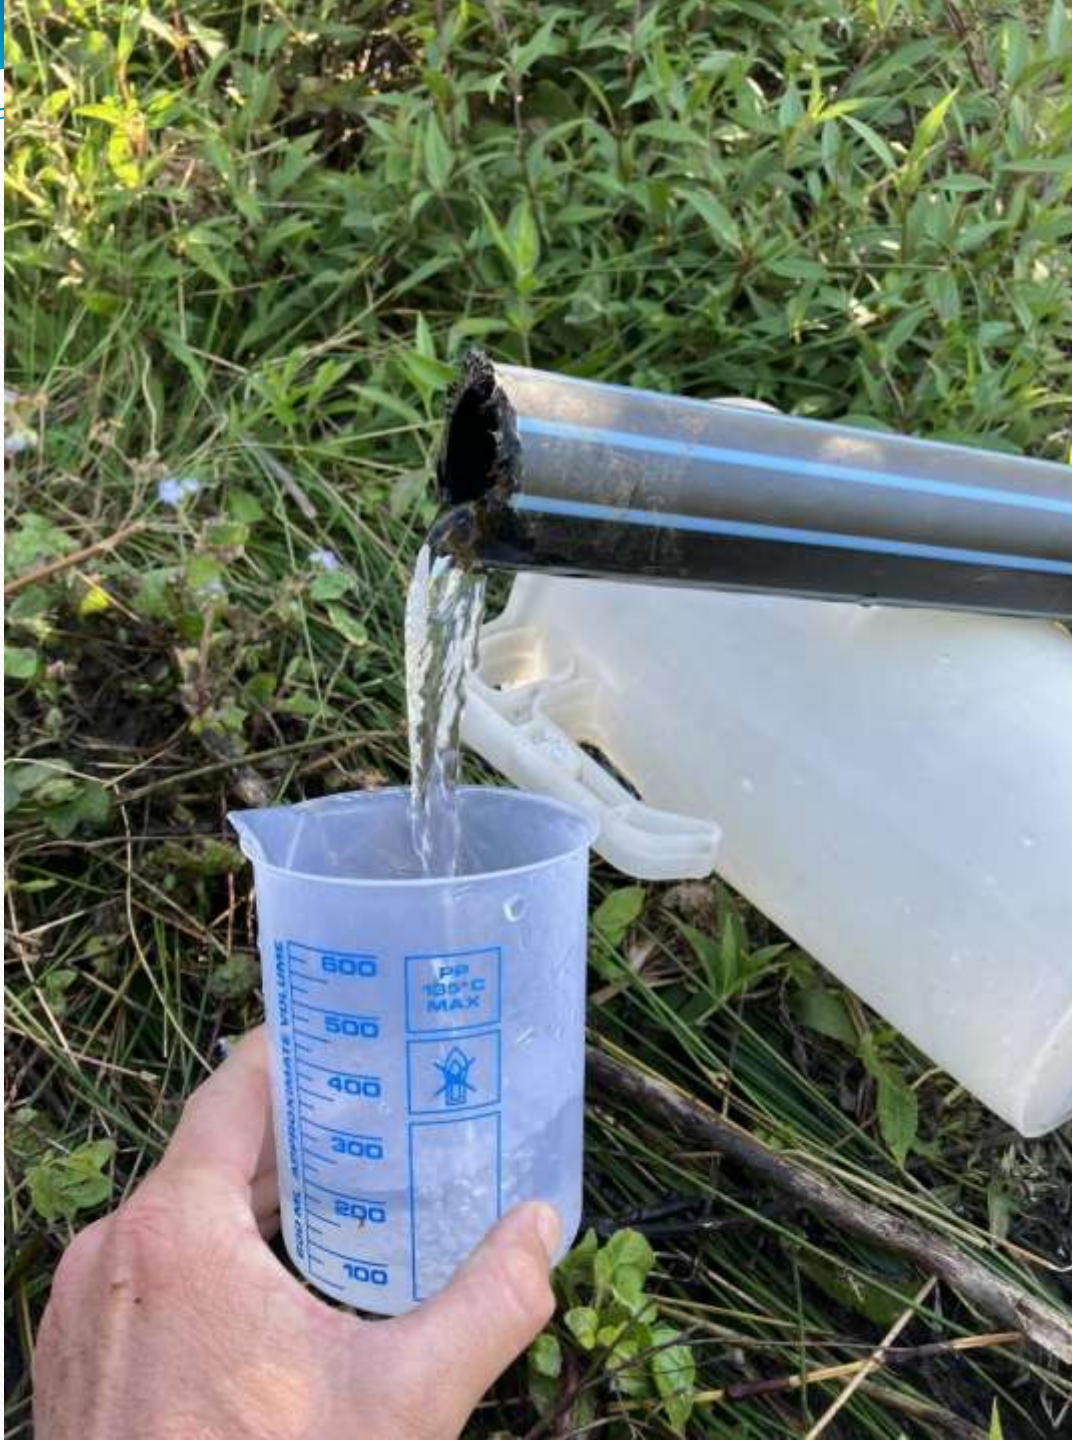
## Well 1

- 31-5-23 –  
5,760 L/Day

- 26/7/23 –  
3,927 L/Day

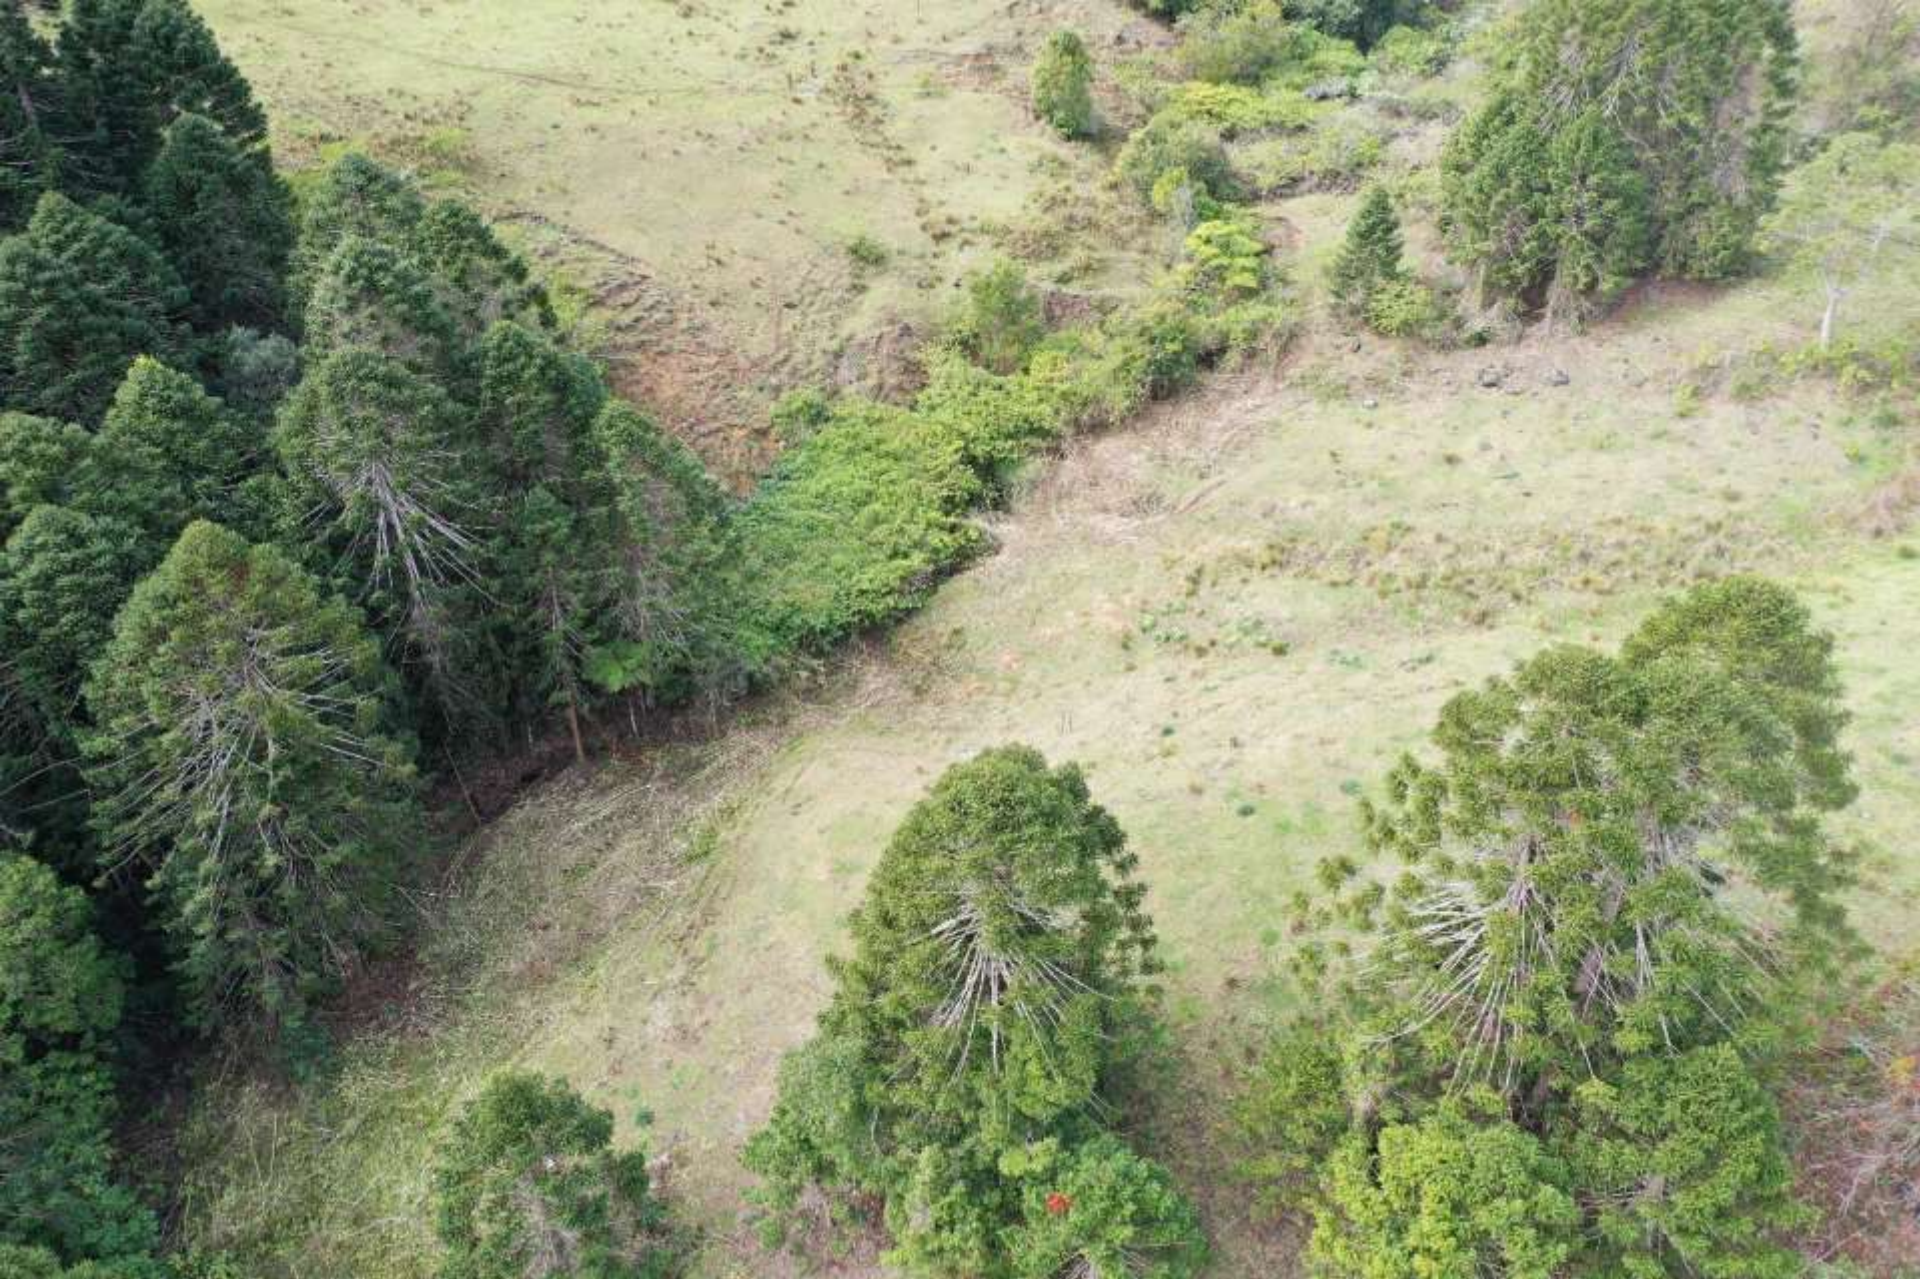
**Bridge Creek (fencing, weed control & revegetation)**

- Creek system with large areas of instability

- Weed Control – New contractors undertaking brushcutting
