LAKE  
BAROON  
CATCHMENT  
CARE  
GROUP

## Erowal Riparian Fencing & Off Stream Watering

PROJECT PLAN

Project No. 1213-008

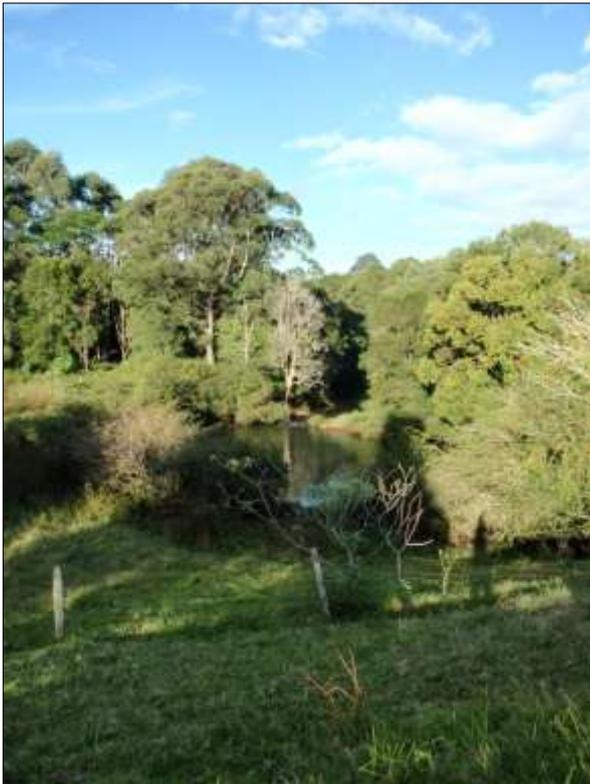
*Left: Upstream Reach on the Obi – note the ineffective riparian fencing.*

Approximately 850 metres of standard cattle fencing (timber splits at 5 metre spacings, 4 strand wire; 3 barb and top plain) with steel gates where required (approximately 5). On the upstream Reach of creek the new fence will closely align to the existing ineffectual/damaged fence. The downstream Reach of the fence will have to be aligned marginally further up the bank as large camphor laurel trees compromise the original alignment. It is expected no grazing will be lost as a consequence as the mature camphors discourage pasture growth anyway.

The existing ineffectual/damaged fencing will require removal.

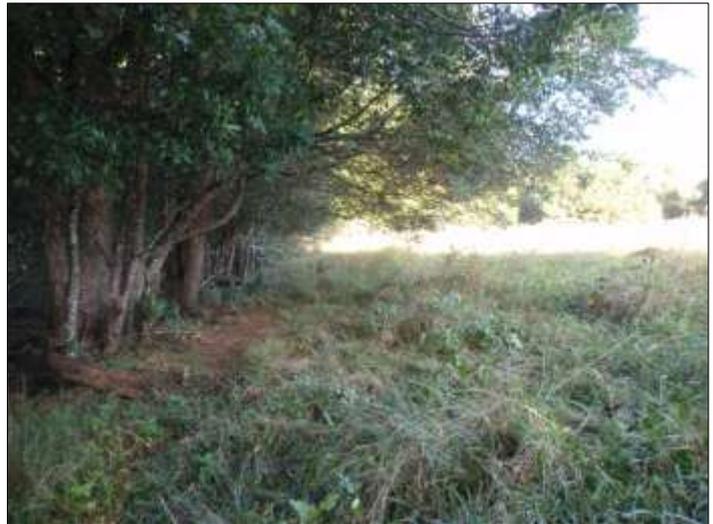
*Above: Downstream Reach on the Obi – fencing damaged and ineffective – note the large camphor laurels.*

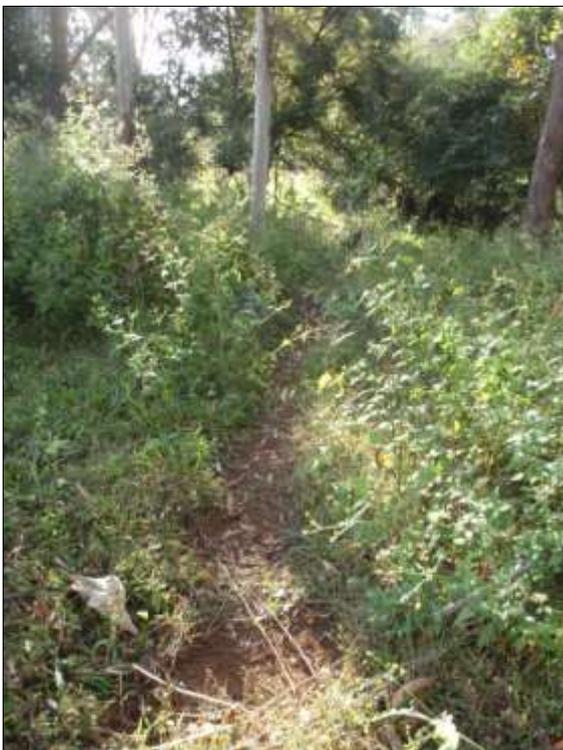
*Above: Weedy riparian zone.*

Weeds will require a medium term management program. Initially the smaller patches of woody weeds will be mulched (upper section only), with follow up to stem inject larger woody weeds, cut and paint smaller isolated trees/shrubs and discretionary spot spraying of groundcover weeds.

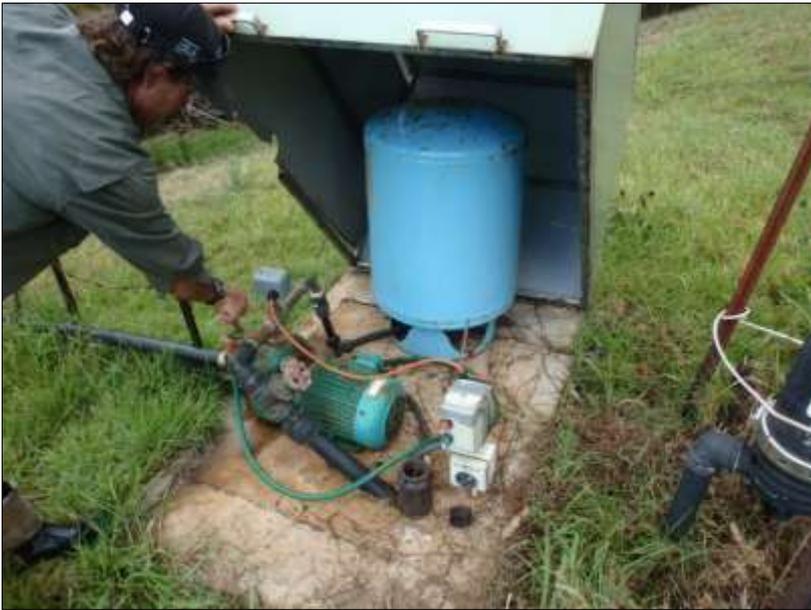
*Left: Existing pump on Obi Obi Creek.*

With livestock access to the Obi Obi Creek removed, a reliable alternative supply of water is required for the livestock. It is proposed to utilise the existing pump on the creek bank to supply a minimum 5,000 gallon tank (22,500 litres) that ideally would be installed adjacent to the small machinery shed 25 metres from the pump. Rainwater from the shed could be (but not essential) directed into the tank to further supplement available water. A single concrete trough (approximately 600 litre capacity) would be installed between the pump and tank – within the small set of cattle yards.

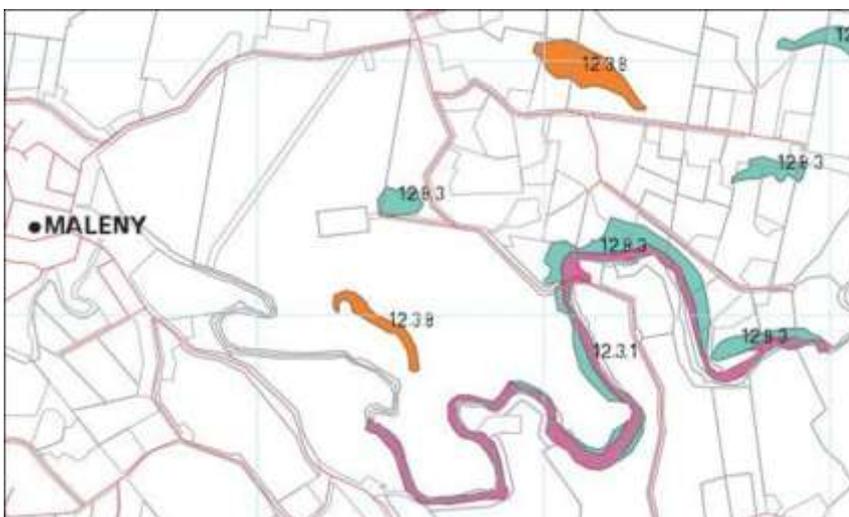
*Left: Map showing the remnant vegetation on the MCP and the proximity to urban Maleny. Note the red coloured endangered remnant 12.3.1.*
